Architectural Analysis
Historic Hebron Academy
Hebron New Hampshire
December 17, 2010

STRUCTURAL ASSESSMENT REPORT

HEBRON TOWN HALL

HEBRON, NEW HAMPSHIRE

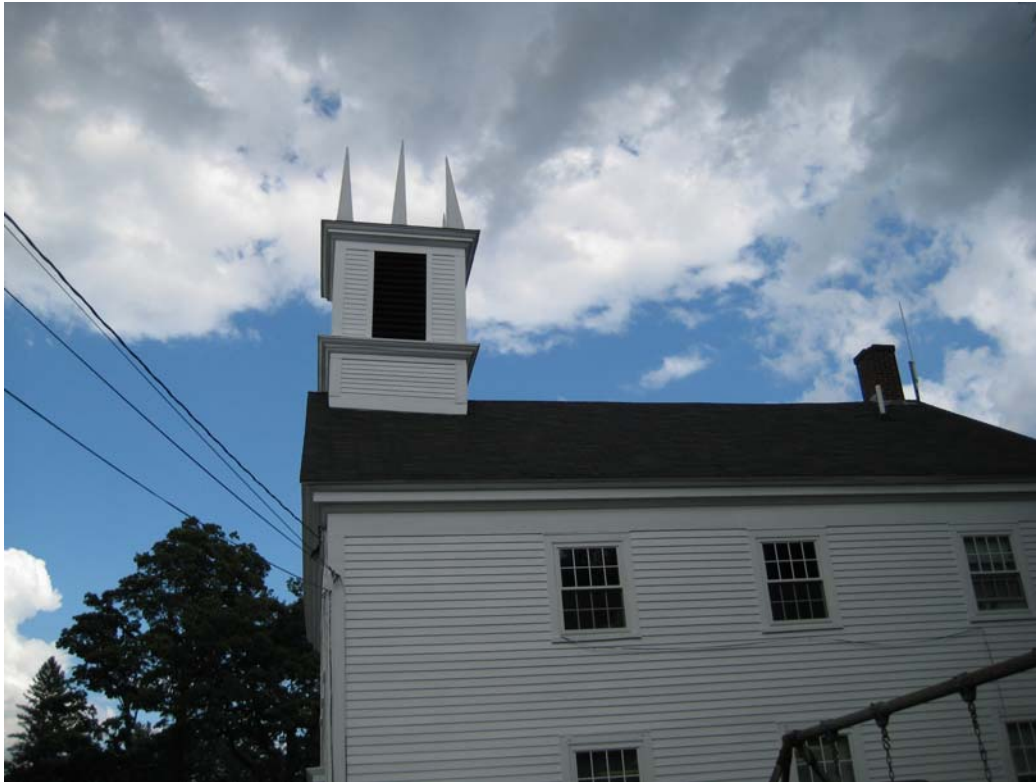
Original tower leans toward the south (rear) of the building. Stabilize the tower in place and inspect roofing for leaks at joints between main roof and tower walls.

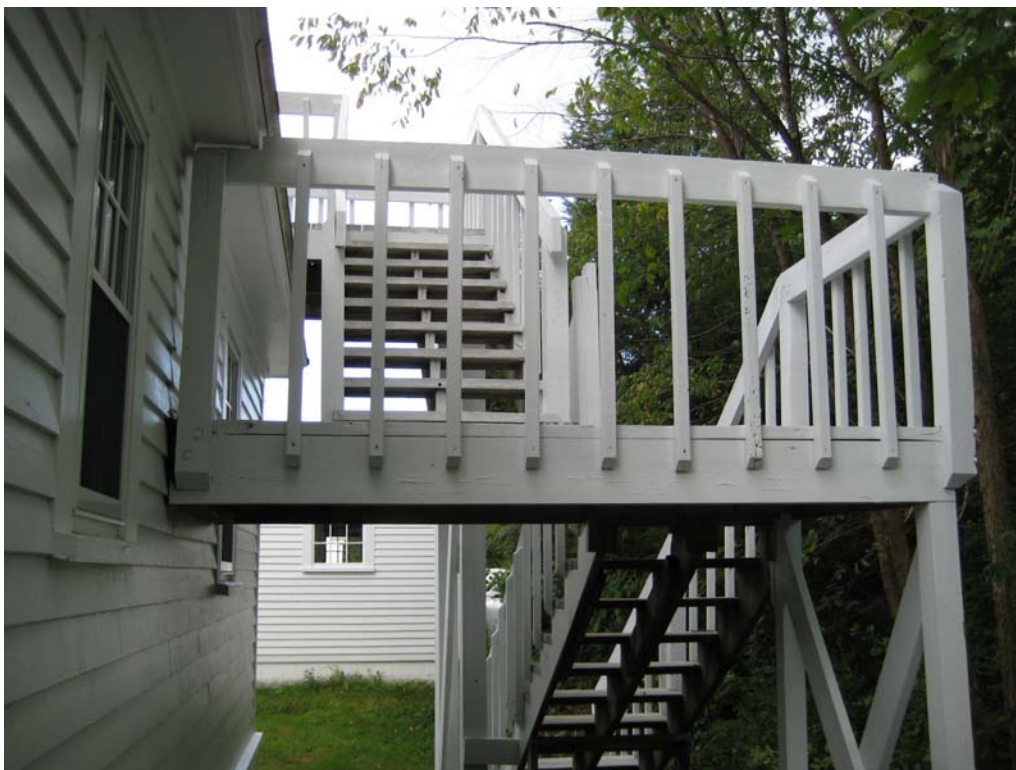
Non-compliant exterior egress stair should be modified or replaced, ideally with an interior stair.

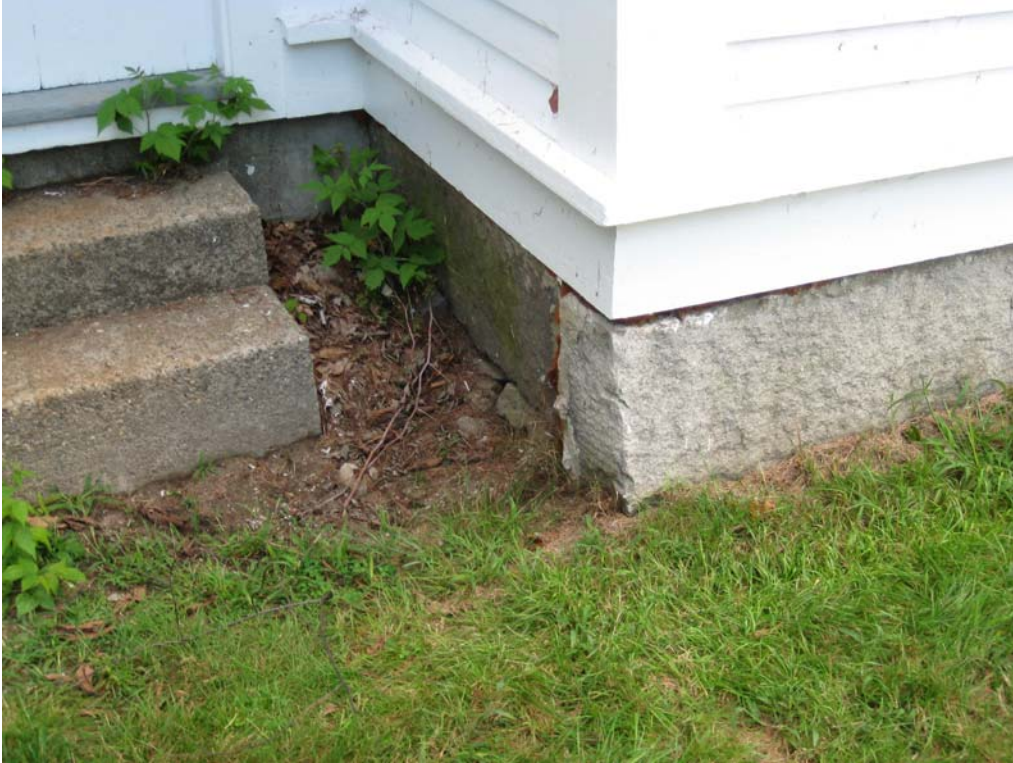
Dressed granite capstone of existing foundation at east facade – note gap caused by stone tipping outward.

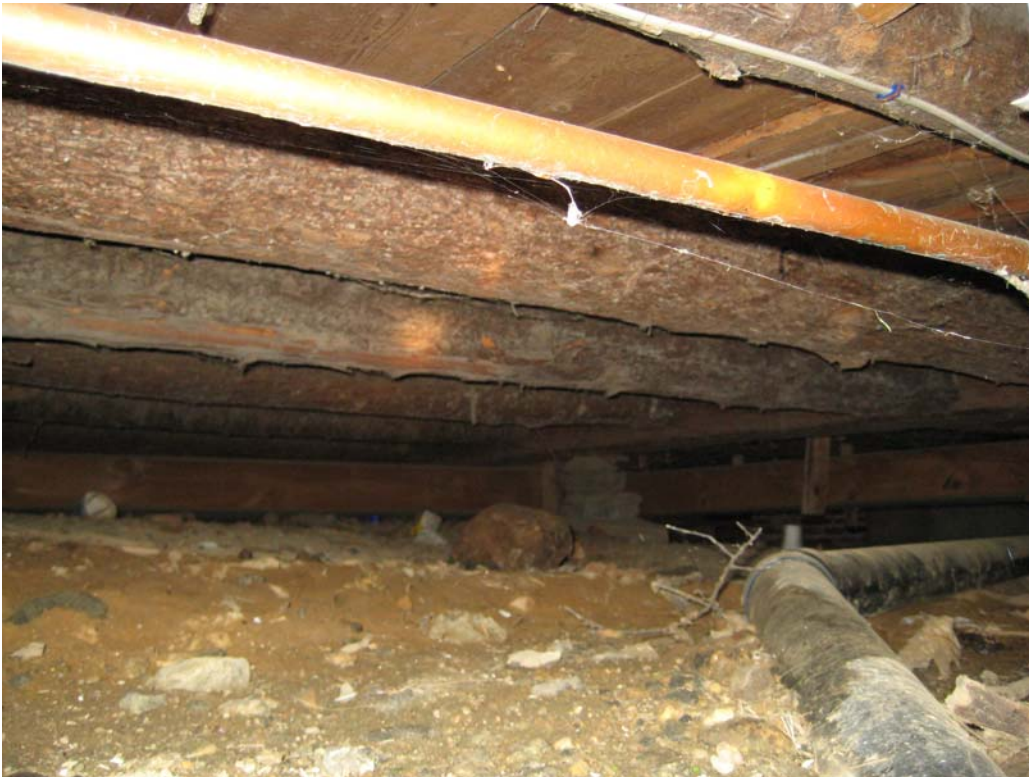
Existing crawl space with wooden plumbing chase and stone mid-beam support - note proximity of floor framing to soil and complete lack of insulation in floor system above.

The floor framing for the main level of the Hebron Academy is not separated appropriately from the exposed soils of the crawlspace. At a minimum, the crawlspace should be excavated to a minimum of 18" deep and have a reinforced vapor barrier installed over all the exposed soil. Animals that have been allowed to come and go through the unscreened vent holes in the foundation should be prevented from doing so in the future through the installation of screens in these openings. In the summer, these openings should be closed with built-to-fit insulated panels to limit condensation of summer moisture on the top side of the vapor barrier. The same panels can then be used in the winter to keep the building more comfortable and energy efficient. At the same time this work is done, it would be appropriate to install proper footings under at all of the piled stone and concrete block support locations. Estimated Construction Cost \$21,500-24,800

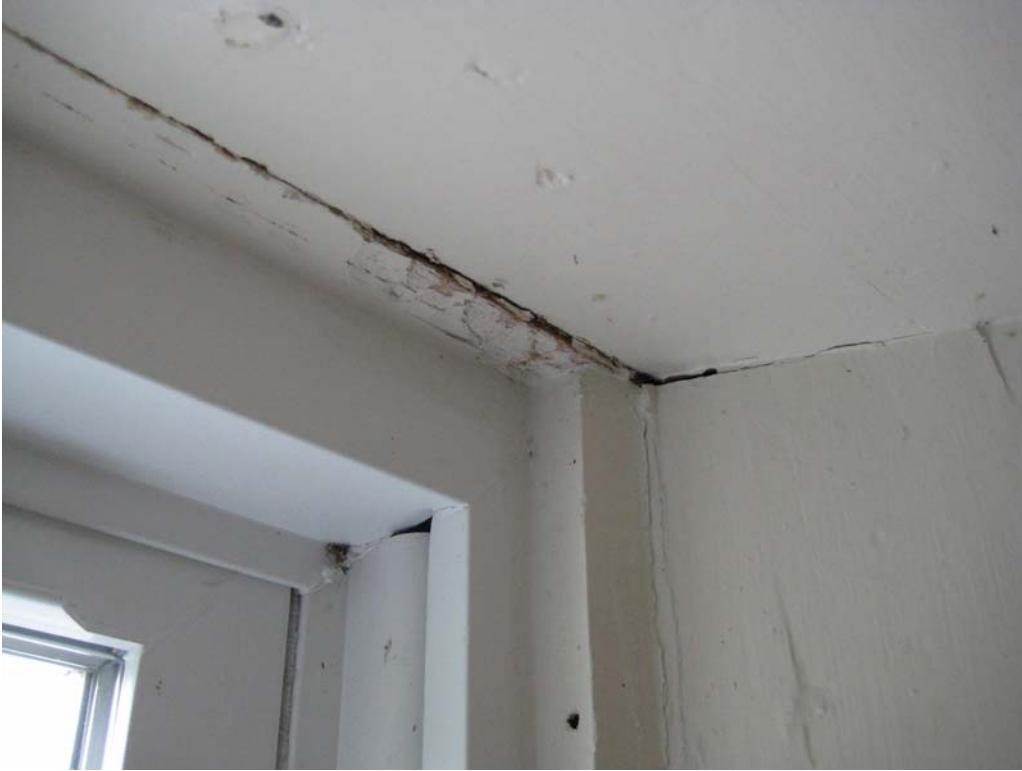
Typical water damage at windows in Entry Stairwell. Similar but less dramatic staining occurs in the Meeting Room windows

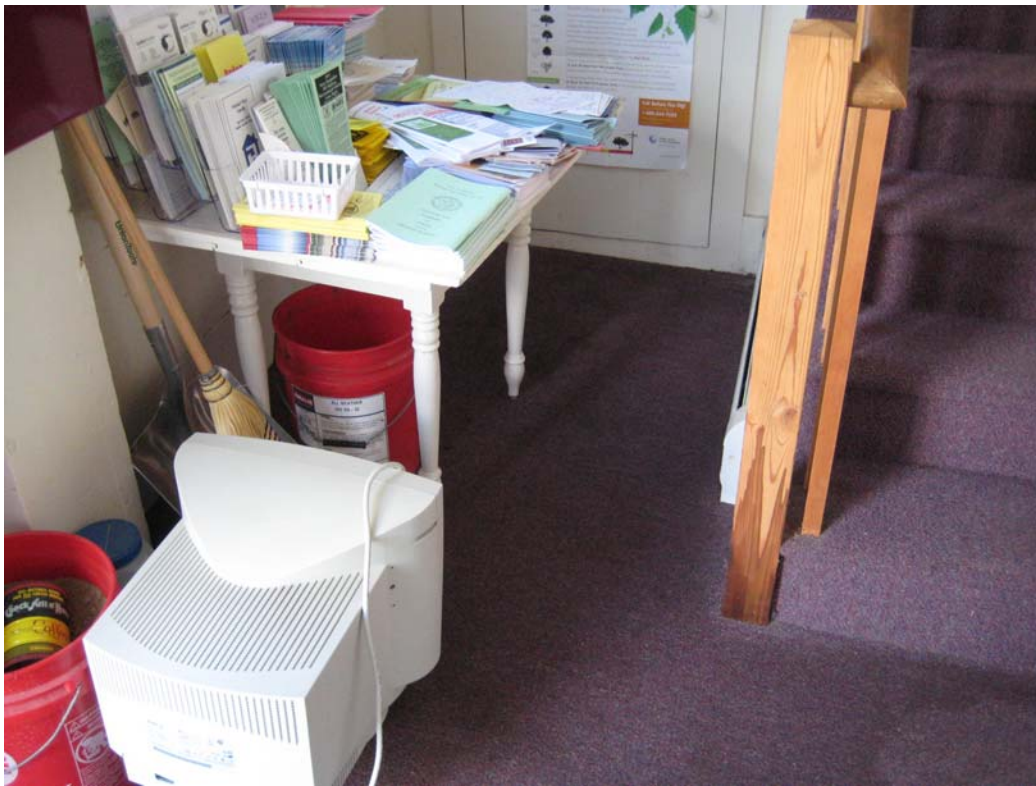
Water damage at bottom of stairs is likely caused by past or present leaking plumbing. Replace newel post (drawing dark staining materials up from bottom) if required.

The carpet in the Entry Vestibule should be replaced. It appears that the liquid saturated in carpet at the base of the stair is not merely water and may be a glycol or alcohol mix leaking from the radiator adjacent. The water poses a hazard to the sheathing and frame, which may be subject to mold or rot. The glycol, if that is what it proves to be, poses perhaps a greater danger to children if ingested. With the carpet removed, a determination should be made as to the exact source of the spill. The apparently recurrent leak may still be leaking from the radiator or may instead be rainwater somehow finding its way in from the north facing exterior wall. This wall has very recently been painted and it is hoped that if this was the source of the leak, that it has already been addressed. After the source of the water at the bottom of the stairs has been identified and the leak confirmed to be repaired, new carpeting should be reinstalled. Estimated Construction Cost \$3,400 - \$5,400.

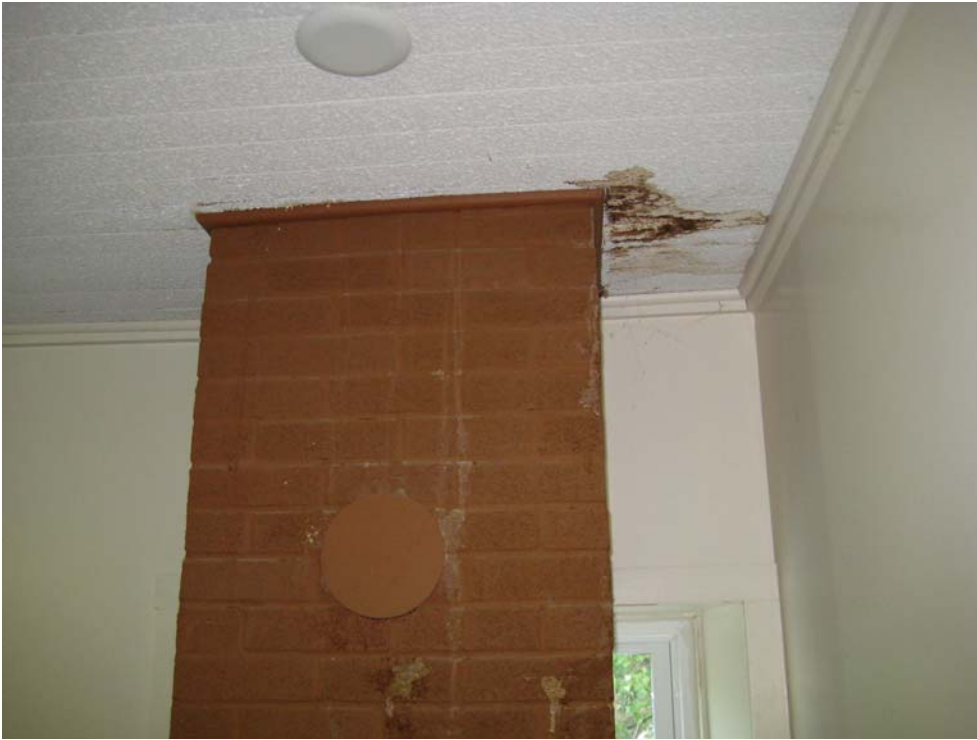
Water staining at chimney in Meeting Room is likely the result of flashing issues at the roof– note older wooden ceiling not original to building.

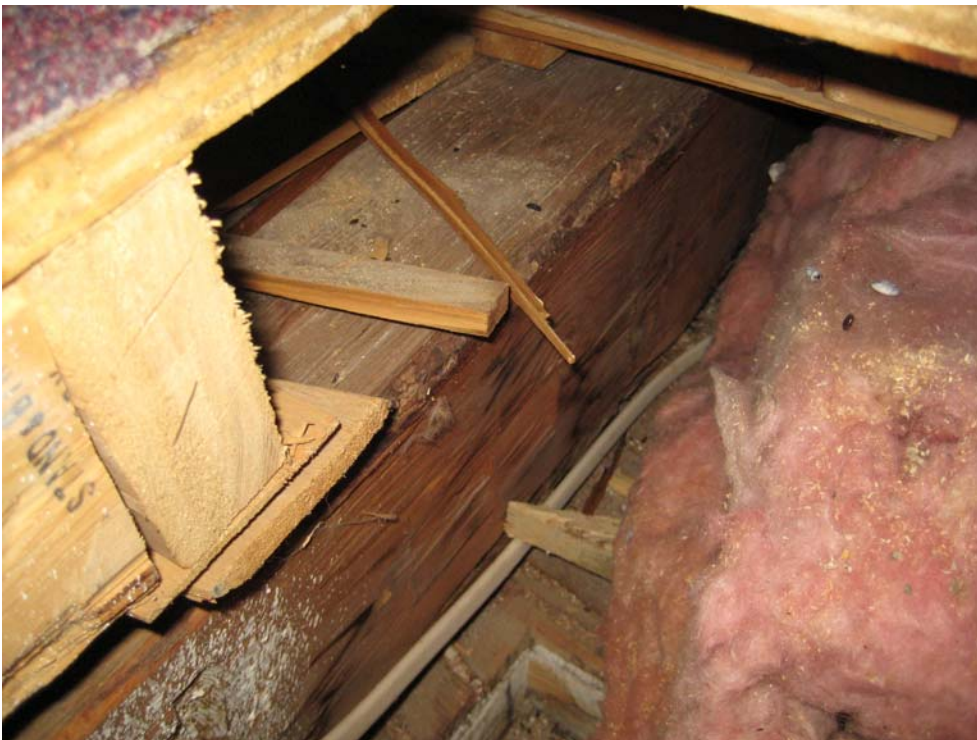
Original floor framing below Meeting Room has newer cross framing running perpendicular over the top. Note the split lath and plaster ceiling still attached to the bottom of the old timber joist. This is now hidden above the Selectmen's office by a poorly installed gypsum board ceiling.

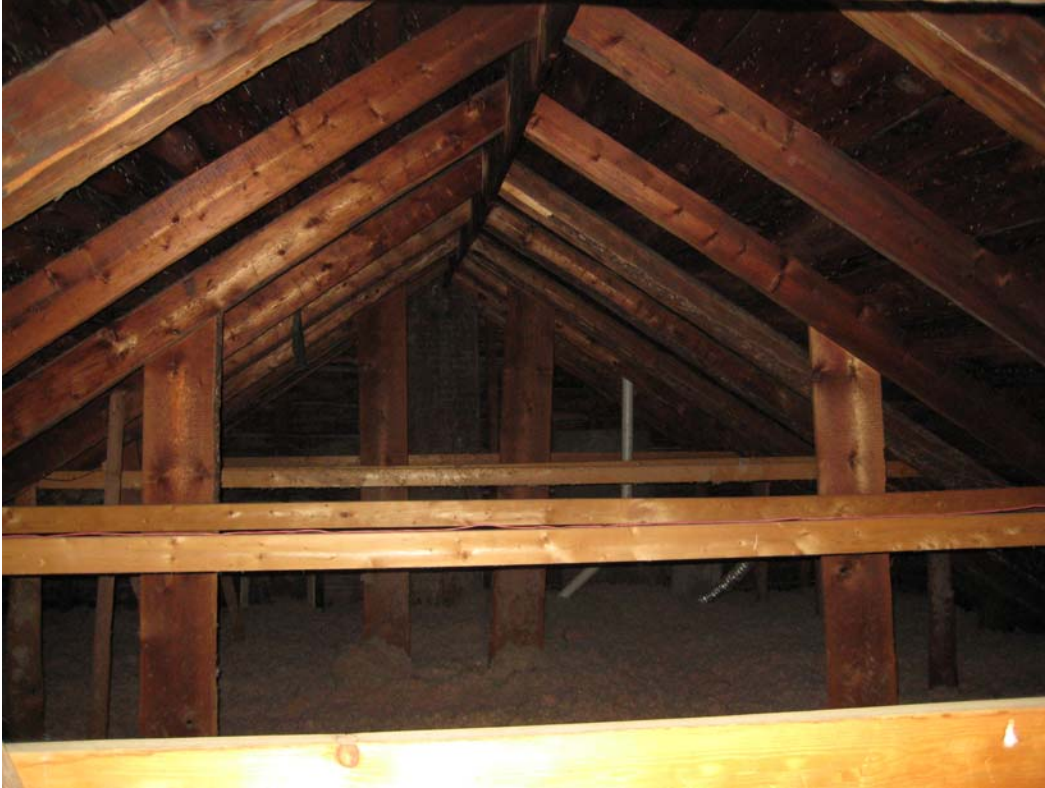
Attic with hand hewn and sawn common rafters

The roof frame is constructed of a mixture of hand hewn and sawn common rafters and all of these are undersized for the requirements of the current New Hampshire codes. These bearing requirements are set to establish evidence that the roof will perform satisfactorily through the worst likely weather scenario and do not consider the evidence that the building has been standing for eighty years with no failure of the roof. It is clear from previous repairs visible in the attic that improvements in the original capacity were attempted. The engineer has made specific recommendations in his report for further improving the load carrying capacity of the framing. These include adding additional rafters between those existing and installing ceiling ties to better protect the walls from spreading compared with the current collar ties. A structural ridge beam is suggested but perhaps unnecessary if the ceiling ties are appropriately sized and installed. The hewn timber framed bell tower should be re-supported with the installation of new beams (and perhaps bracing) to prevent further leaning of the tower. The posts used to support new beams at the second floor level might be sized to carry some of the tower loads. Roof framing repair, as well as roofing replacement, could be done integrally with any expansion of the building as this work will require the disturbance of whatever finishes are in place at the time of expansion.

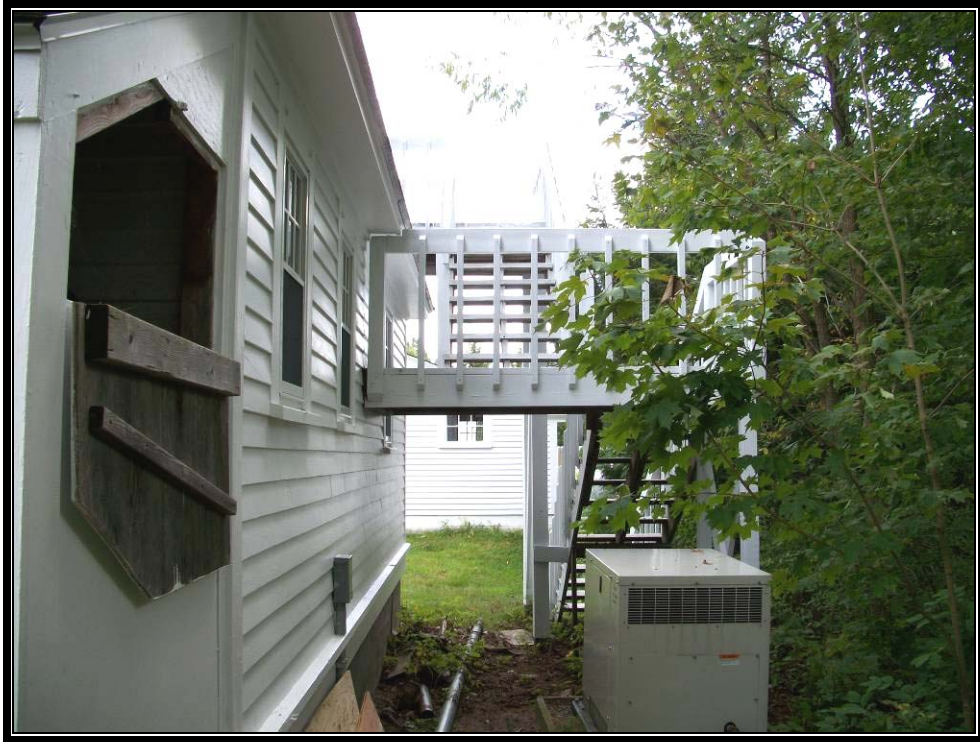
The emergency egress stairway off the rear of the building appears to be relatively new compared to the rest of the structure. It is framed with conventional lumber and is supported by concrete sono-tubes. The framing appears to be in good condition. However, the beams and joists are not adequately fastened together. The railing system does not appear to meet current building code requirements.

Photo 3: View of the emergency staircase off the south end of the building facing east.

The emergency stairway does not meet the code-required 60 psf snow load or 100 psf live load. We recommend bringing the stairway up to code by installing additional floor joists, adding proper hangers and caps, increasing the height of the railing to the required 42 inches, and properly fastening the ledger board to the building using lag bolts.

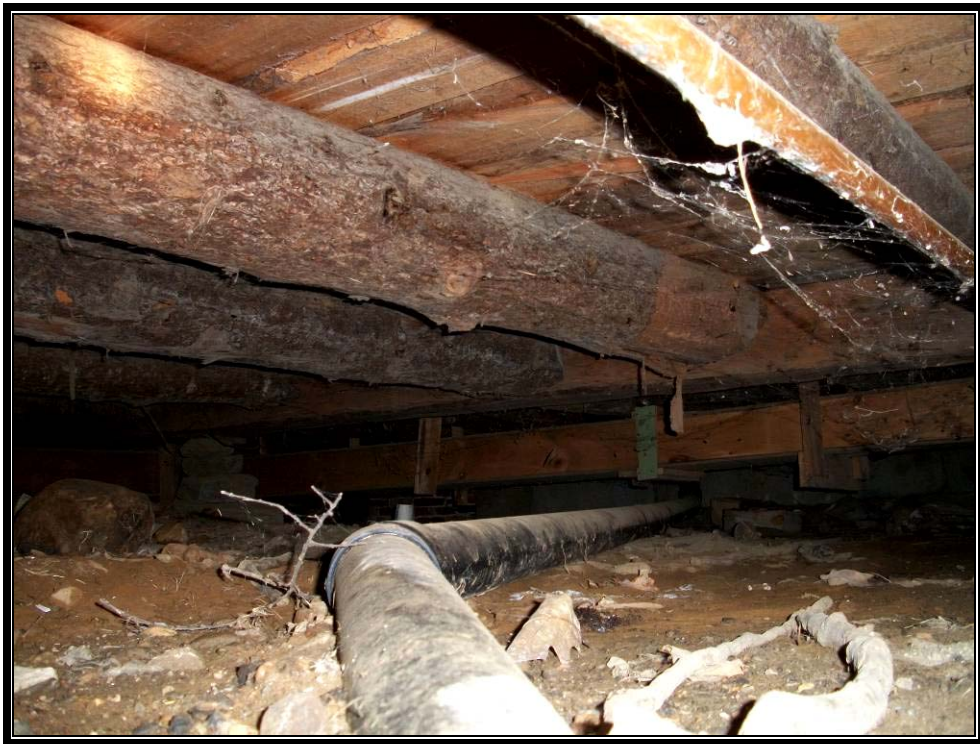
The first floor framing was assessed from the basement. The floor joists are timber logs approximately 6"-10" in diameter (see Photo 4). The joists have been notched at the ends. The maximum joist span is 10 feet with typical spacing of 24" on-center (o.c.). The joists are supported by (3) hand-hewn 8"x10" beams spanning the full length of the building in the east-west direction. There are built-up timber and rock columns supporting the beams at approximately the mid-span (see Photo 5). The log floor joists are notched about 2" to fit into the 8"x10" beams (see Photo 5). There appear to be small holes in several of the log floor joists giving signs of powder post beetle damage. The severity of the damage is unknown at this time.

Photo 4: View of first floor timber joists.

The beams and joists in the first floor are overstressed when the code-required 50 psf live load for office areas is applied. There are also signs of insect damage in some of the floor joists. We recommend bringing the floor system up to code by adding columns under each of the first floor beams and by adding additional floor joists.

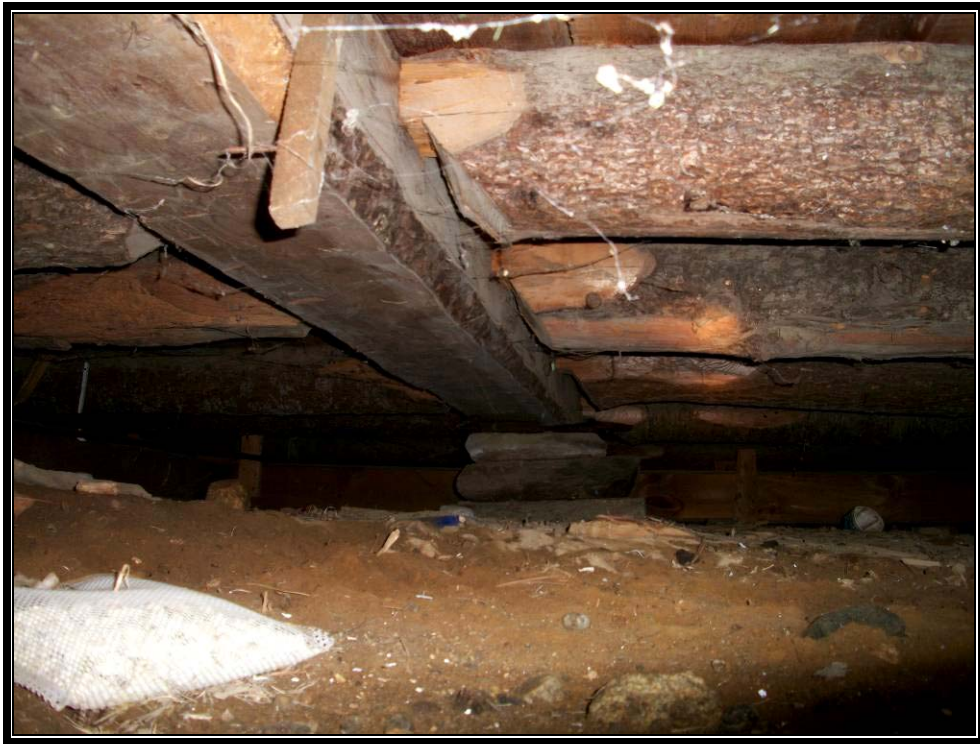
Photo 5: View of first floor built-up columns and notched floor joists.

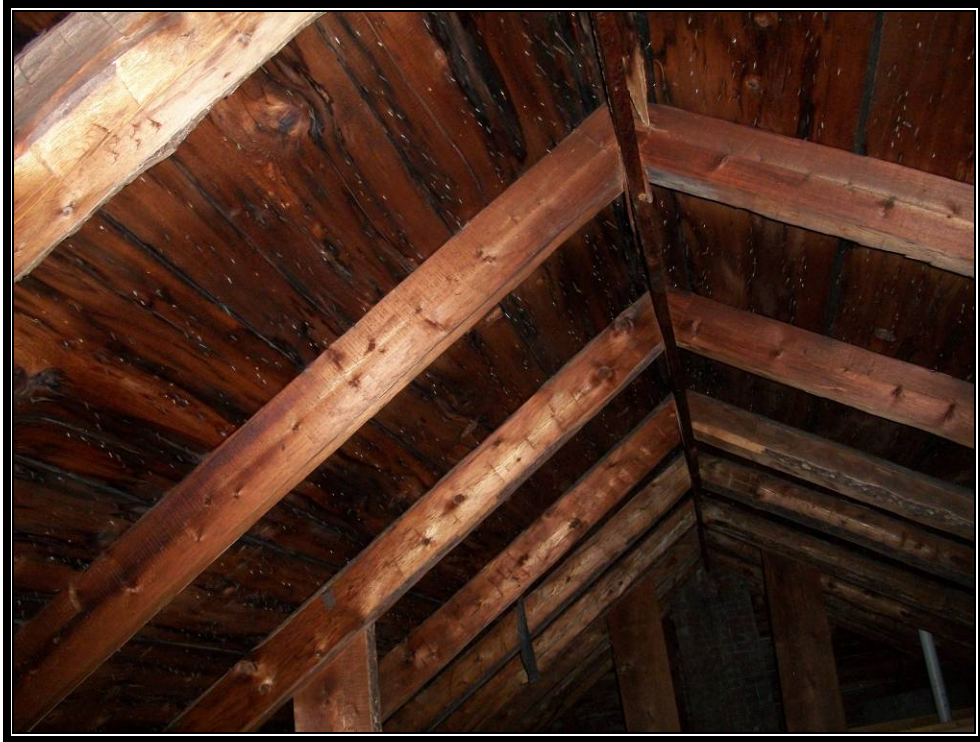
The roof is a gable style with an 8:12 slope. The original roof rafters are hand-hewn 3"x7" timbers spaced at 36" o.c. The rafters are attached at the ridge by a timber ridge board with no actual ridge beam. There are 2x4 timber rafter ties on every other set of rafters that were added at an unknown date (see Photo 7) to support the ceiling below. There is one steel tie rod across the building, but the exterior wall is still bowing out near the top of the wall due to the outward thrust of the rafters. The bell tower at the front of the building is framed with 8"x8" hand-hewn timbers. The timbers appear to be in good condition, however the entire tower appears to be leaning backwards toward the building.

Photo 7: View of roof framing.

The roof is overstressed when code-required 60 psf snow load is applied. We recommend bringing the roof up to code by installing a ridge beam under the existing rafters, installing additional roof rafters between each existing rafter, and installing ceiling ties to prevent the walls from bowing out. We recommend installing additional support beams under the existing bell tower as well as some additional diagonal braces on the tower itself to prevent it from leaning further.
