Hebron, NH

Tree Inventory

Hebron Town Common

June 6, 2016

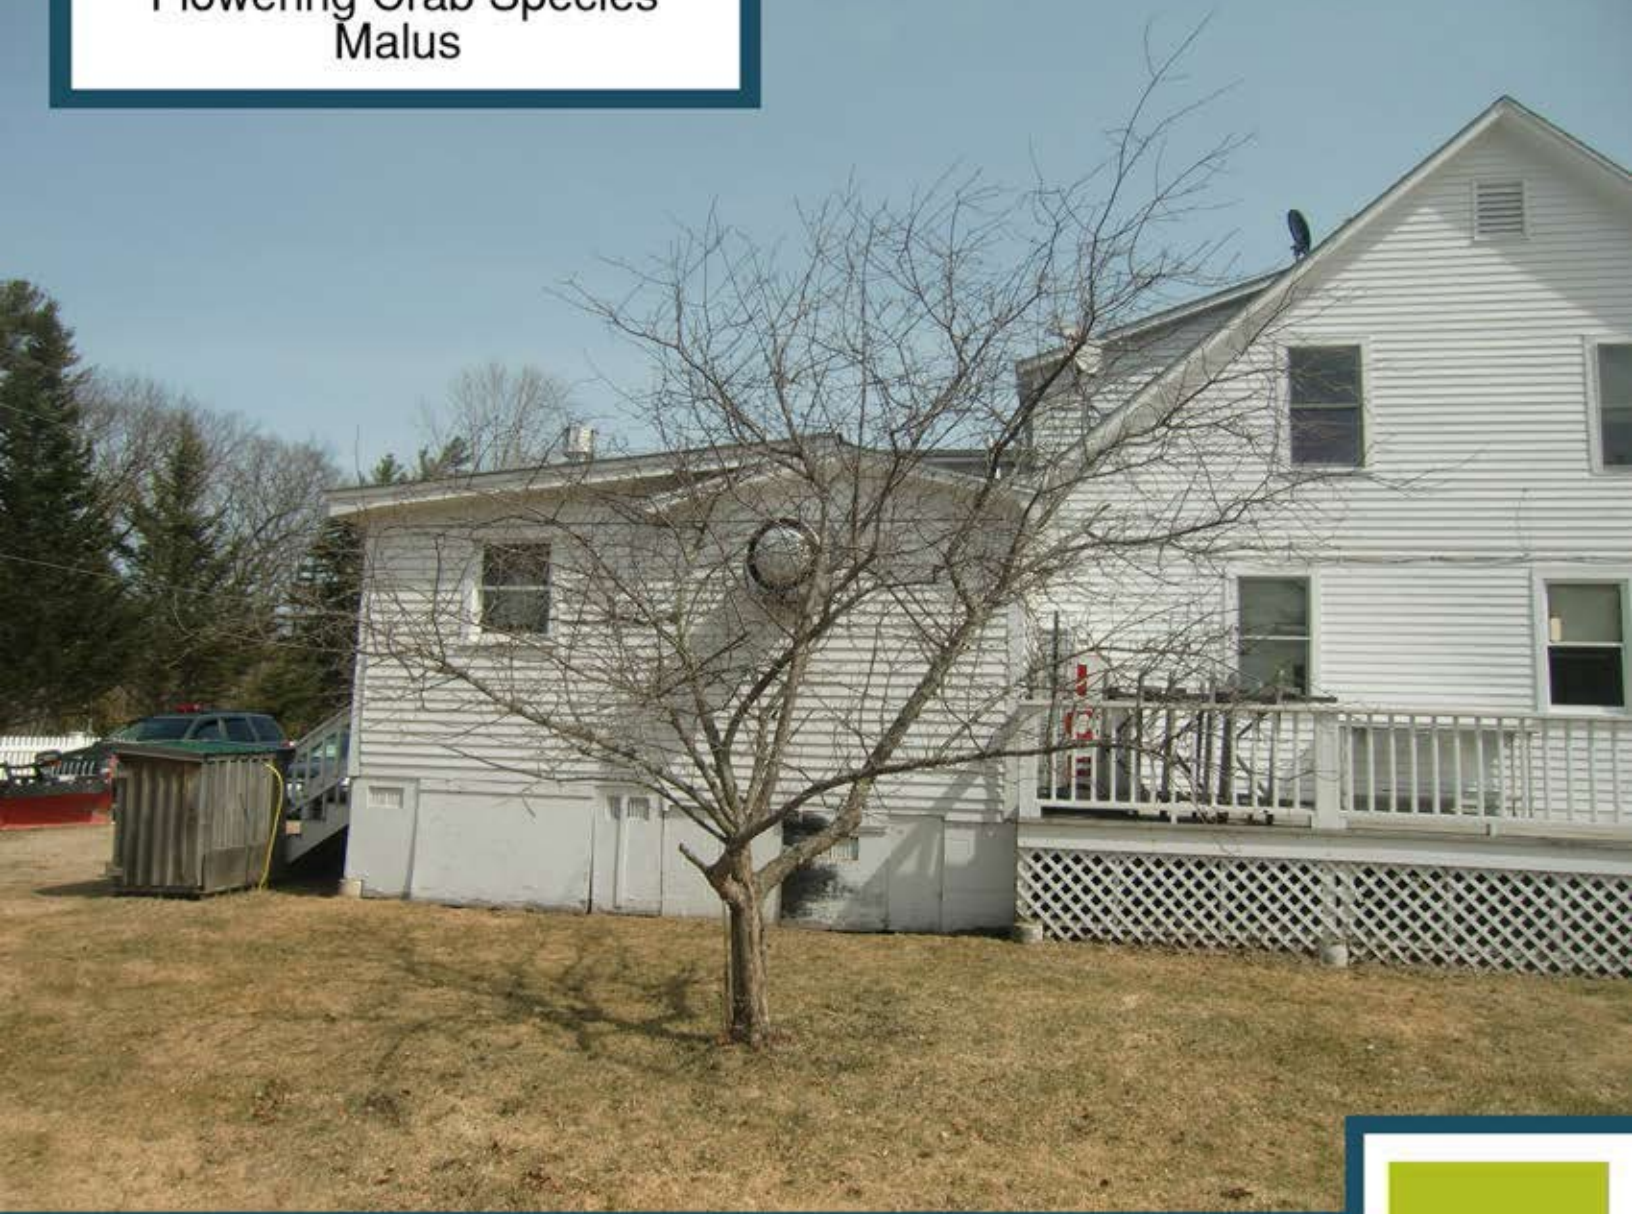
Tree #1
Flowering Crab Species
Malus

1. Condition - Good

2. Save or Remove - Save

- a. a. The tree needs to be root fertilized and the crown pruned. The interior branches need to be removed. Crossing branches need to be removed, proper removal of branch stubs from previous pruning should be removed. The tree should be pruned on an annual basis as if it was a standard apple tree.

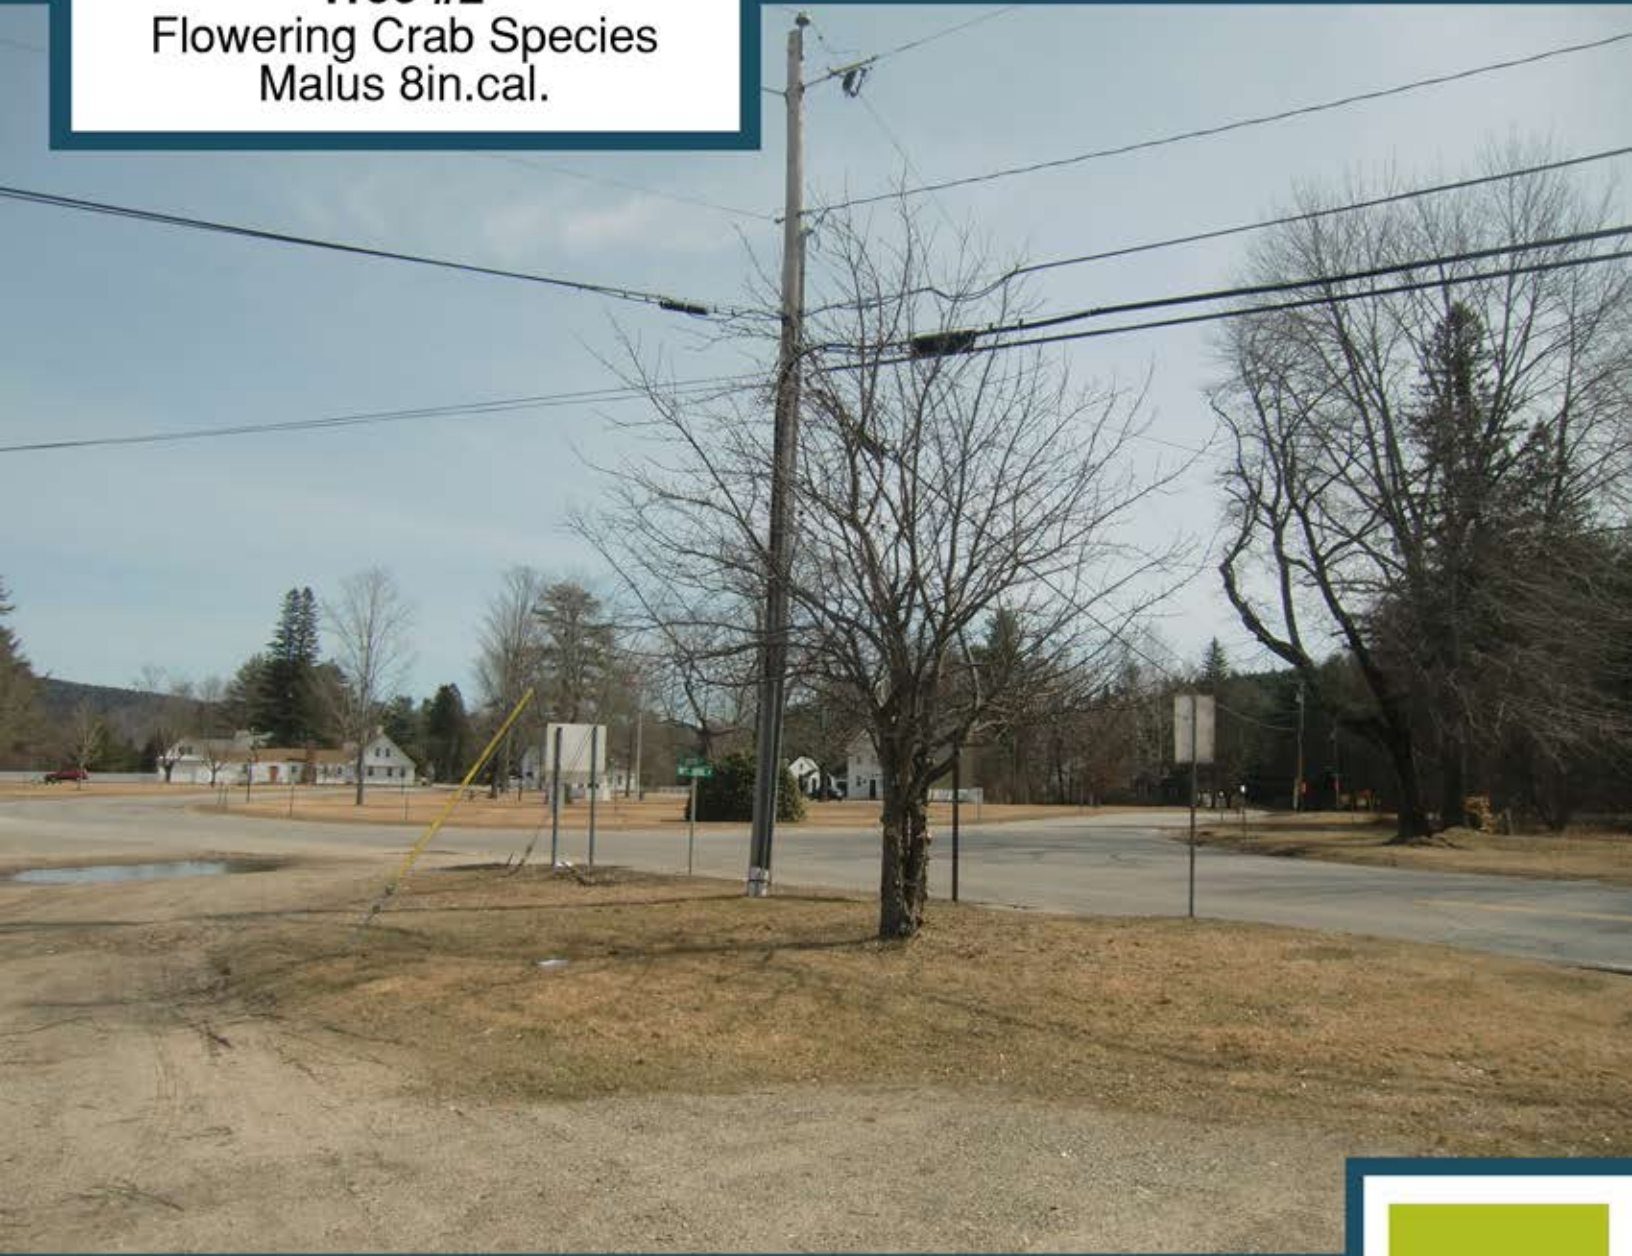
Tree #2
Flowering Crab Species
Malus 8in.cal.

1. Condition - Good

2. Save or Remove - Save

- a. Root fertilize, prune out crossing branches, remove any interior branches and prune off stubs that remain from a previous pruning of the tree.

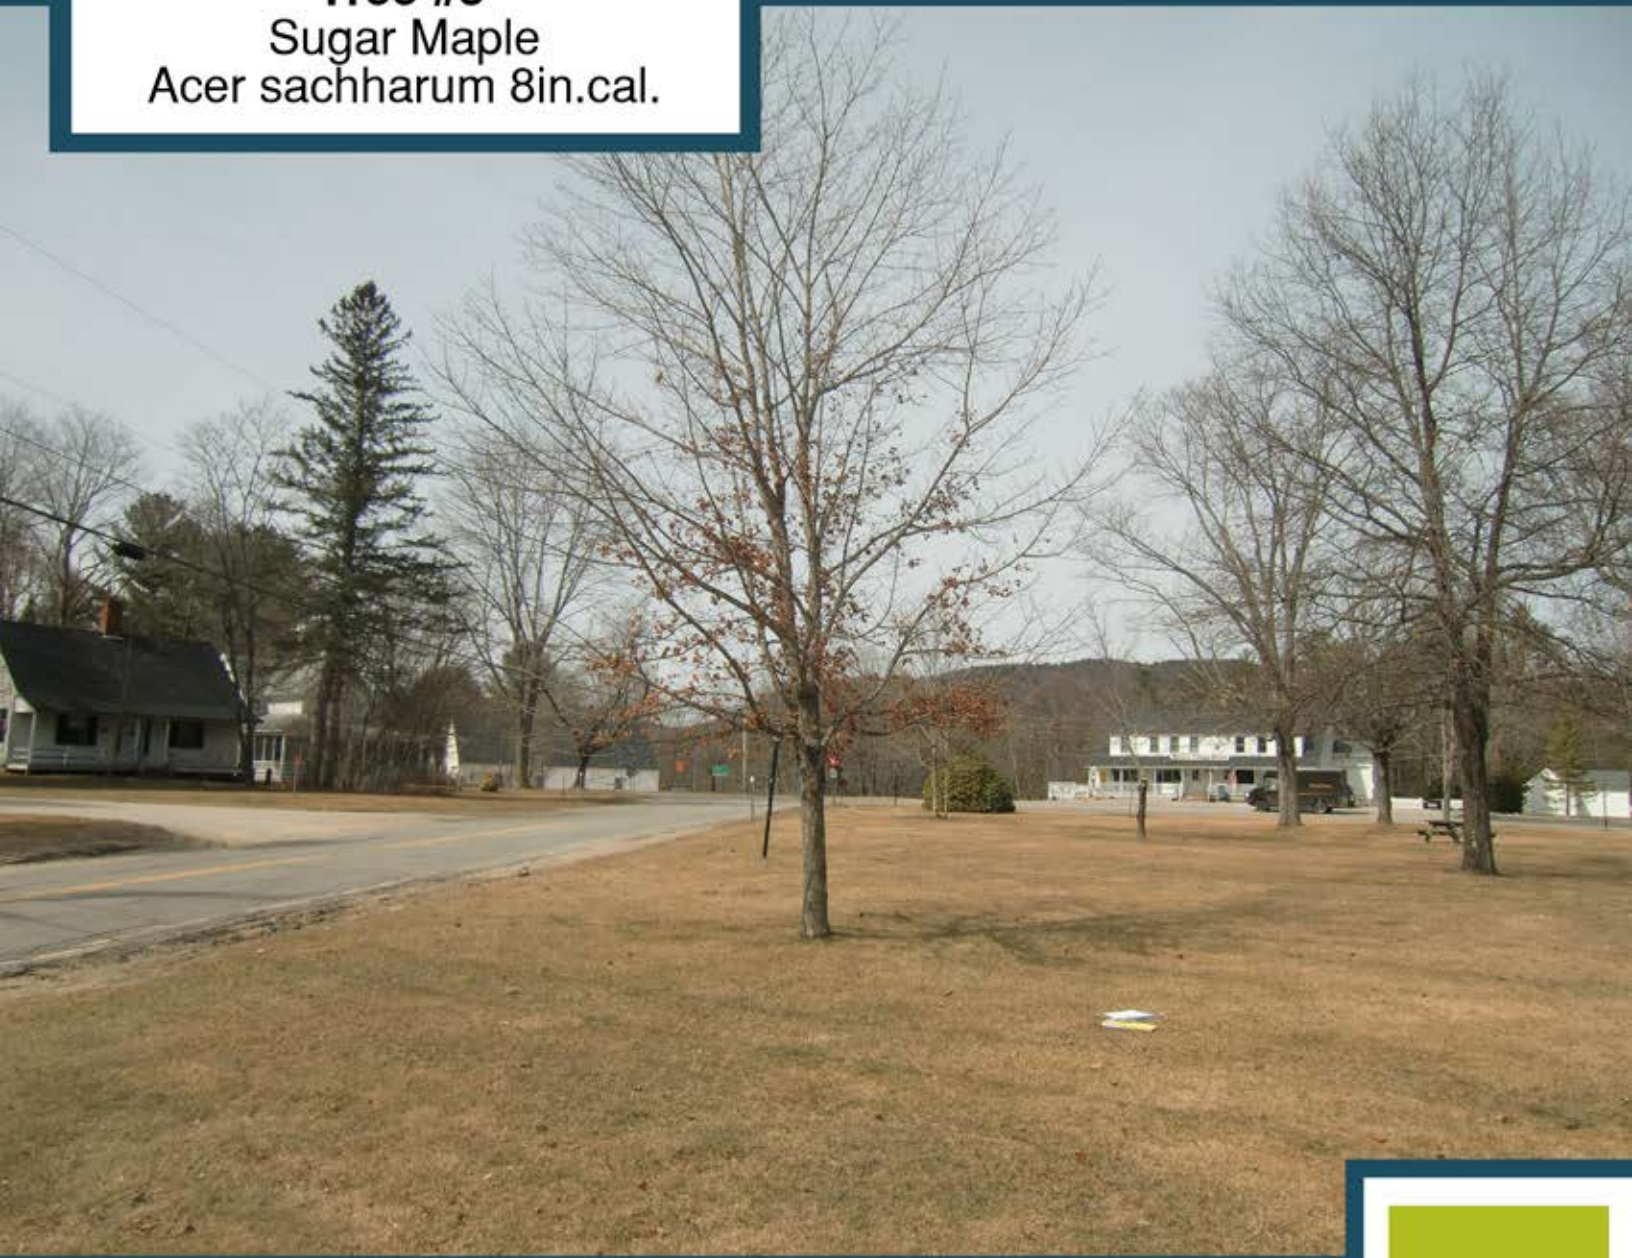
Tree #3
Sugar Maple
Acer sachharum 8in.cal.

1. Condition - Excellent

2. Save or Remove - Save

- a. Root fertilize this tree, soil aeration the soil is compact and is not allowing proper nutrients to the root area of the tree. Prune out any interior branches in the fall. Remove any branches that are lower than six (6) feet from the ground.

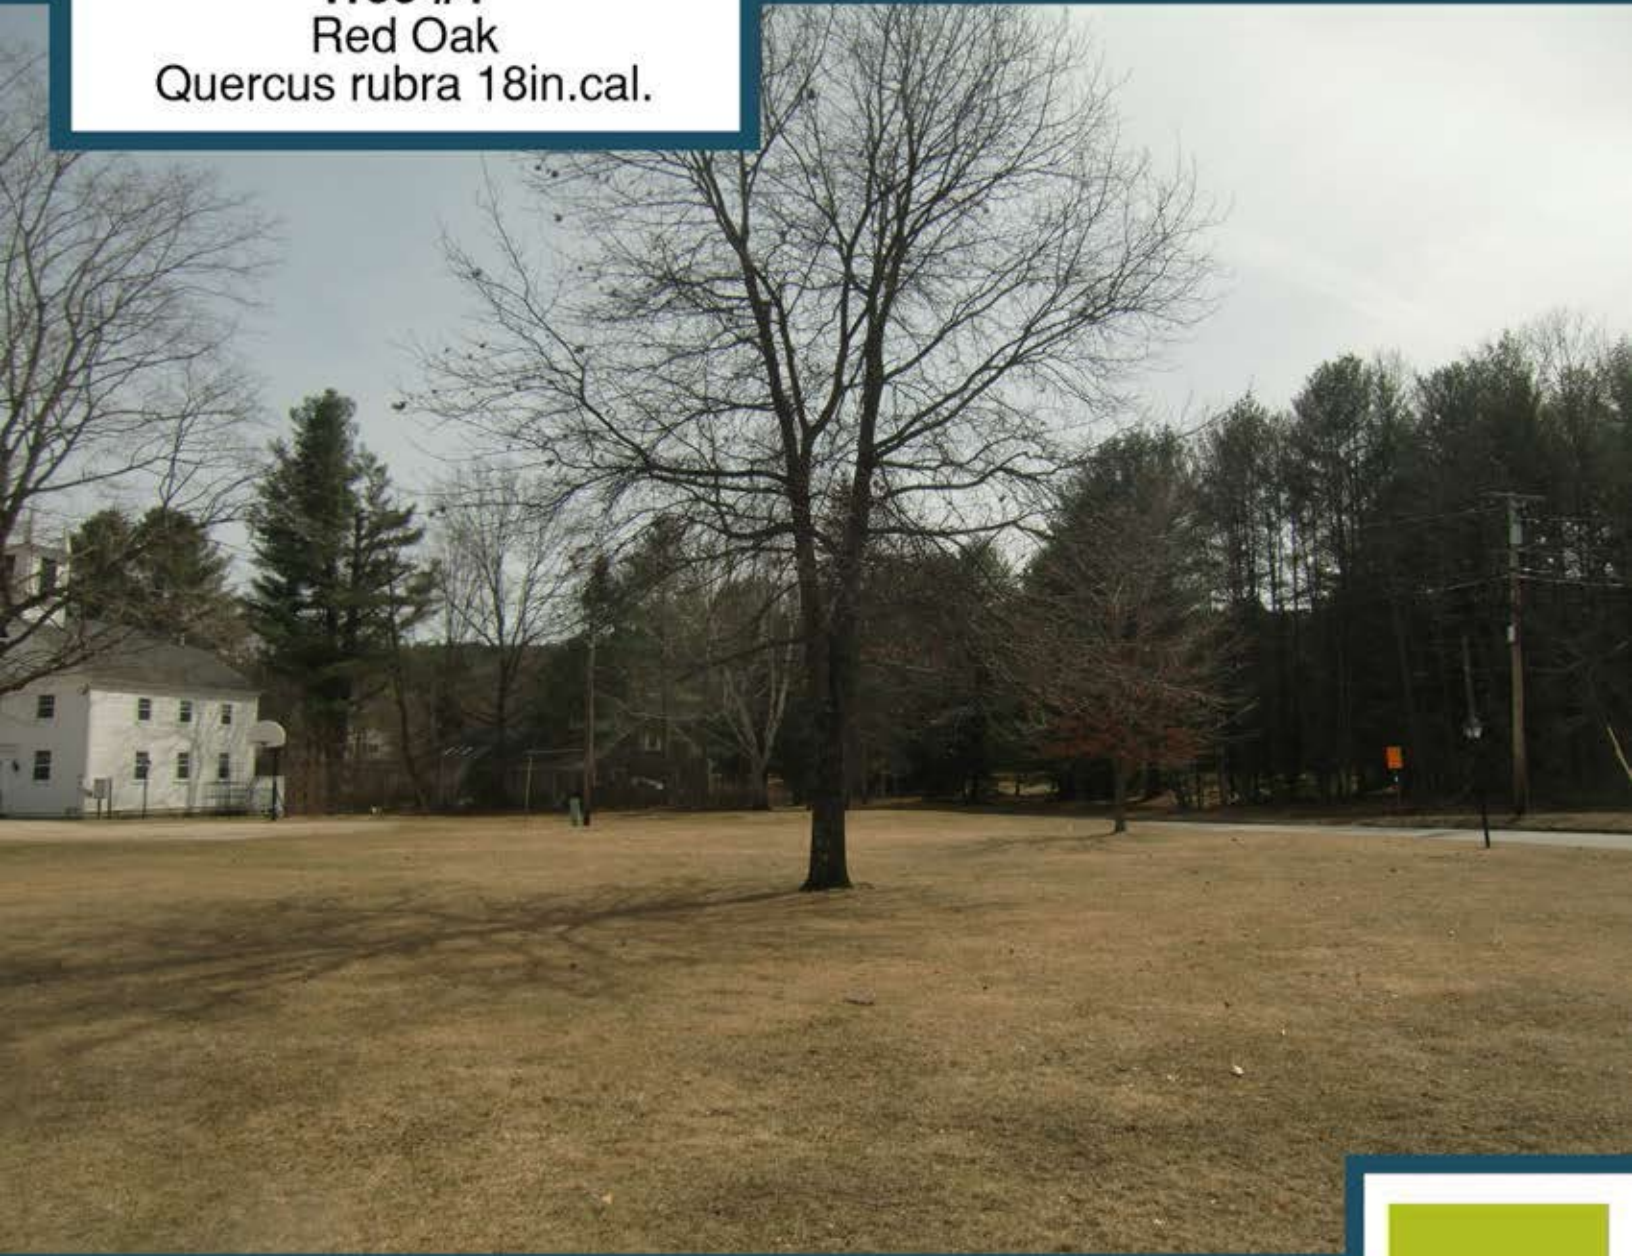
Tree #4
Red Oak
Quercus rubra 18in.cal.

1. Condition - Excellent

2. Save or Remove - Save

The "V" crotch of the tree is a weak crotch and over time as the tree increases in size, there is concern that the tree will split at this weak spot thus the recommendation of cabling the branches. As with all the trees on the common the soil is compacted to the point that proper nutrients are not getting to the roots. Aeration and root fertilization is recommended.

a. Properly prune off all stubs of branches from a previous pruning.

The crown of the tree should be thinned by a licensed arborist.

Eventually the two primary stems of the tree should be cabled.

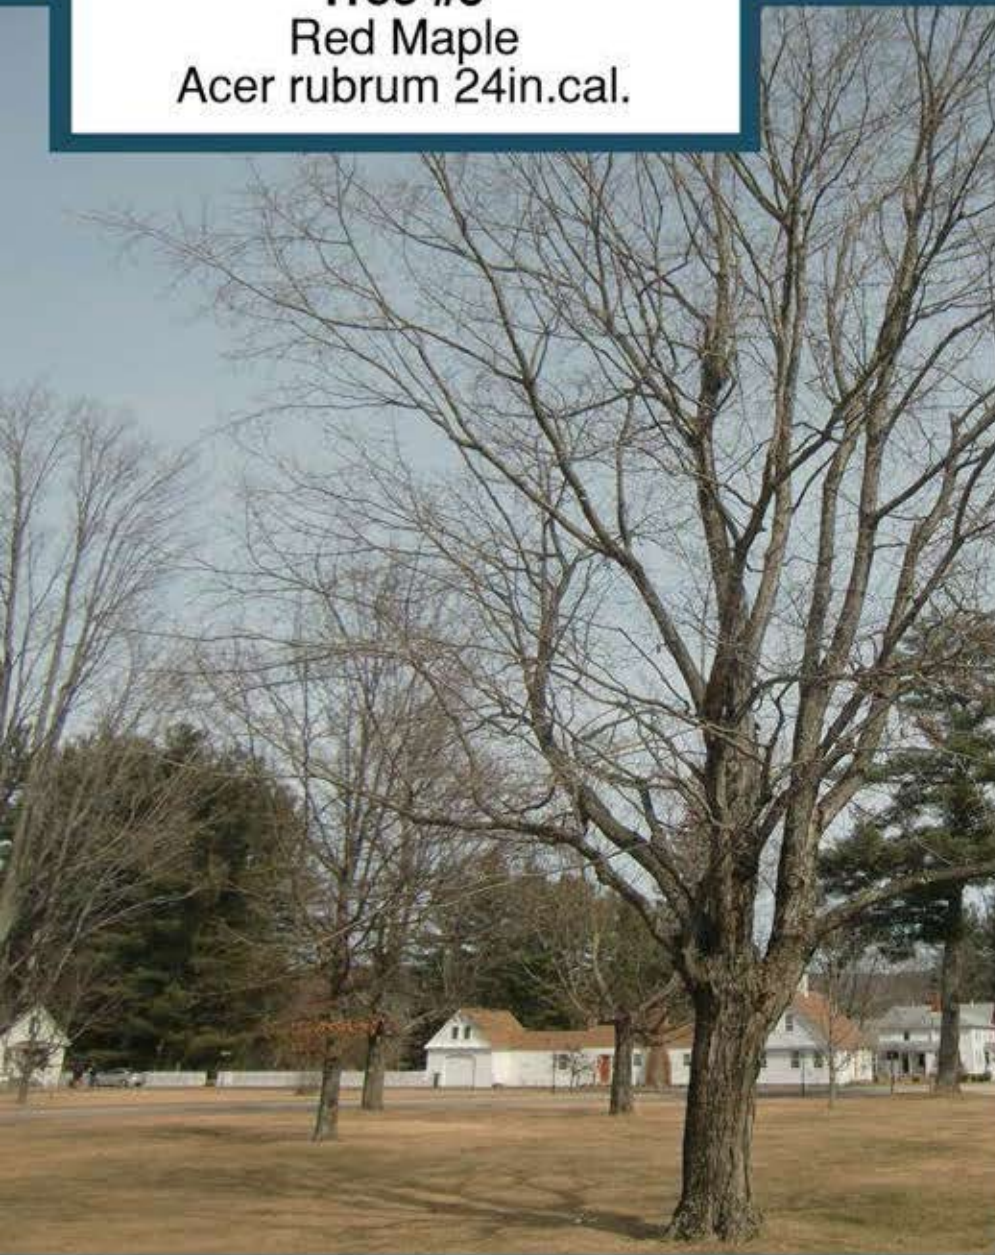
Tree #5
Red Maple
Acer rubrum 24in.cal.

1. Condition - Good condition there is some decay just starting under the 18 in side branch

2. Save or Remove - Save

A licensed arborist should be hired to prune out the dead wood in the tree.

Aerate and fertilized the root zone of the tree.

b.Recommendation: At the time the tree is removed it should be replaced with a Burgundy Belle Red Maple Acer rubrum 'Burgundy Belle', this tree has dark green leaves during the summer turning to a red-burgundy in the fall and the fall foliage remains on the tree for a much longer period of time. The replacement tree should be planted closer to the parking lot.

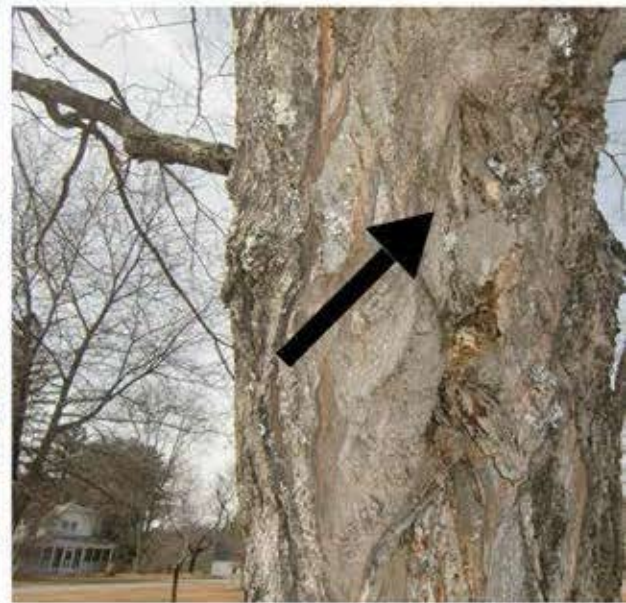
The large 18in side stem of the tree should be cabled to the main stem of the tree to keep it from breaking off as a result of heavy snows. (bottom right picture) (Fungus top right picture).

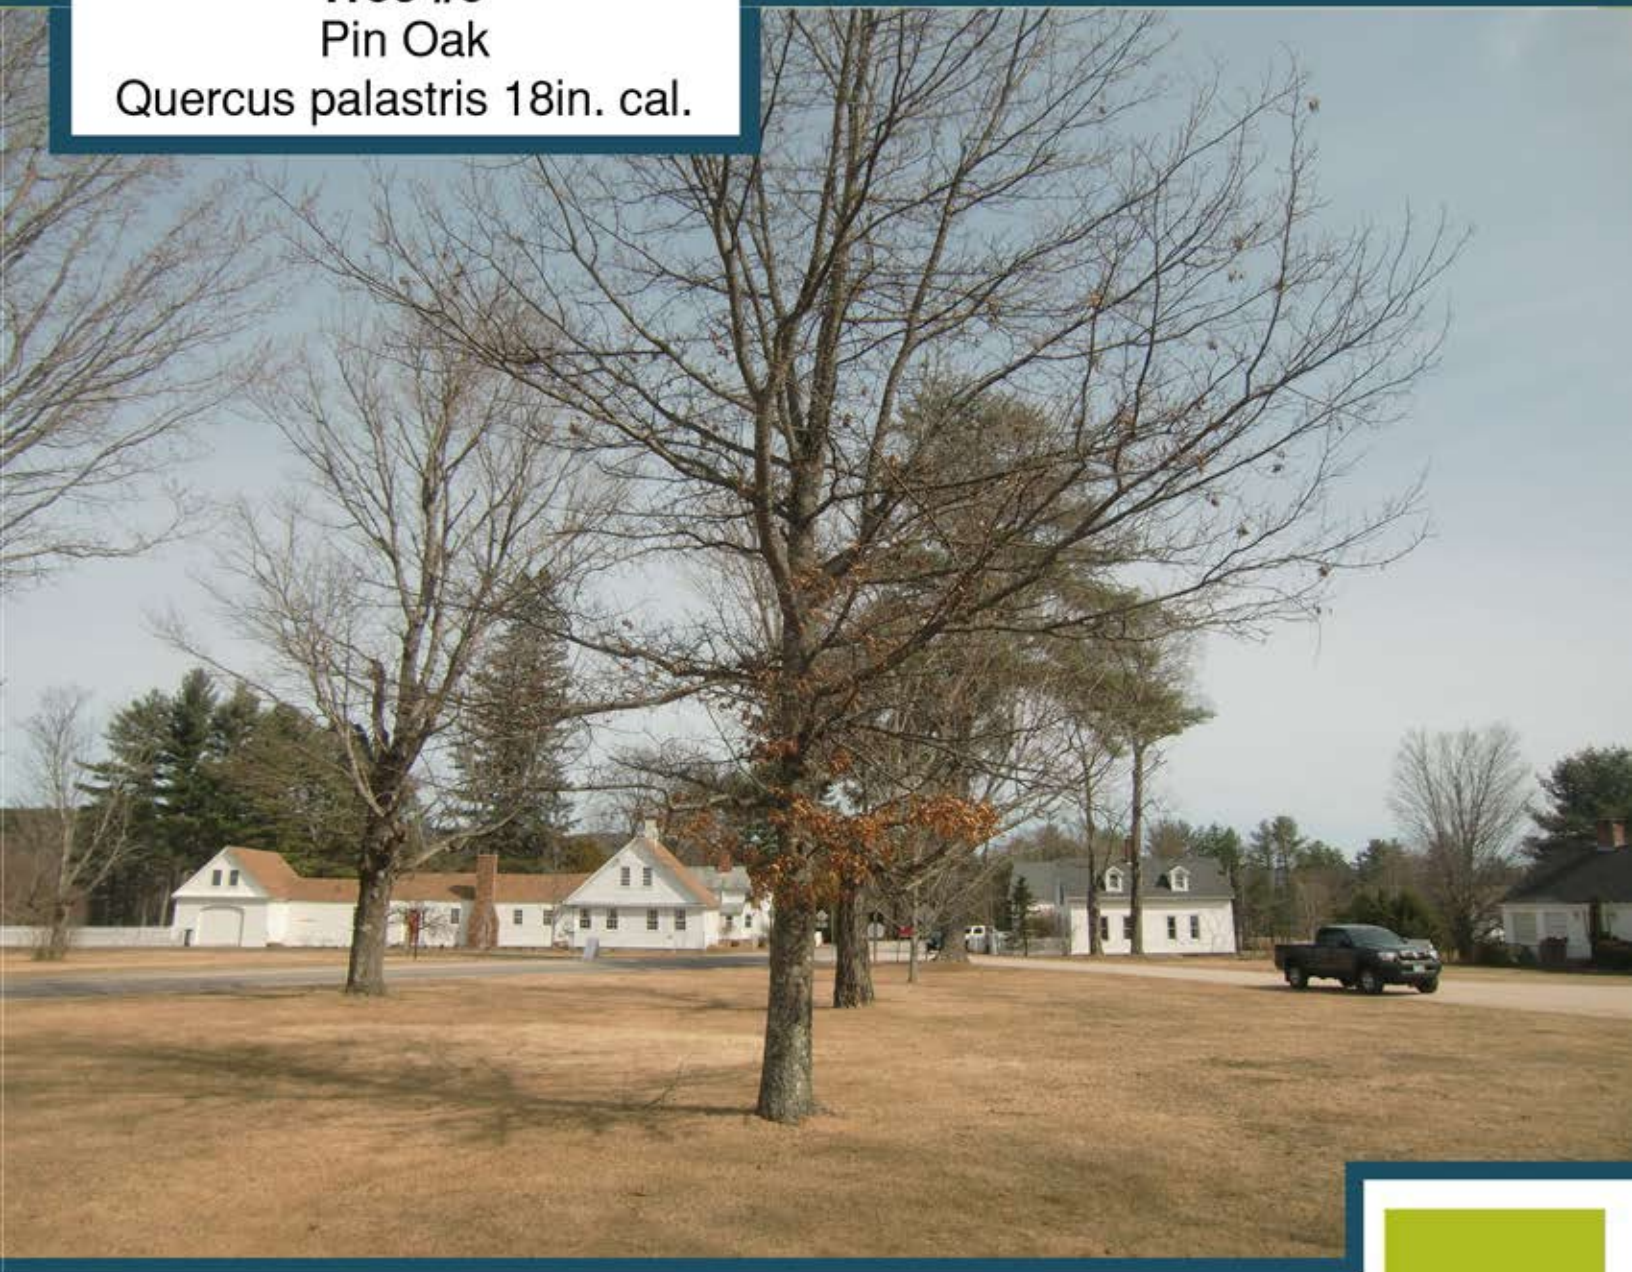
Tree #6
Pin Oak
Quercus palustris 18in. cal.

1. Condition - Good

2. Save or Remove - Save

- a.** Prune lower sprout branches from the trunk of the tree. Hire a professional arborist to thin the crown of the tree and remove any crossing branches. The stub branches from a previous pruning should be removed. Root fertilize and aerate the root zone of the tree

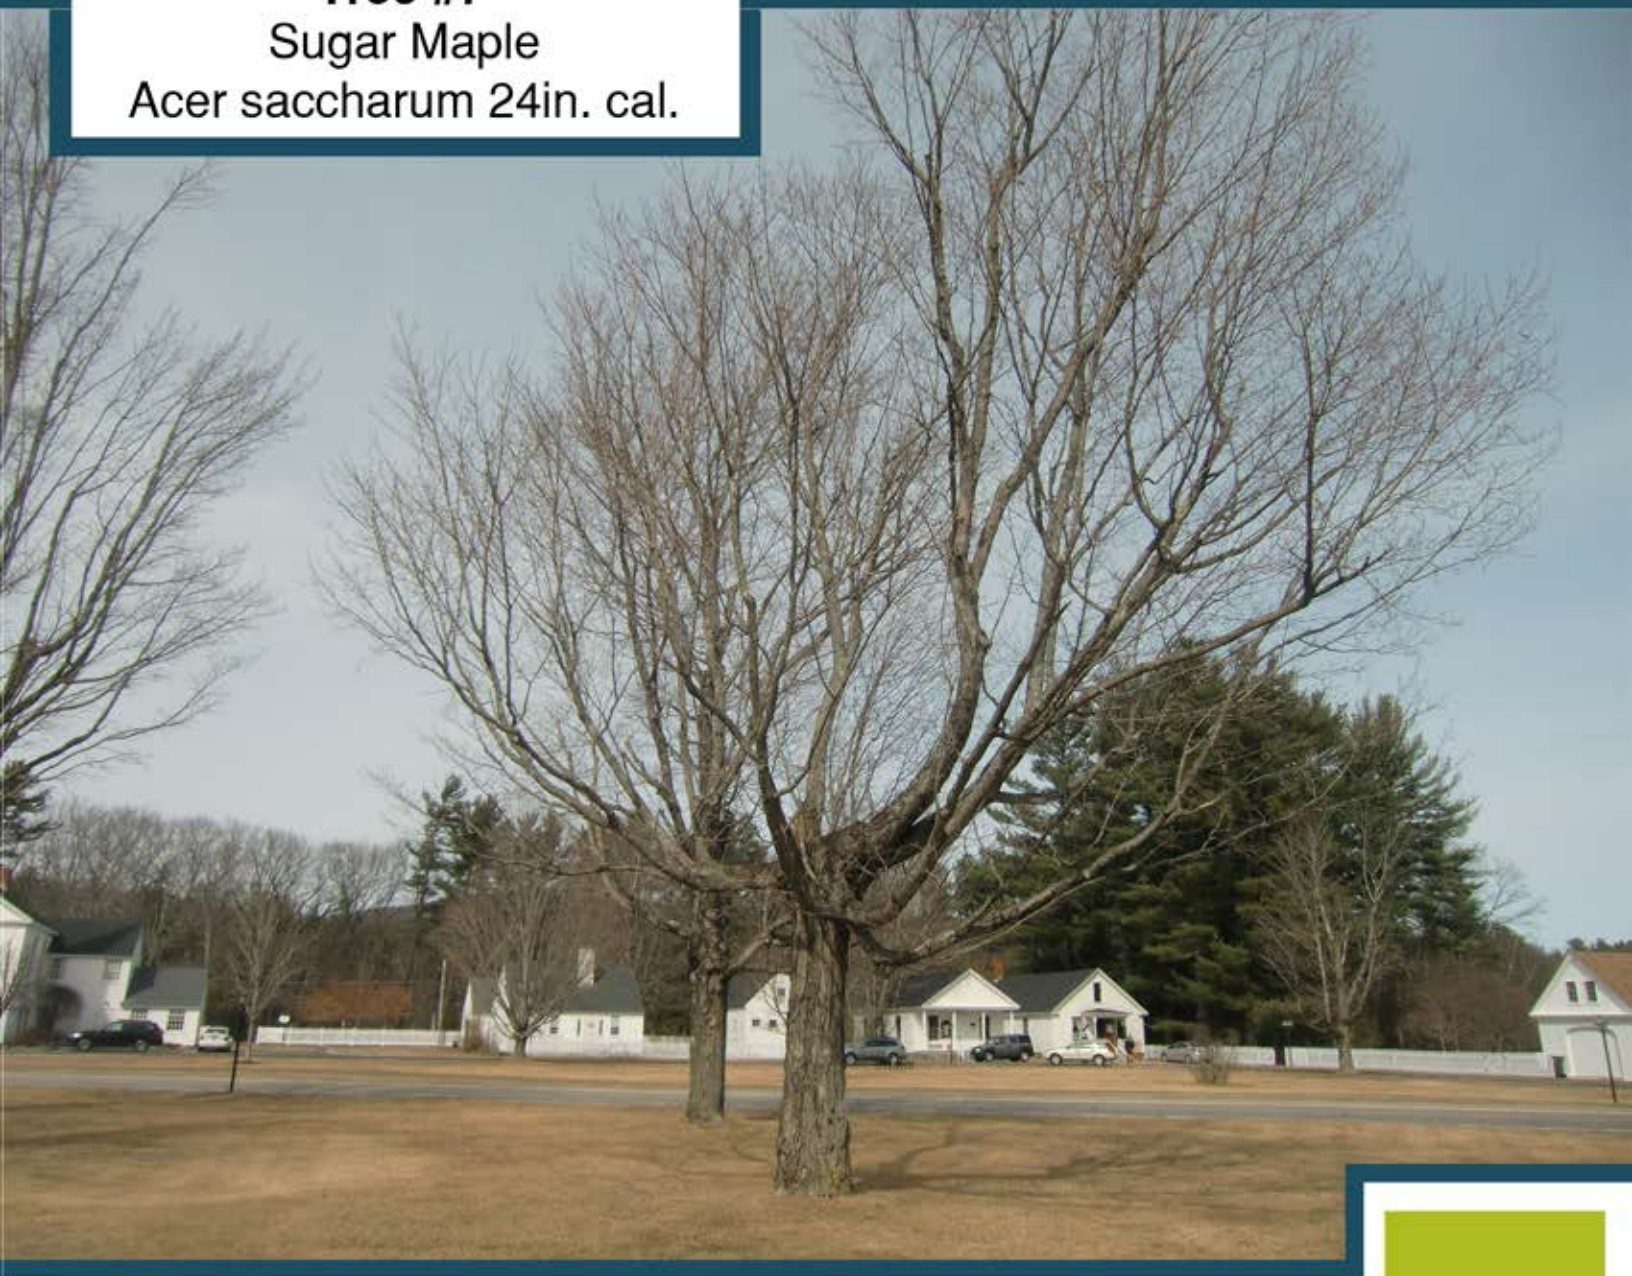
Tree #7
Sugar Maple
Acer saccharum 24in. cal.

1. Condition - Poor

2. Save or Remove - Remove

- a.** This tree is in very poor condition. It has the potential of lasting several years but the leader has been removed and the side branches are taking over. The side branches at the moment are secure but potentially over a period of time, under the right conditions, will break off. This tree should be replaced with a Legacy Sugar Maple *Acer saccharum* 'Legacy' closer to the parking lot and in line with the existing White Pine and Tree #5.

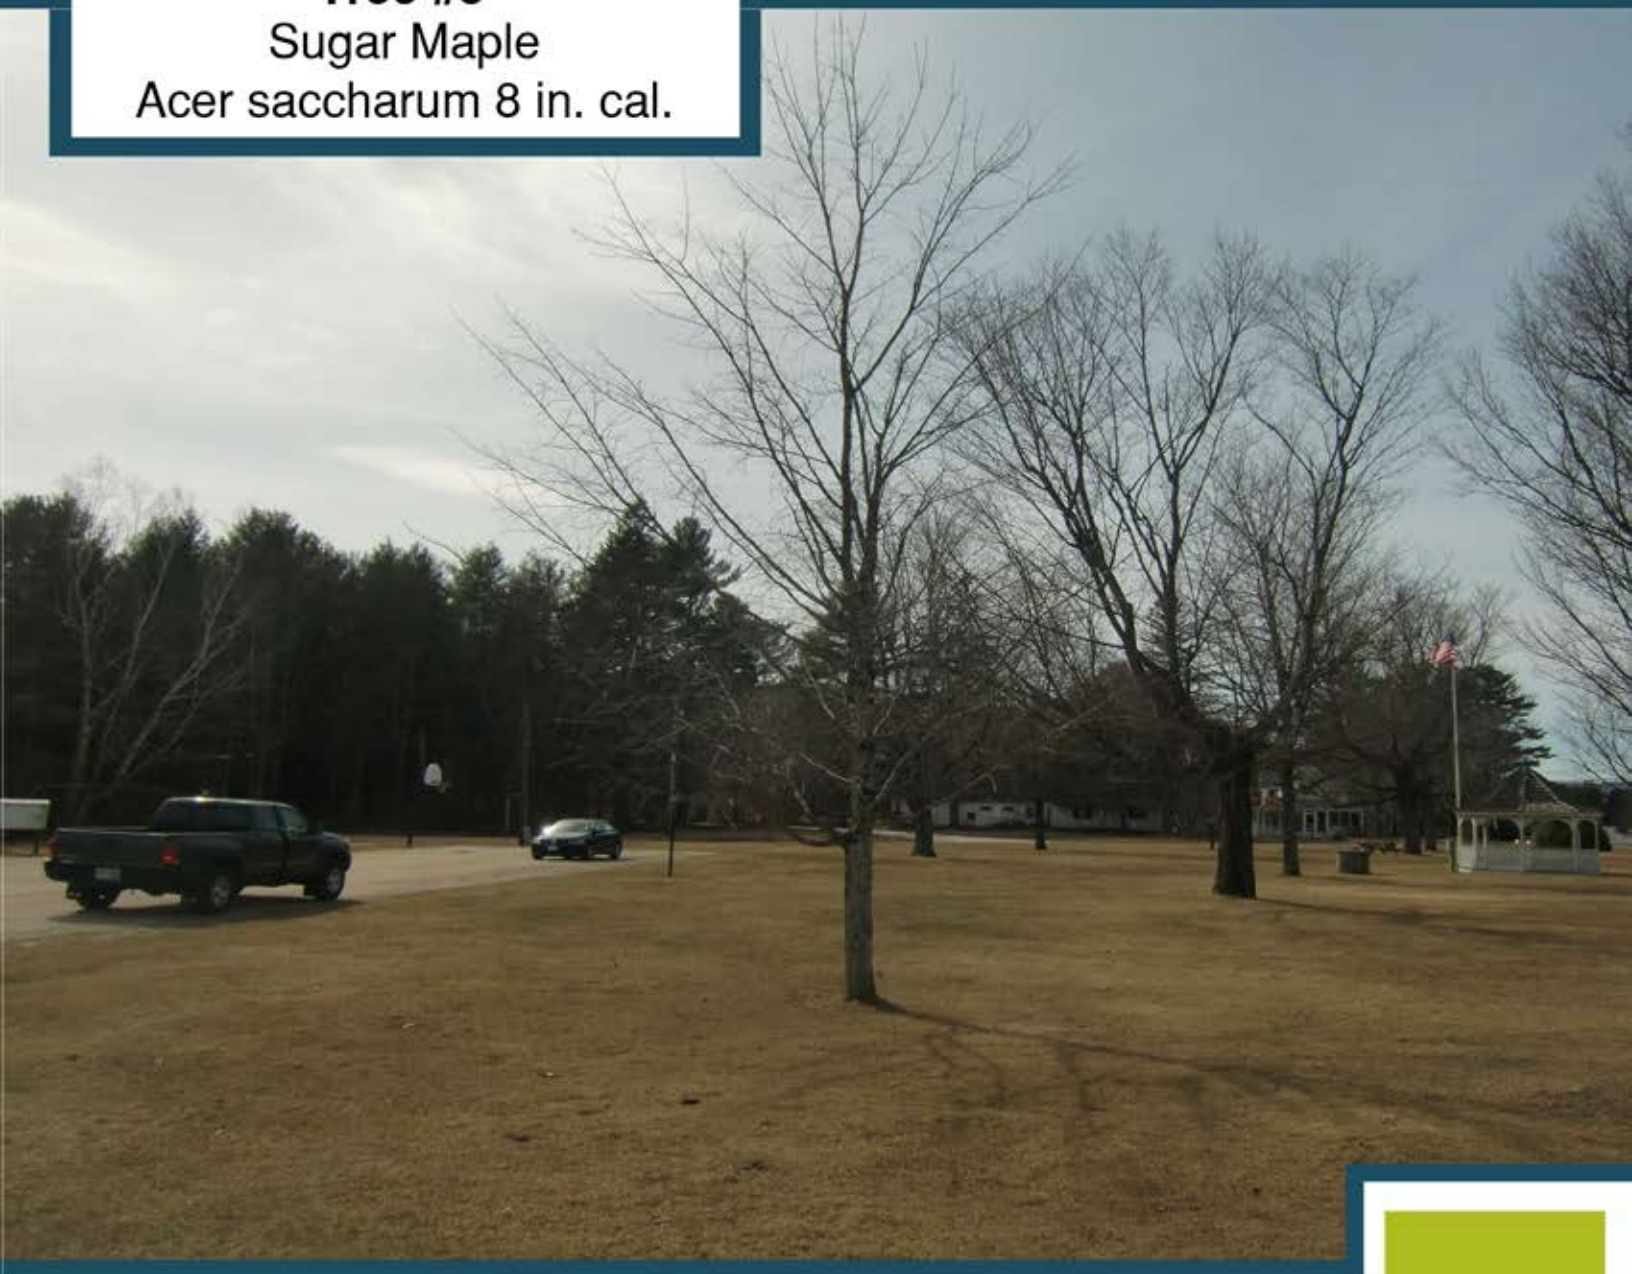
Tree #8
Sugar Maple
Acer saccharum 8 in. cal.

1. Condition - Good

2. Save or Remove - Save

- a.** There is some dead wood in this young tree. This is somewhat unusual for a tree this young. Some minor pruning of dead wood is needed. At some point remove the branches that are lower than six (6) feet above the ground. Root fertilize the tree and aerate the soil in the root zone of the tree

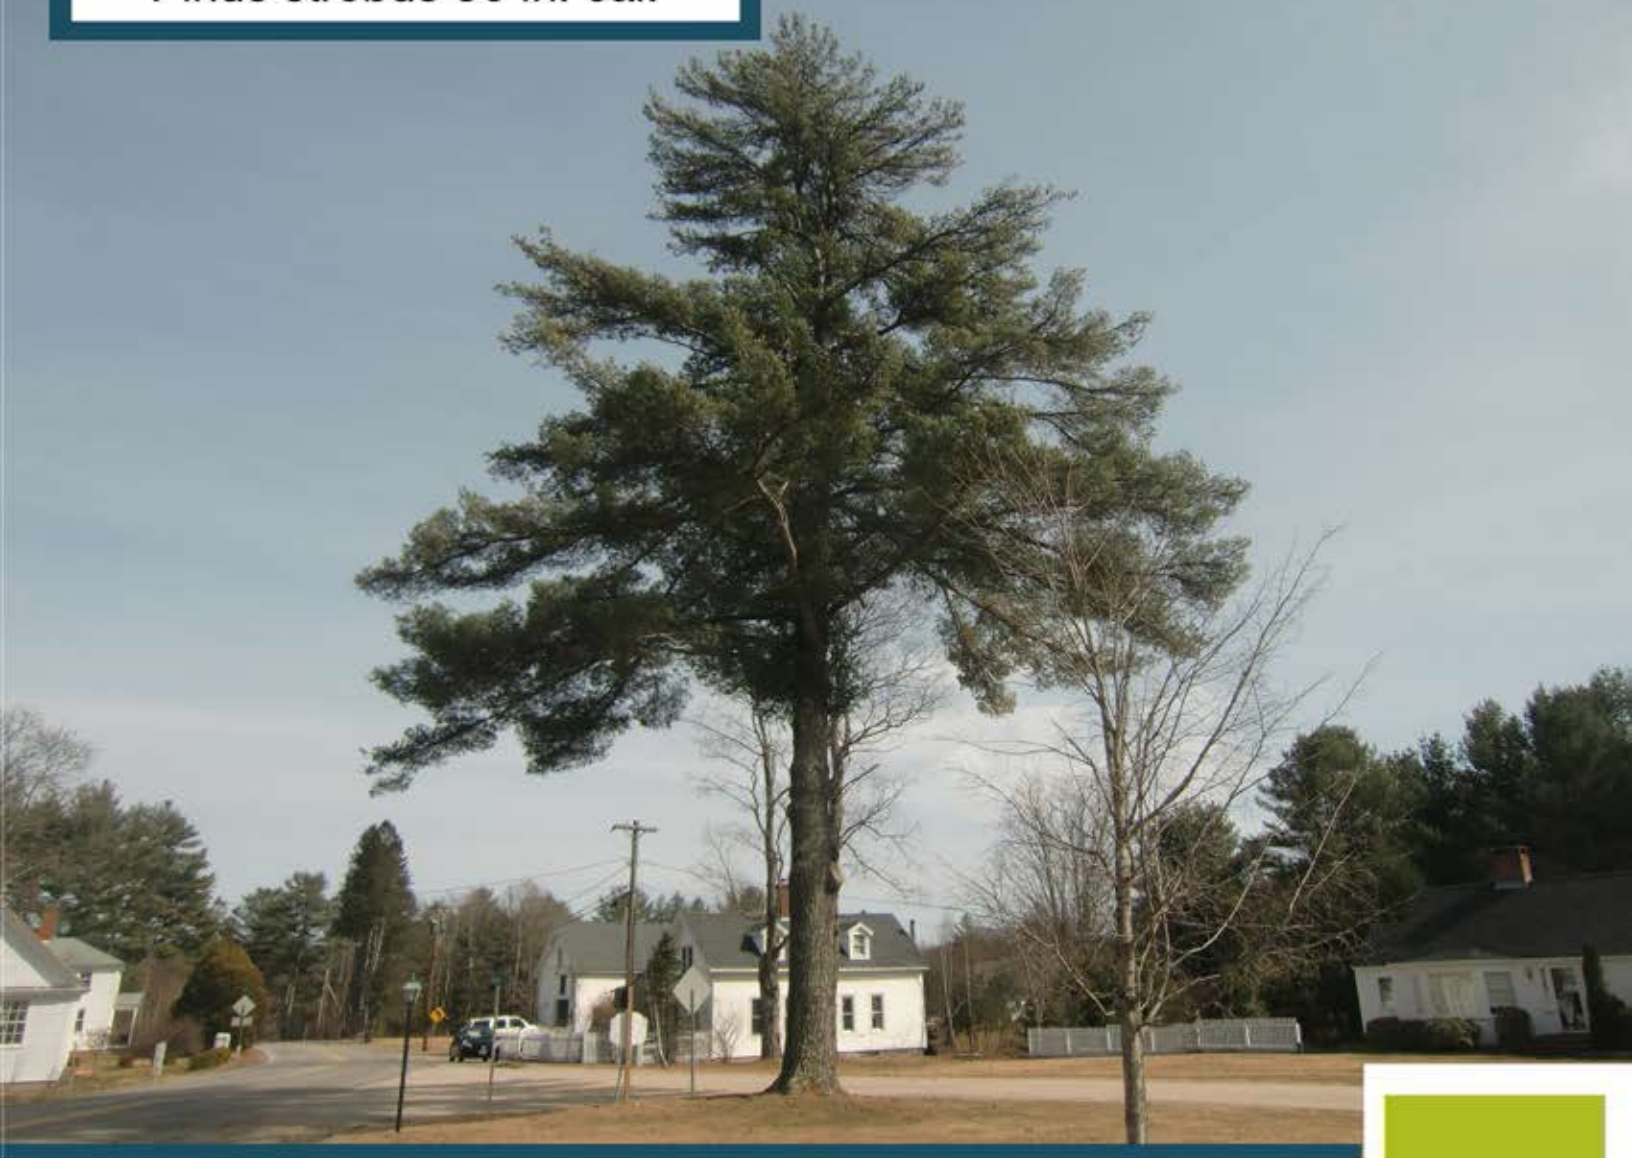
Tree #9
Eastern White Pine
Pinus strobus 36 in. cal.

1. Condition - For a White Pine this size it appears to be in good condition.

2. Save or Remove - Save until a licensed arborist can take a core sample to determine the soundness structure of the wood.

a. Many times Eastern White Pines this size have interior rot that makes the interior structure of the tree weak. This tree could last many more years or it could come down in the next wind storm or heavy snow. The structure of the tree is naturally weak, large branches have a tendency to break off and fall. If this tree was to come down it would most likely come down in the direction of the small Cape Style home next to "Hebron Academy". The preference is to professionally remove the tree to control the direction of fall so as not to damage property. Replace the pine with a small planting of Flowering crabs that would include the proper location of the signage, 1 *Malus* 'Lancelot' 6'-8' tall and 2 *Malus* 'Prairiefire' 15-20' tall.

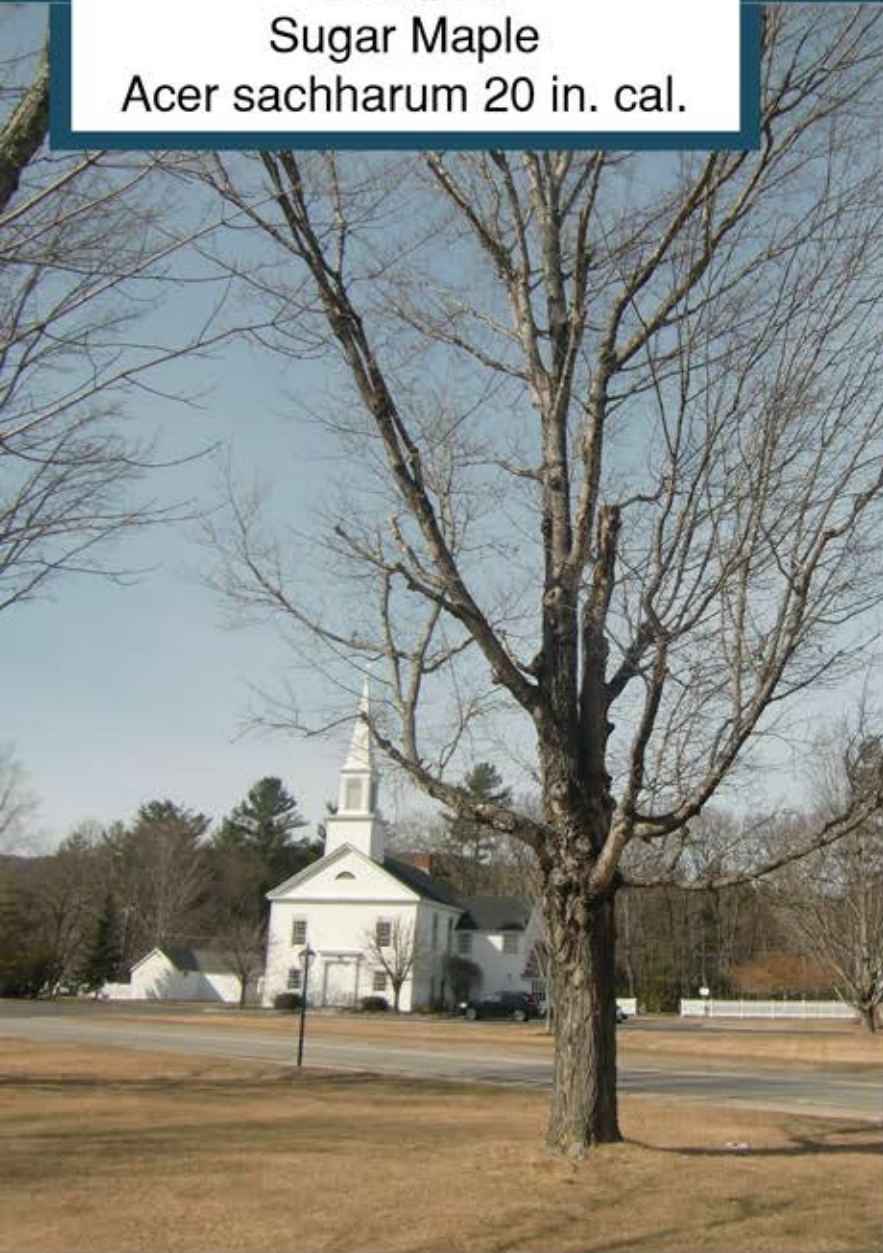
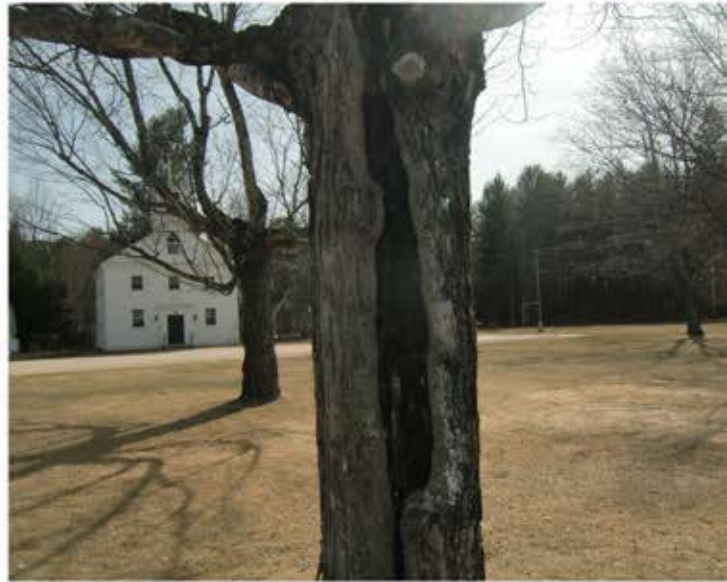
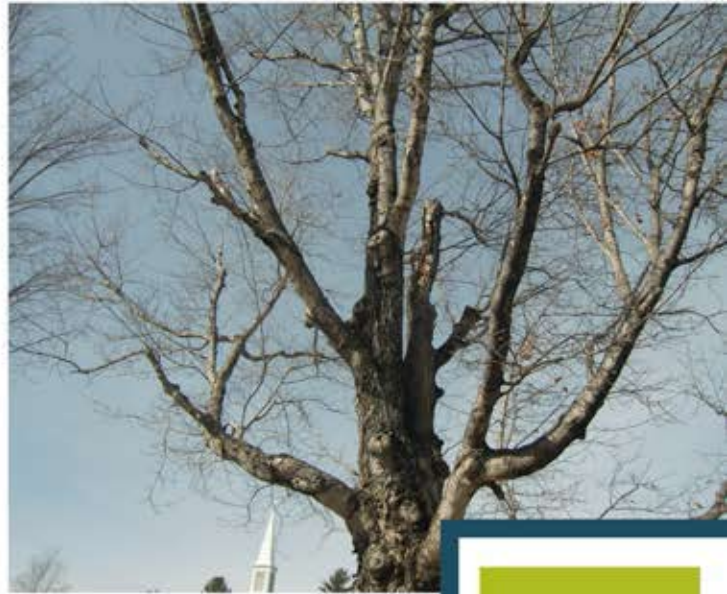
Tree #10
 Sugar Maple
Acer sachharum 20 in. cal.

1. Conditon - Fair

2. Save or Remove - Remove

- a. This tree is not worth spending money on trying to salvage. It may stand for years but with the compacted soil, its life expectancy is not favorable. There is dead wood in the crown of the tree (bottm right picture) and major interior rot (top right picture) within the trunk of the tree. Recommend replacing this tree with a Lagacy Sugar Maple *Acer saccharum* 'Legacy' Heavy crown, dense foliage, heat resistant, great yellow-orange fall color. It should be planted 6' closer to North Shore Road.

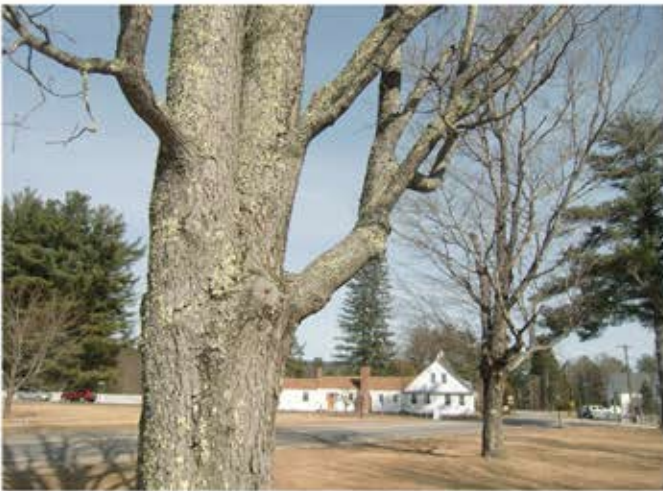
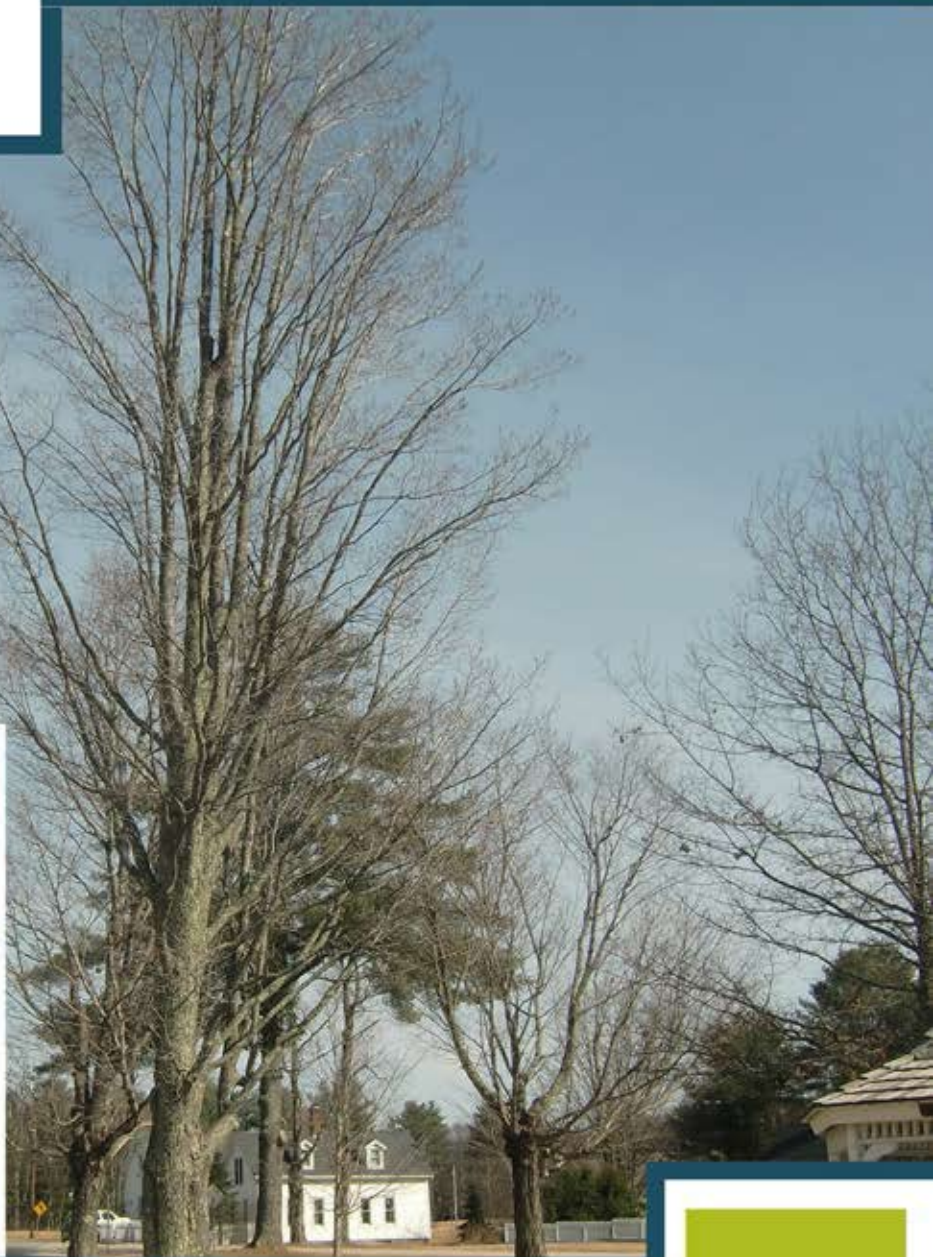
Tree #11
Red Maple
Acer rubrum 32 in. cal.

1. Condition - Good to Fair

2. Save or Remove - Save Temporarily

a. Have a licensed arborist cable the two main stems, and remove the 6" cal. side stem (bottom left picture) and remove any dead wood. Root fertilize and aerate the root area of the tree.

Eventually this tree will have to be replaced. It should be replaced with a Burgundy Belle Red Maple, *Acer rubrum* 'Burgundy Belle' and should be planted 6' closer to North Shore Road.
