Hebron, NH

Tree Inventory

Hebron Town Common

June 6, 2016

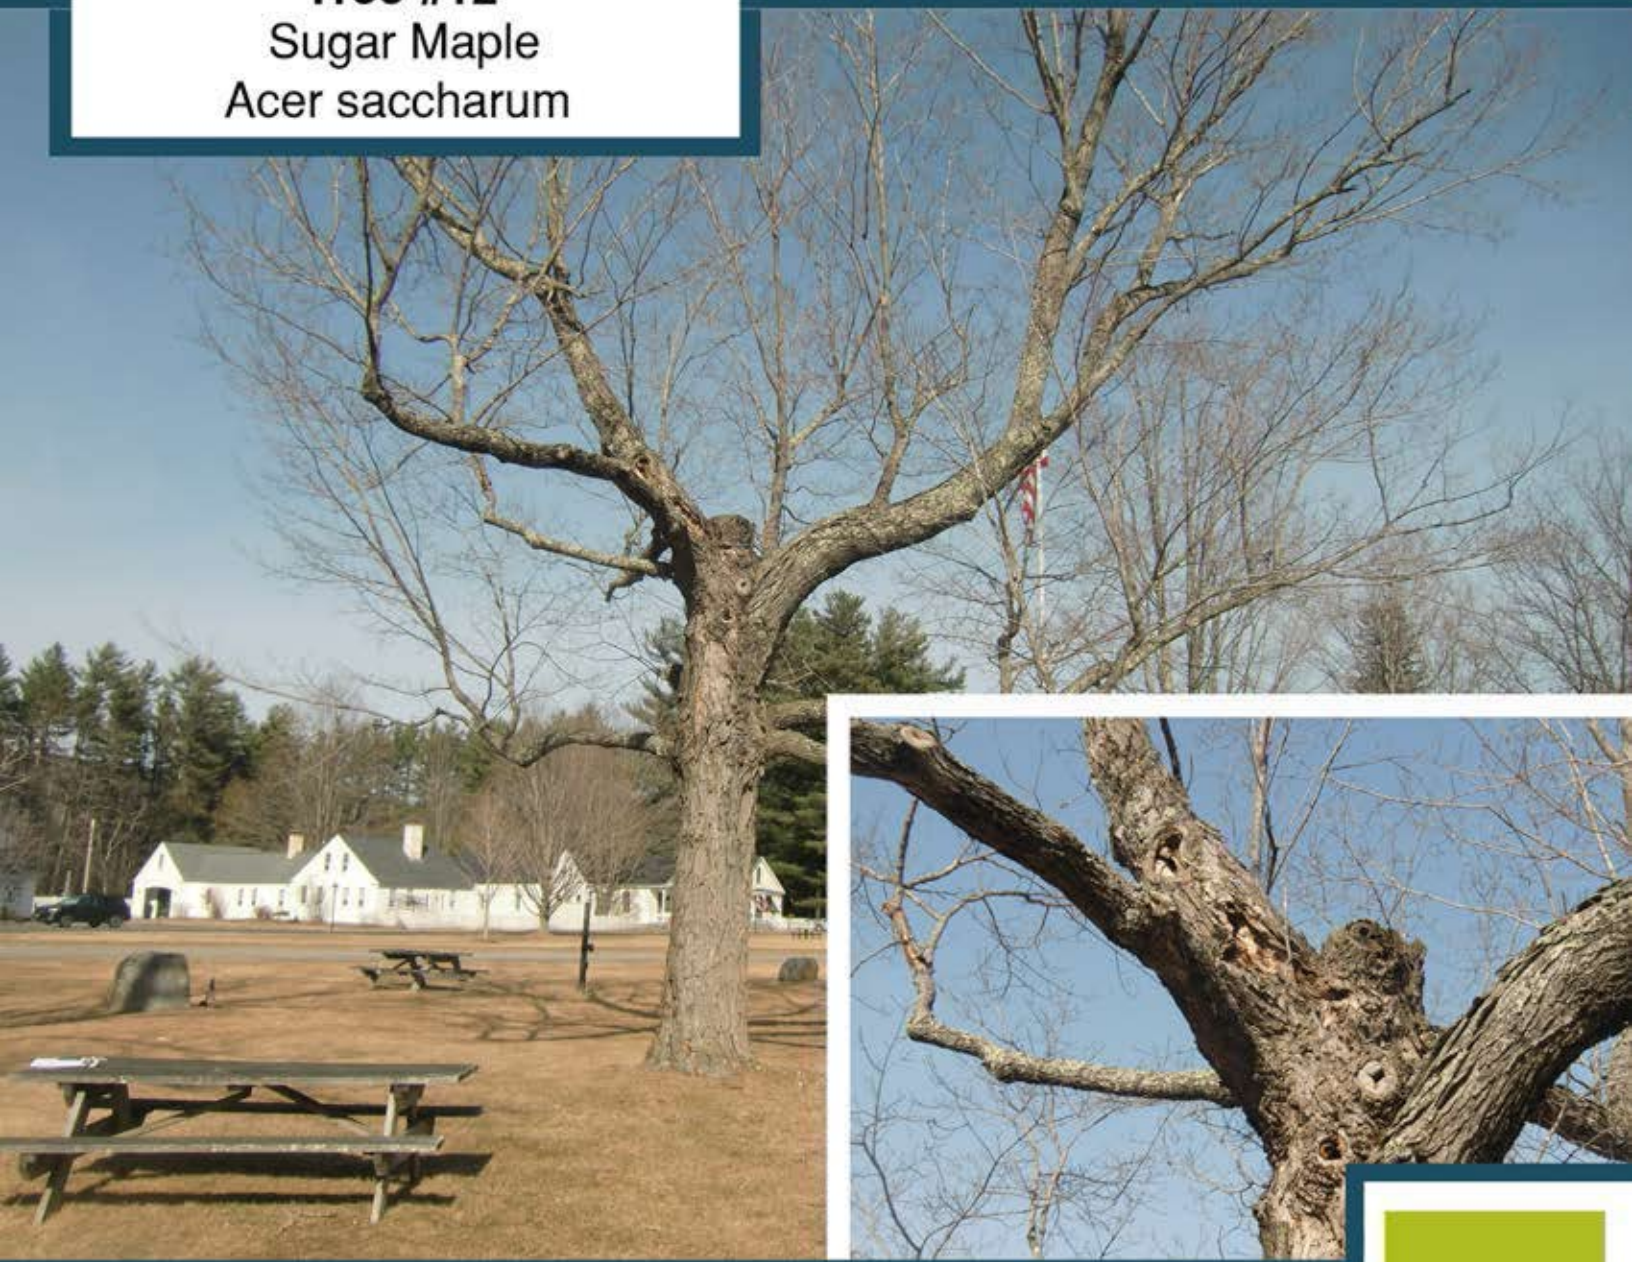
Tree #12
Sugar Maple
Acer saccharum

1. Condition - Very Poor

2. Save or Remove - Remove (Number 1 Priority for removal)

a. This tree should be first priority in removal. It is a hazardous tree, there is a very large branch that is almost rotted through (bottom right picture). It would take little for the branch to break off and fall to the ground or on someone passing by. It should be replaced with a Sugar Maple 'Legacy' *Acer saccharum* 'Legacy'

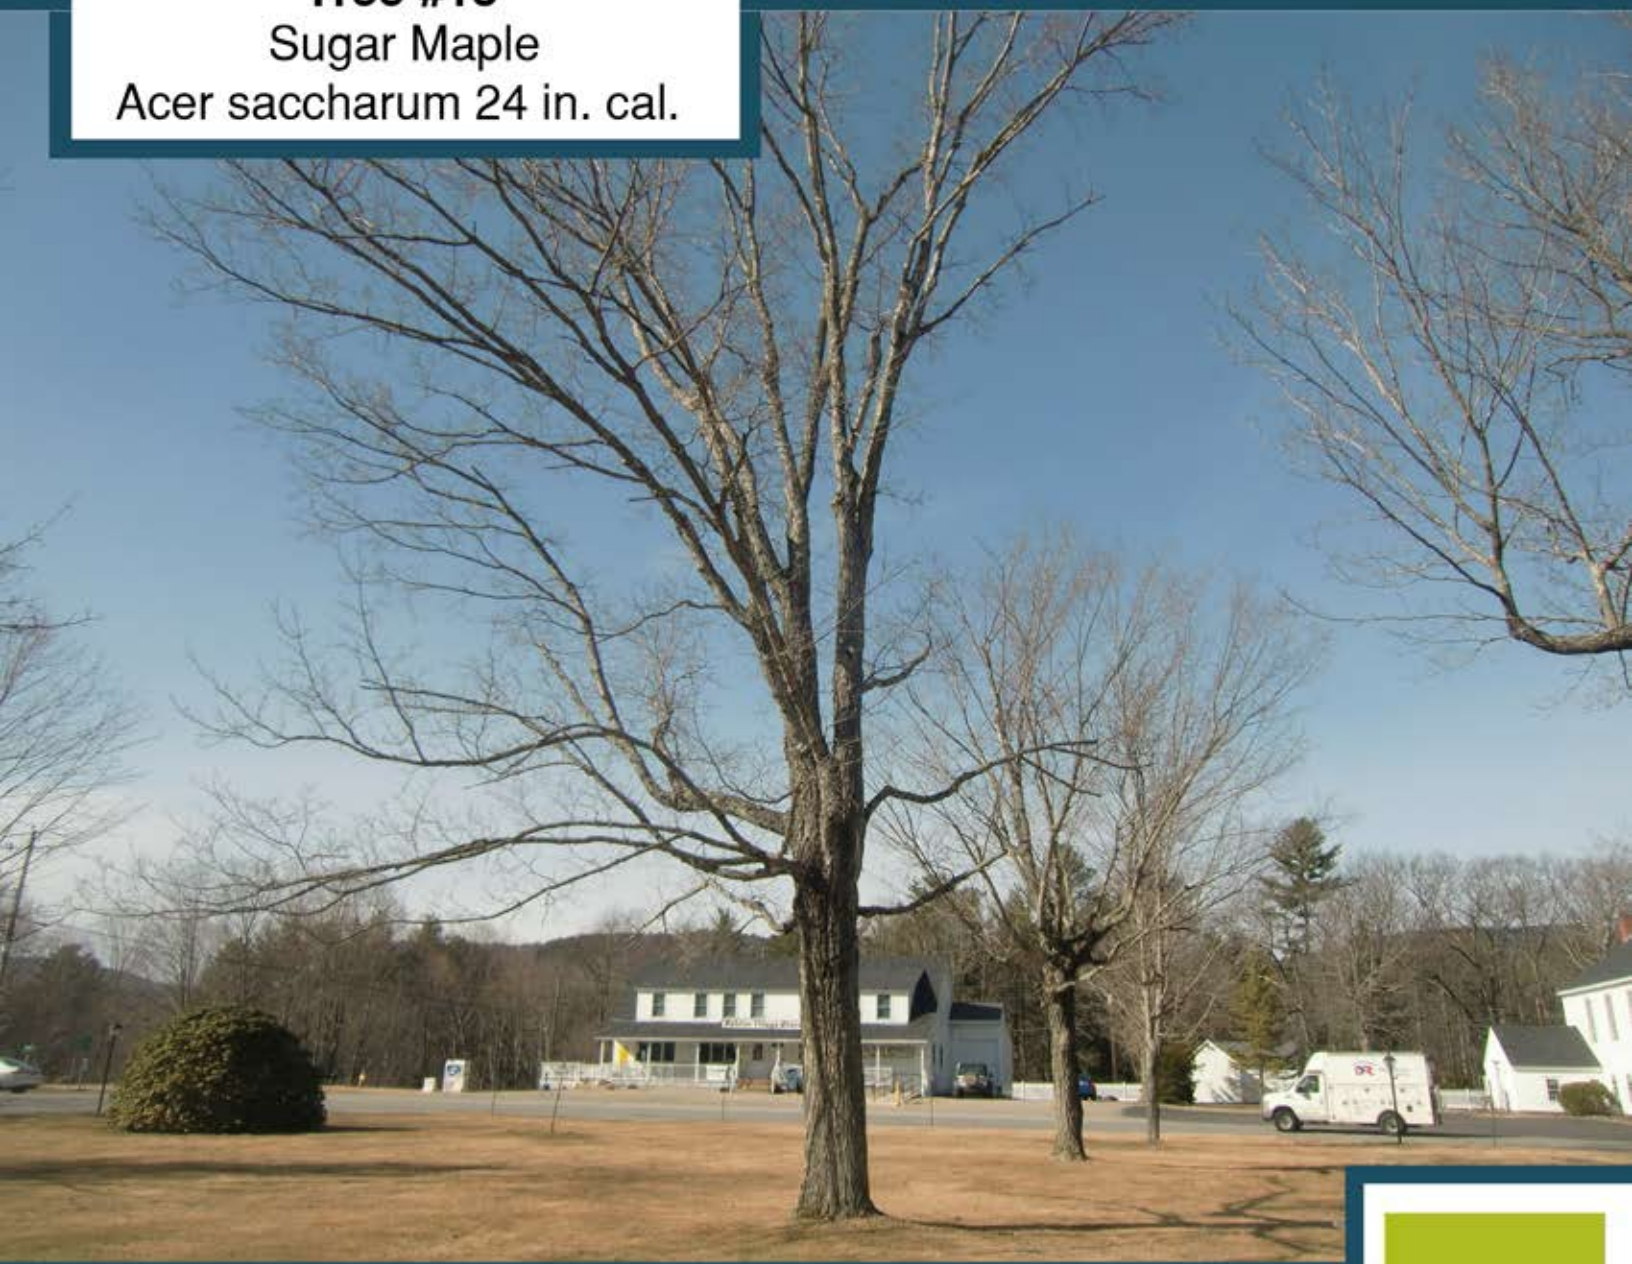
Tree #13
Sugar Maple
Acer saccharum 24 in. cal.

1. Condition - Good

2. Save or Remove - Save

a..Some small dead wood should be removed. Stubs from a previous pruning should be removed. Root fertilization and ground aeration around the root zone is needed.

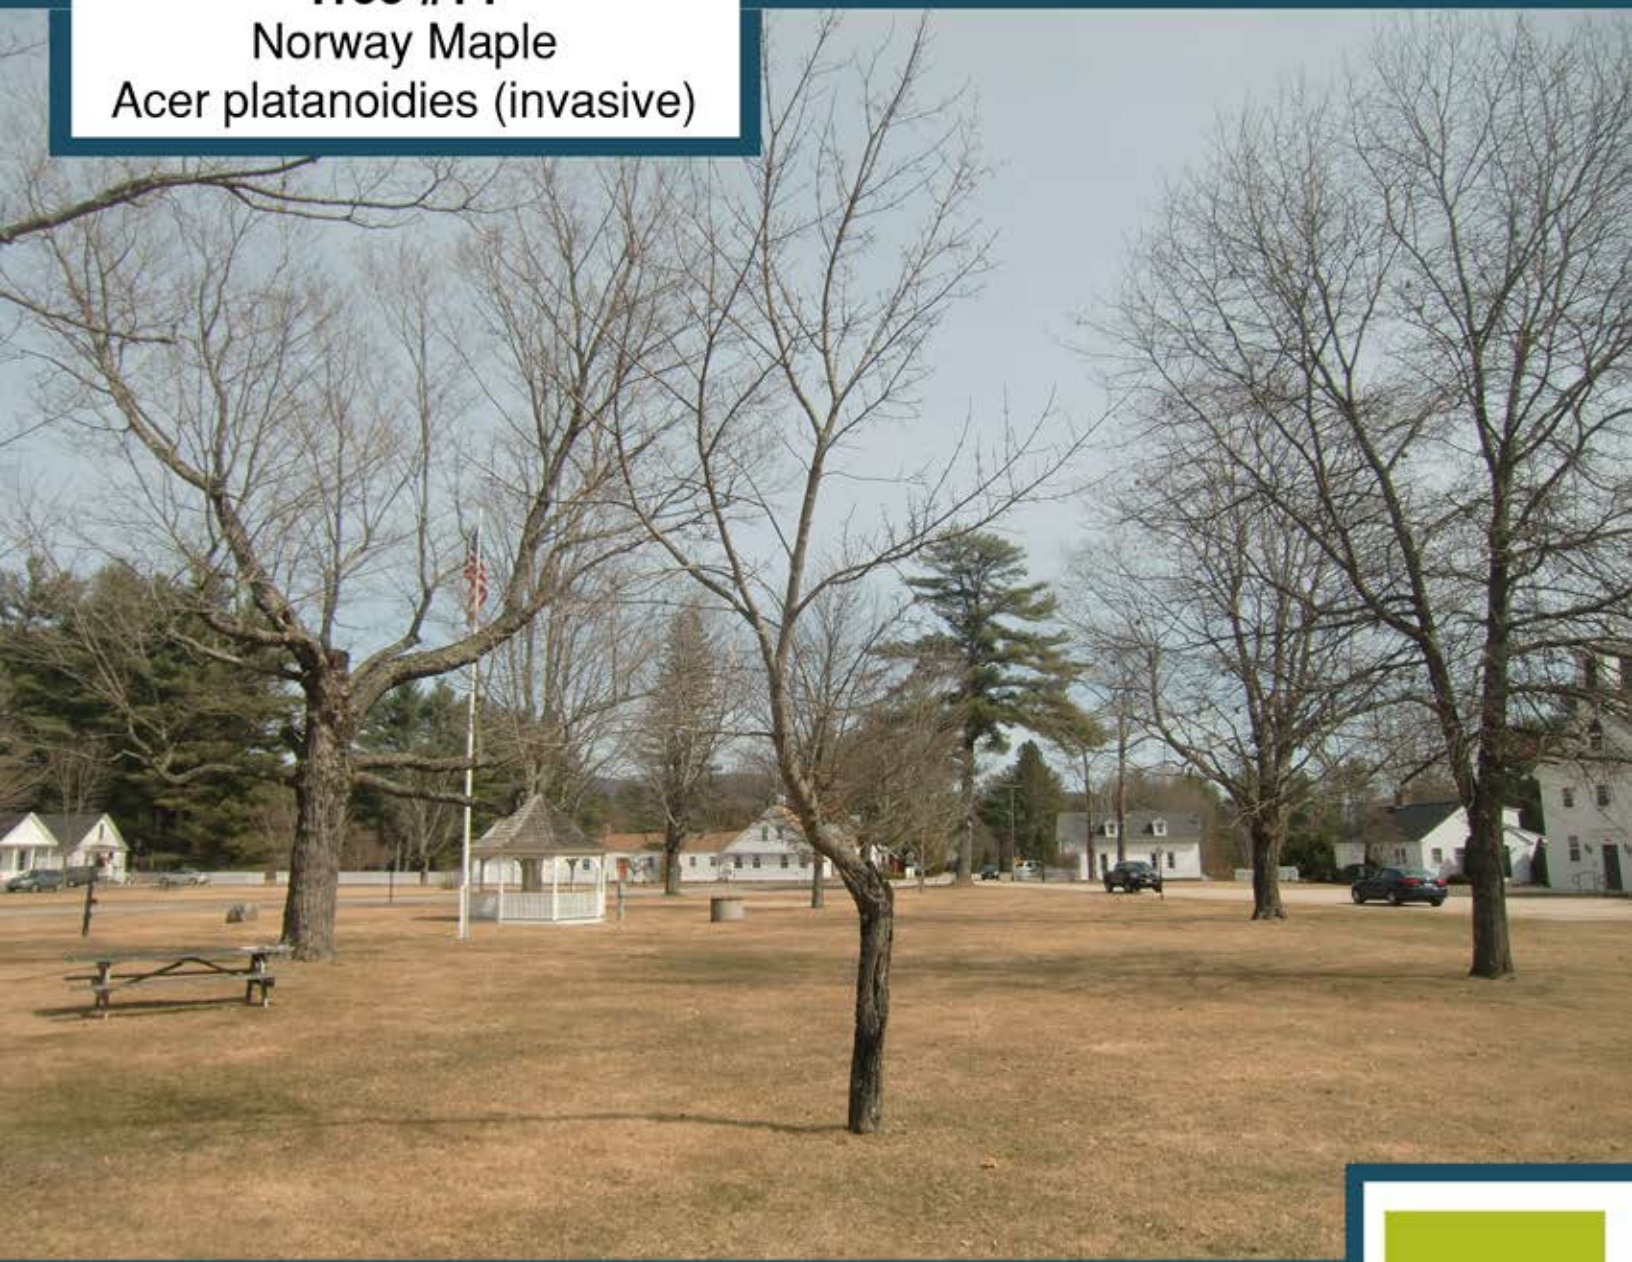
Tree #14
Norway Maple
Acer platanoides (invasive)

1. Condition - Poor

2. Save or Remove - Remove

- a.** Replace with an *Acer rubrum* 'October Glory' October Glory Red Maple.
It should be placed in line with Tree# 3 and Tree #18

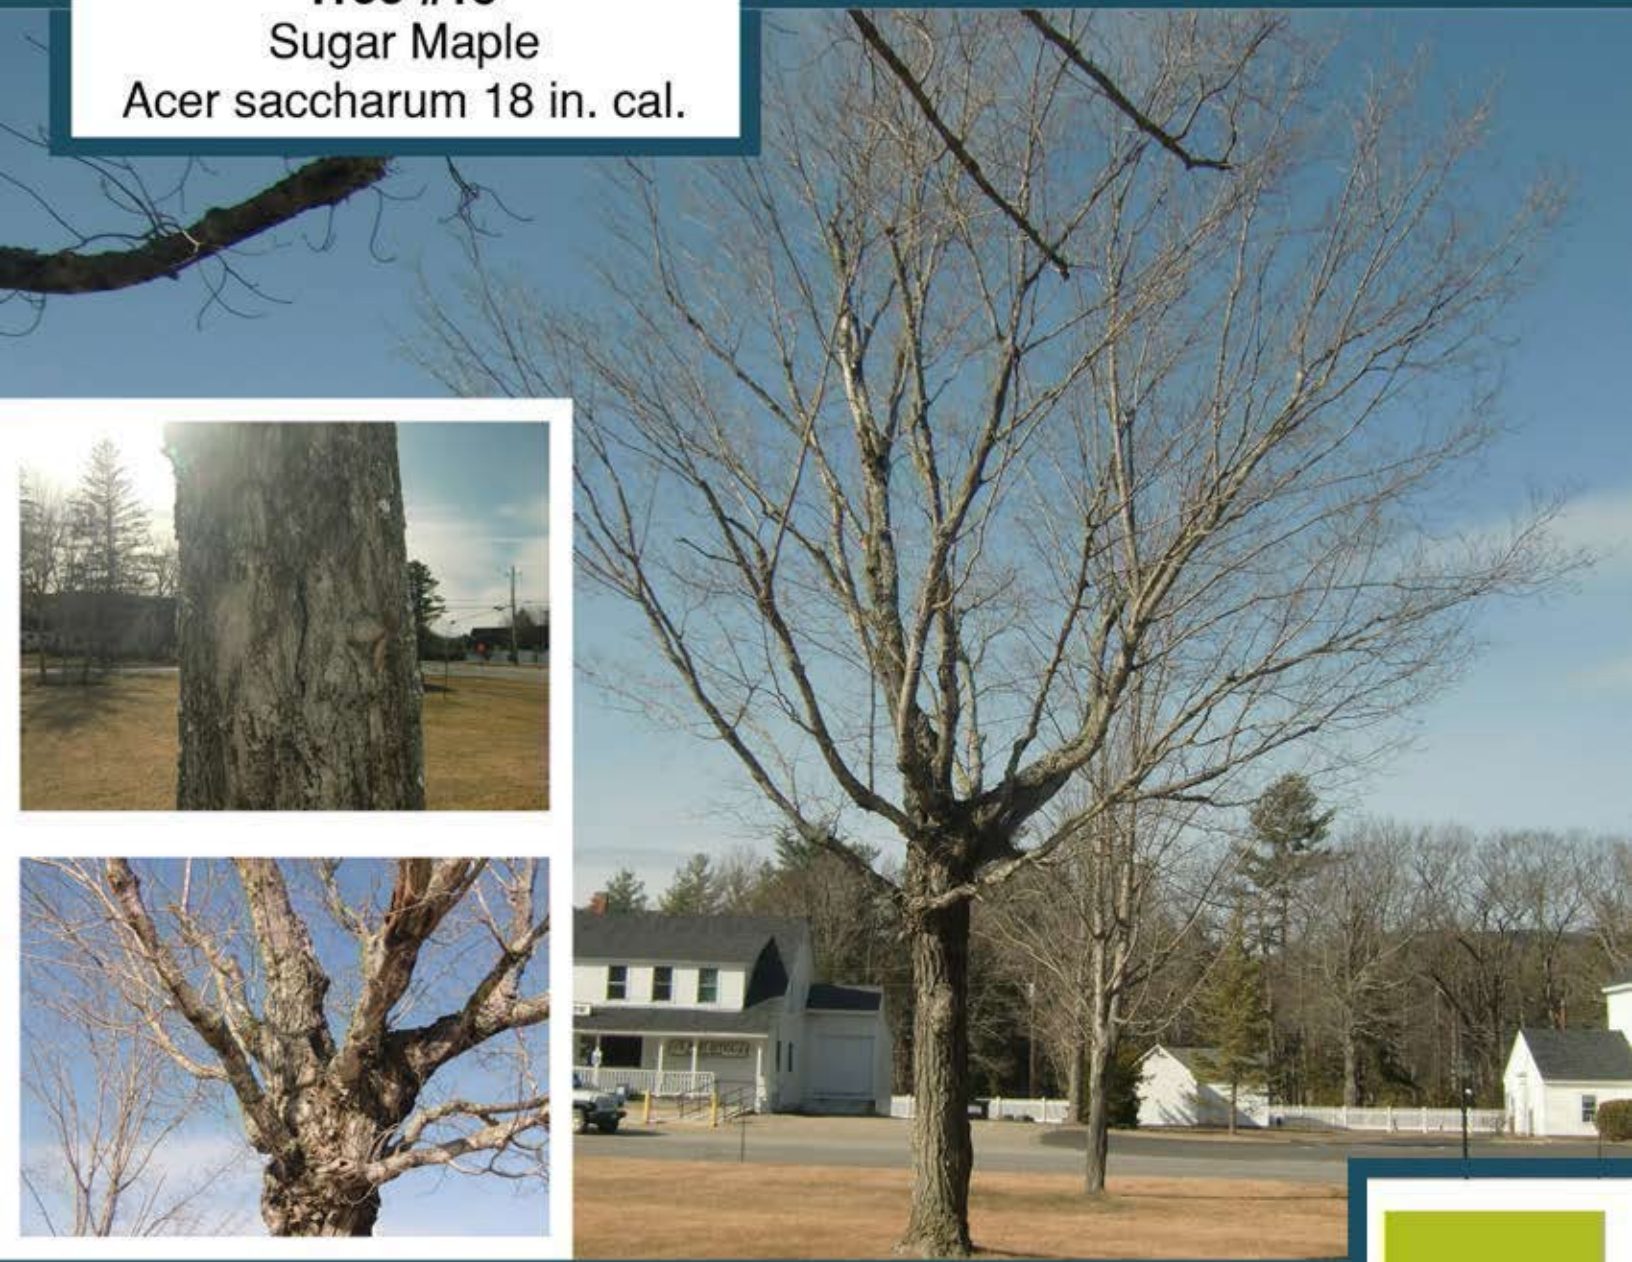
Tree #15
Sugar Maple
Acer saccharum 18 in. cal.

1. Condition - Fair

2. Save or Remove - Remove Eventually

a. The outer structure of the tree is intact but there is interior rot. This tree may survive several more years but should be on the near term removal list. For the moment some basic pruning is necessary. Remove the dead wood, there is a large branch with substantial decay that should be removed before it becomes a hazard.

b. Replace this tree in the same or near the same location with Sugar Maple 'Legacy'
Acer saccharum 'Legacy'

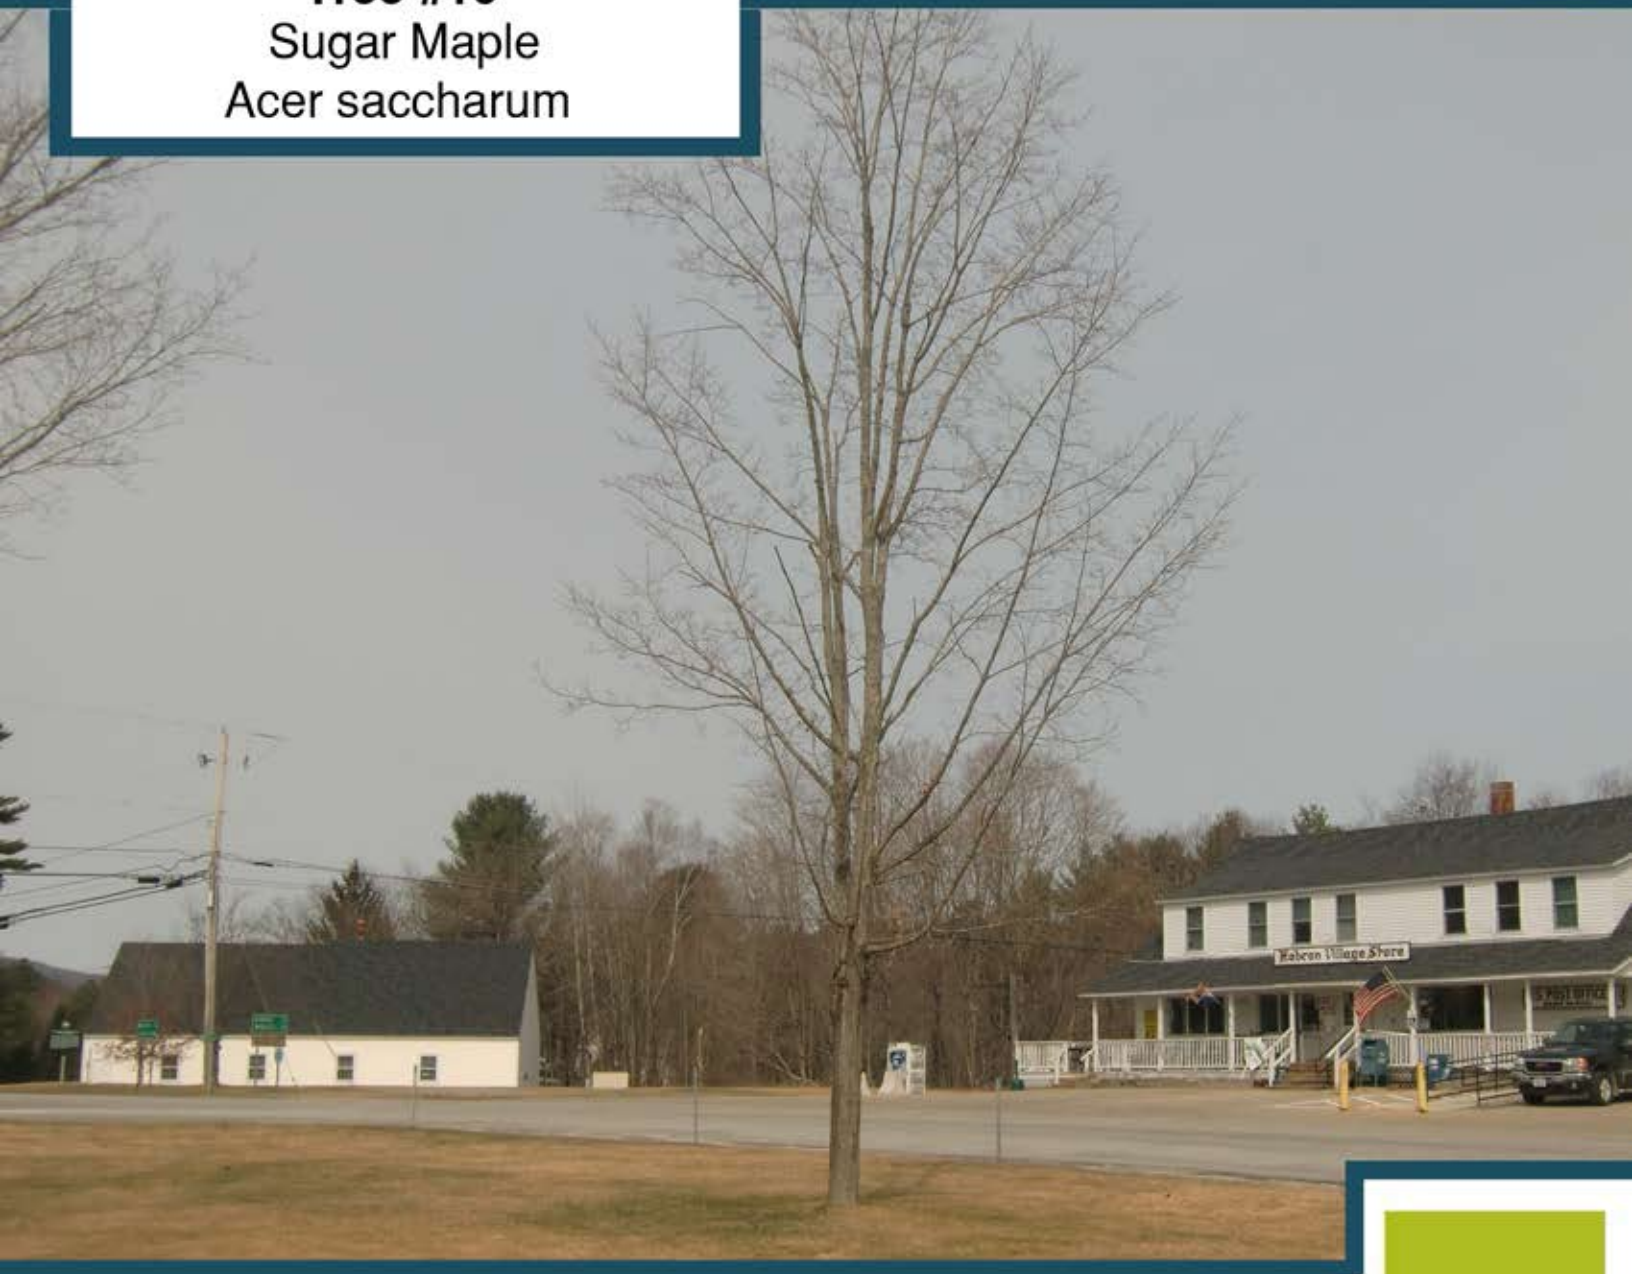
Tree #16
Sugar Maple
Acer saccharum

1. Condition - Excellent

2. Save or Remove - Save

- a. As the tree matures the two main stems may have to be cabled to each other to prevent splitting in the future. Remove any crossing branches, and aerate the soil. Also root fertilize the root zone of the tree.

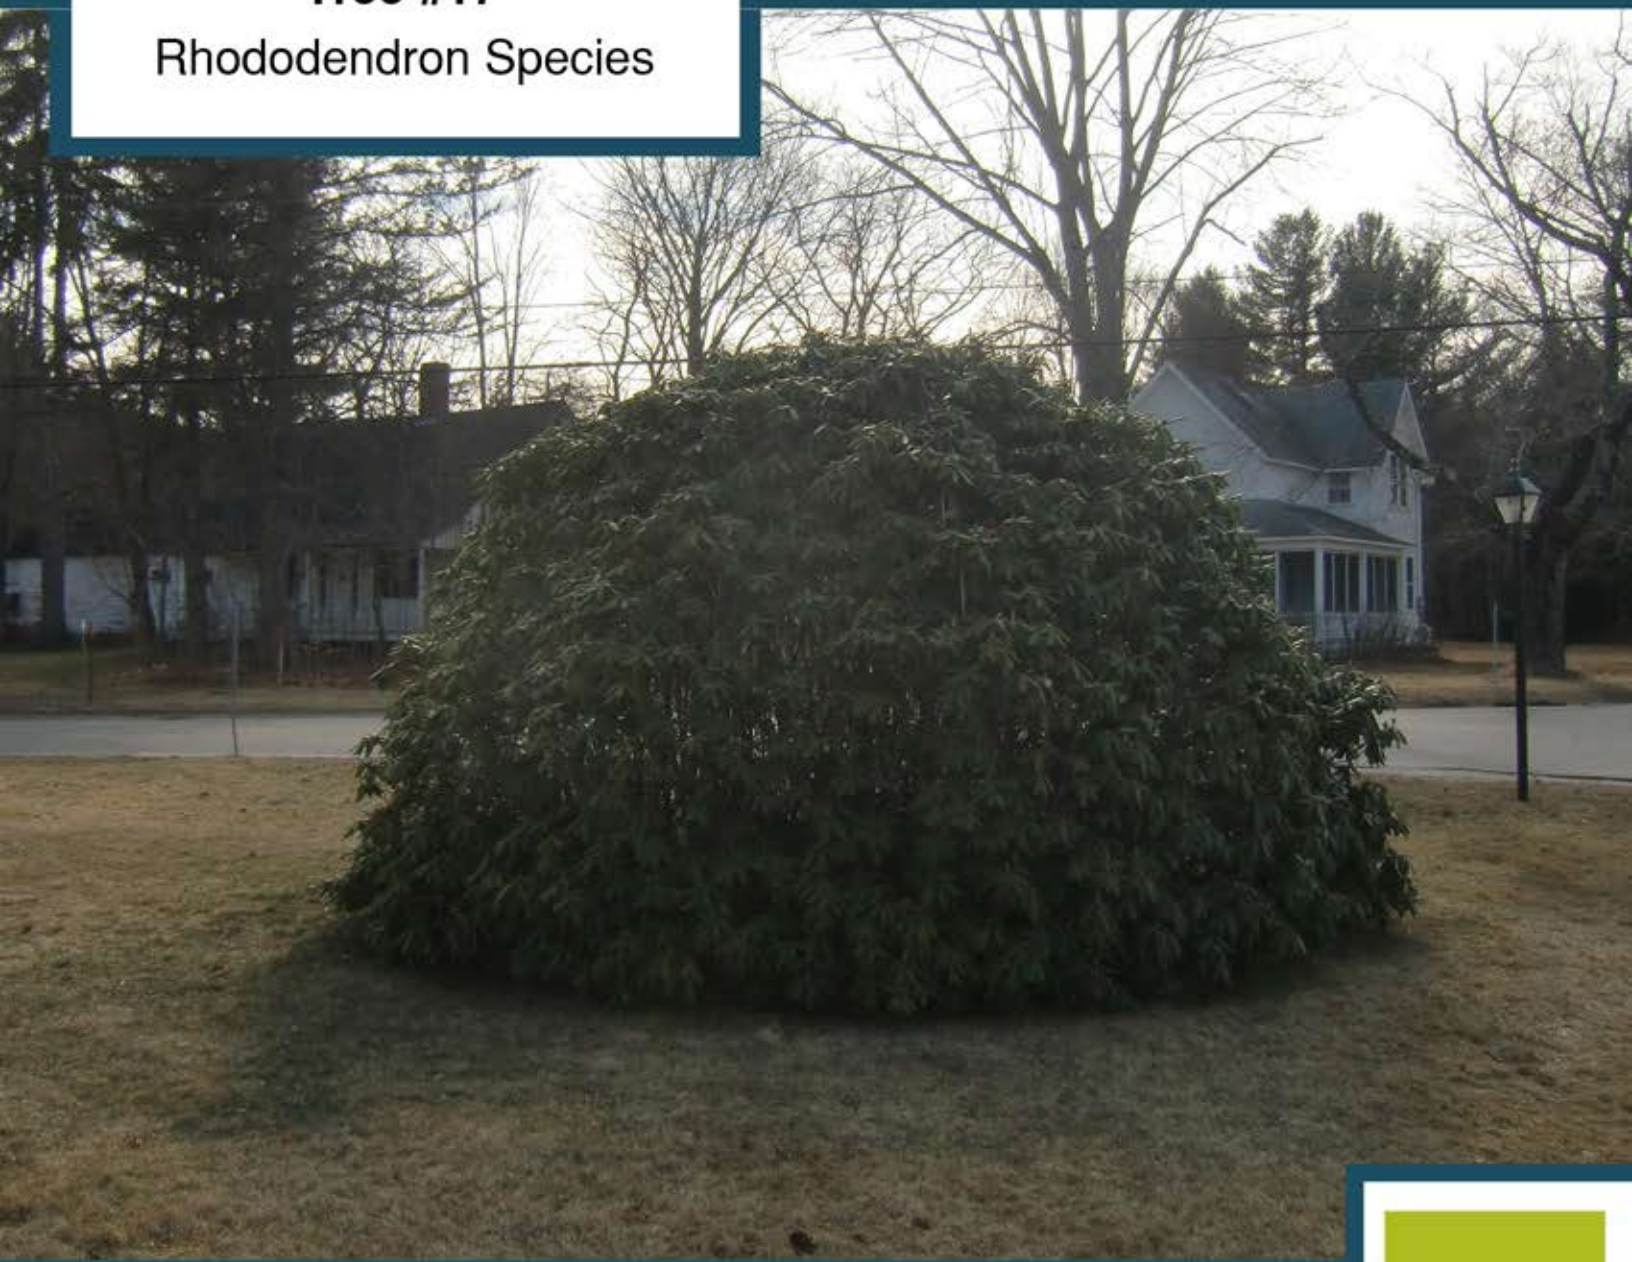
Tree #17

1. Condition - Excellent

2. Save or Remove - Save

- a.** This cluster of rhododendrons seem to be doing just fine without much care. Periodically prune branches that might alter the uniformity of the planting.

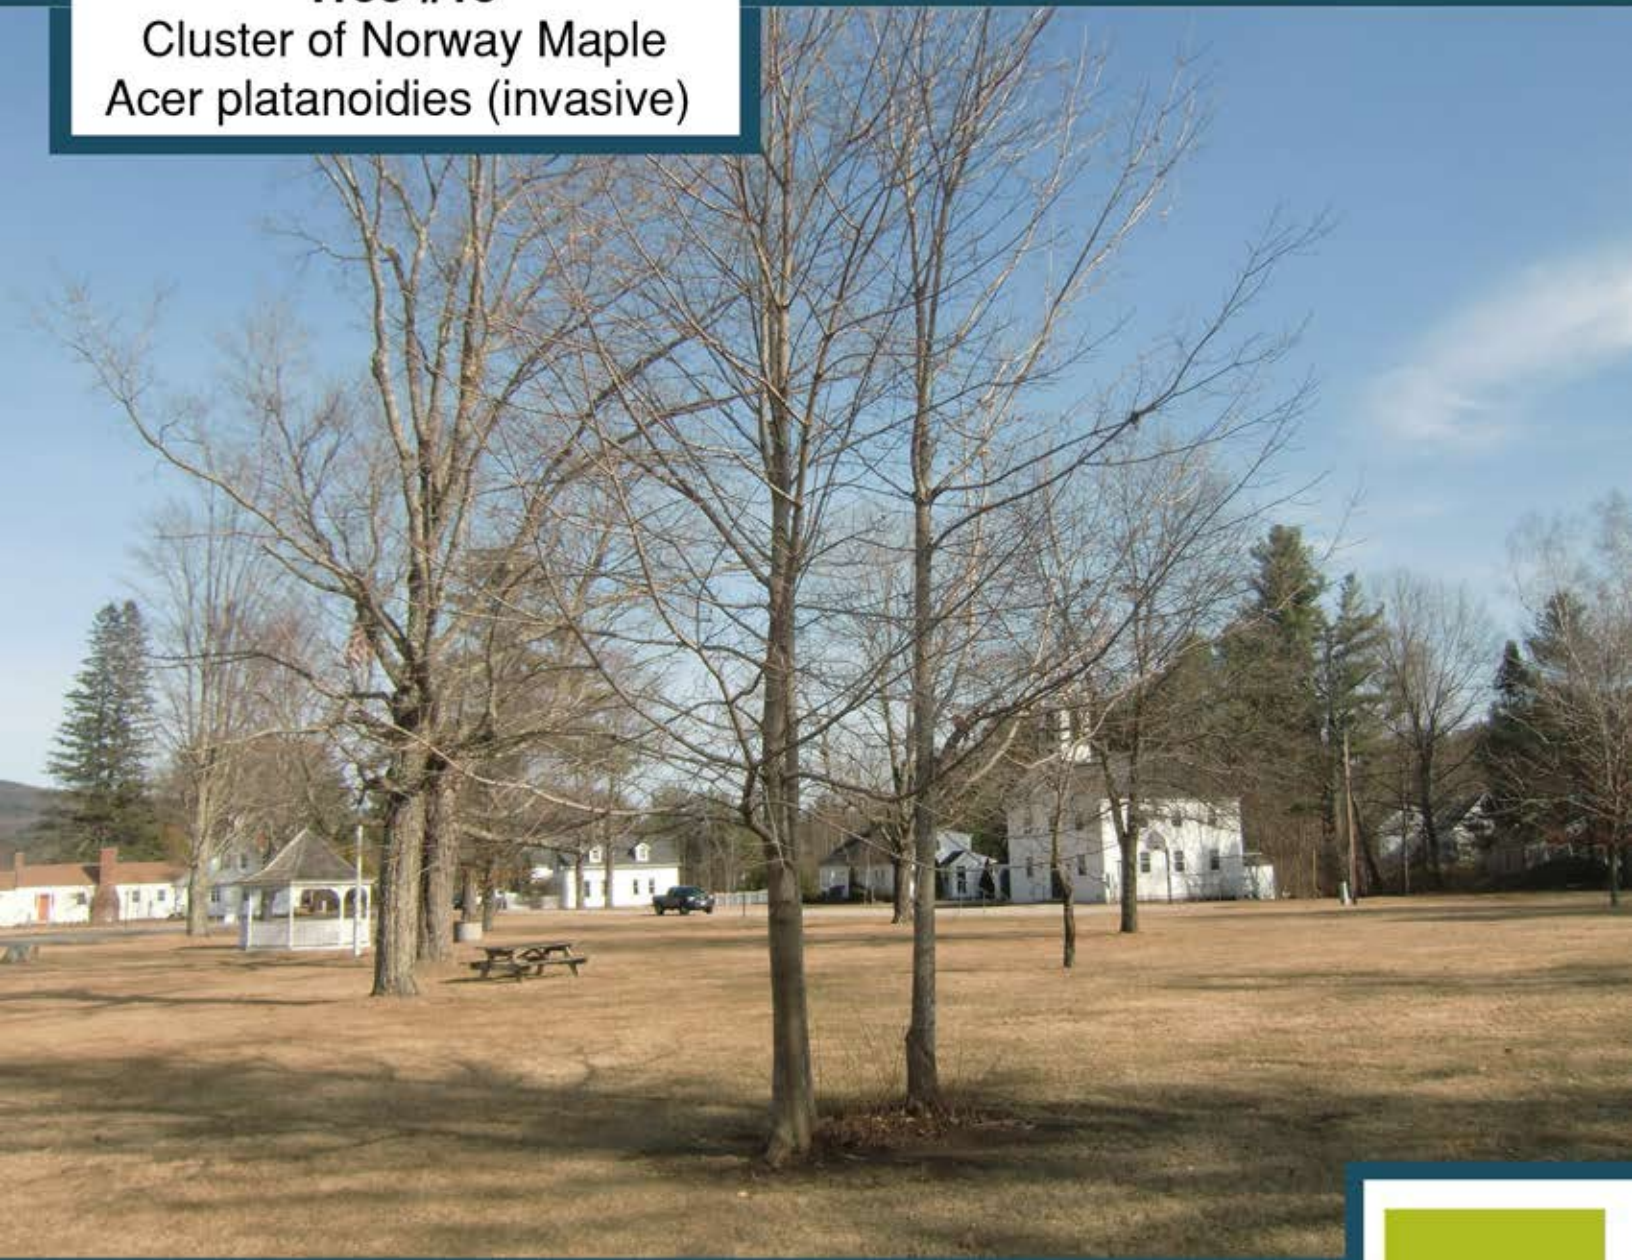
Tree #18
Cluster of Norway Maple
Acer platanoides (invasive)

1. Condition - Good

2. Save or Remove - Remove

- a. This is listed by the State of New Hampshire as an invasive species so it should be removed. Unless there are plans to do a planting of trees along the West Shore Road side of the common there is no reason to replace these trees.

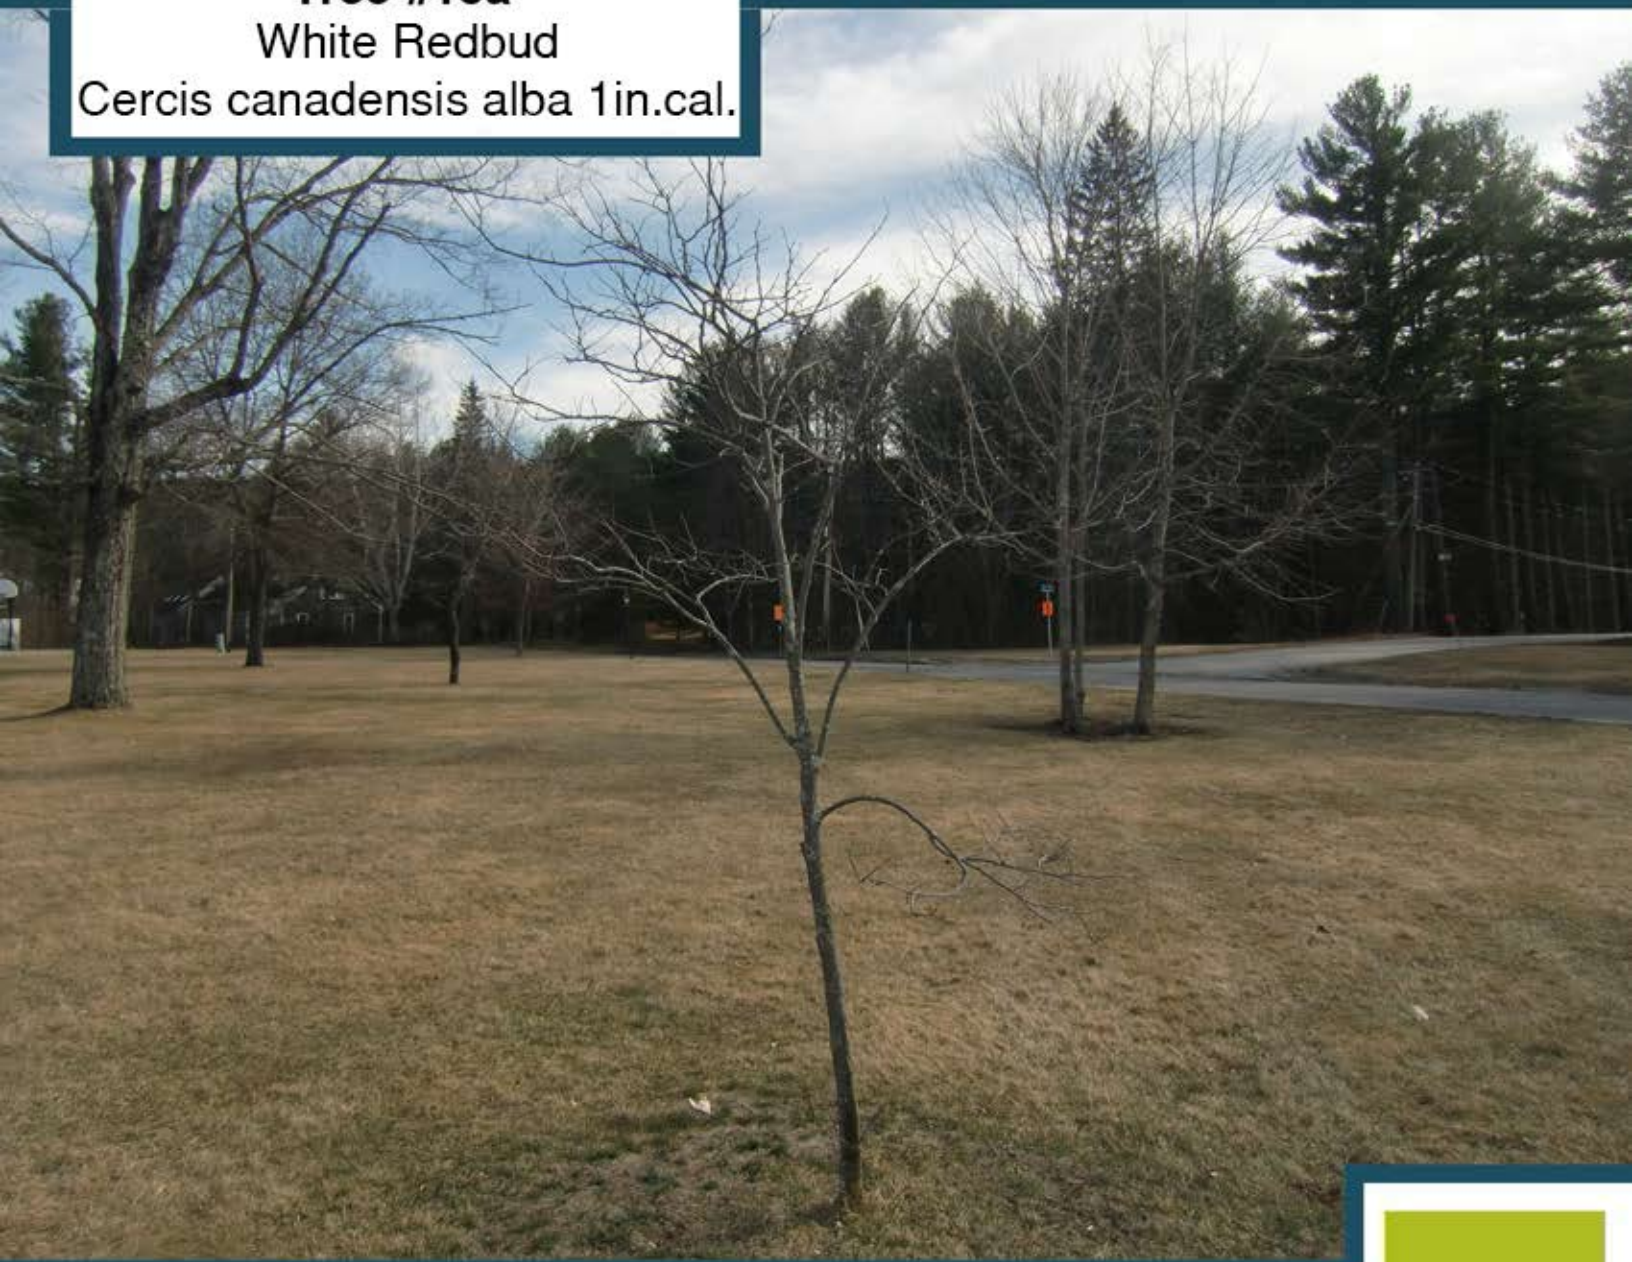
Tree #18a
White Redbud
Cercis canadensis alba 1in.cal.

1. **Conditon** - Good
2. **Save or Remove** - Save
 - a. **If saved what is the treatment plan / pruning needs?**
 - a. Fertilize and Mulch

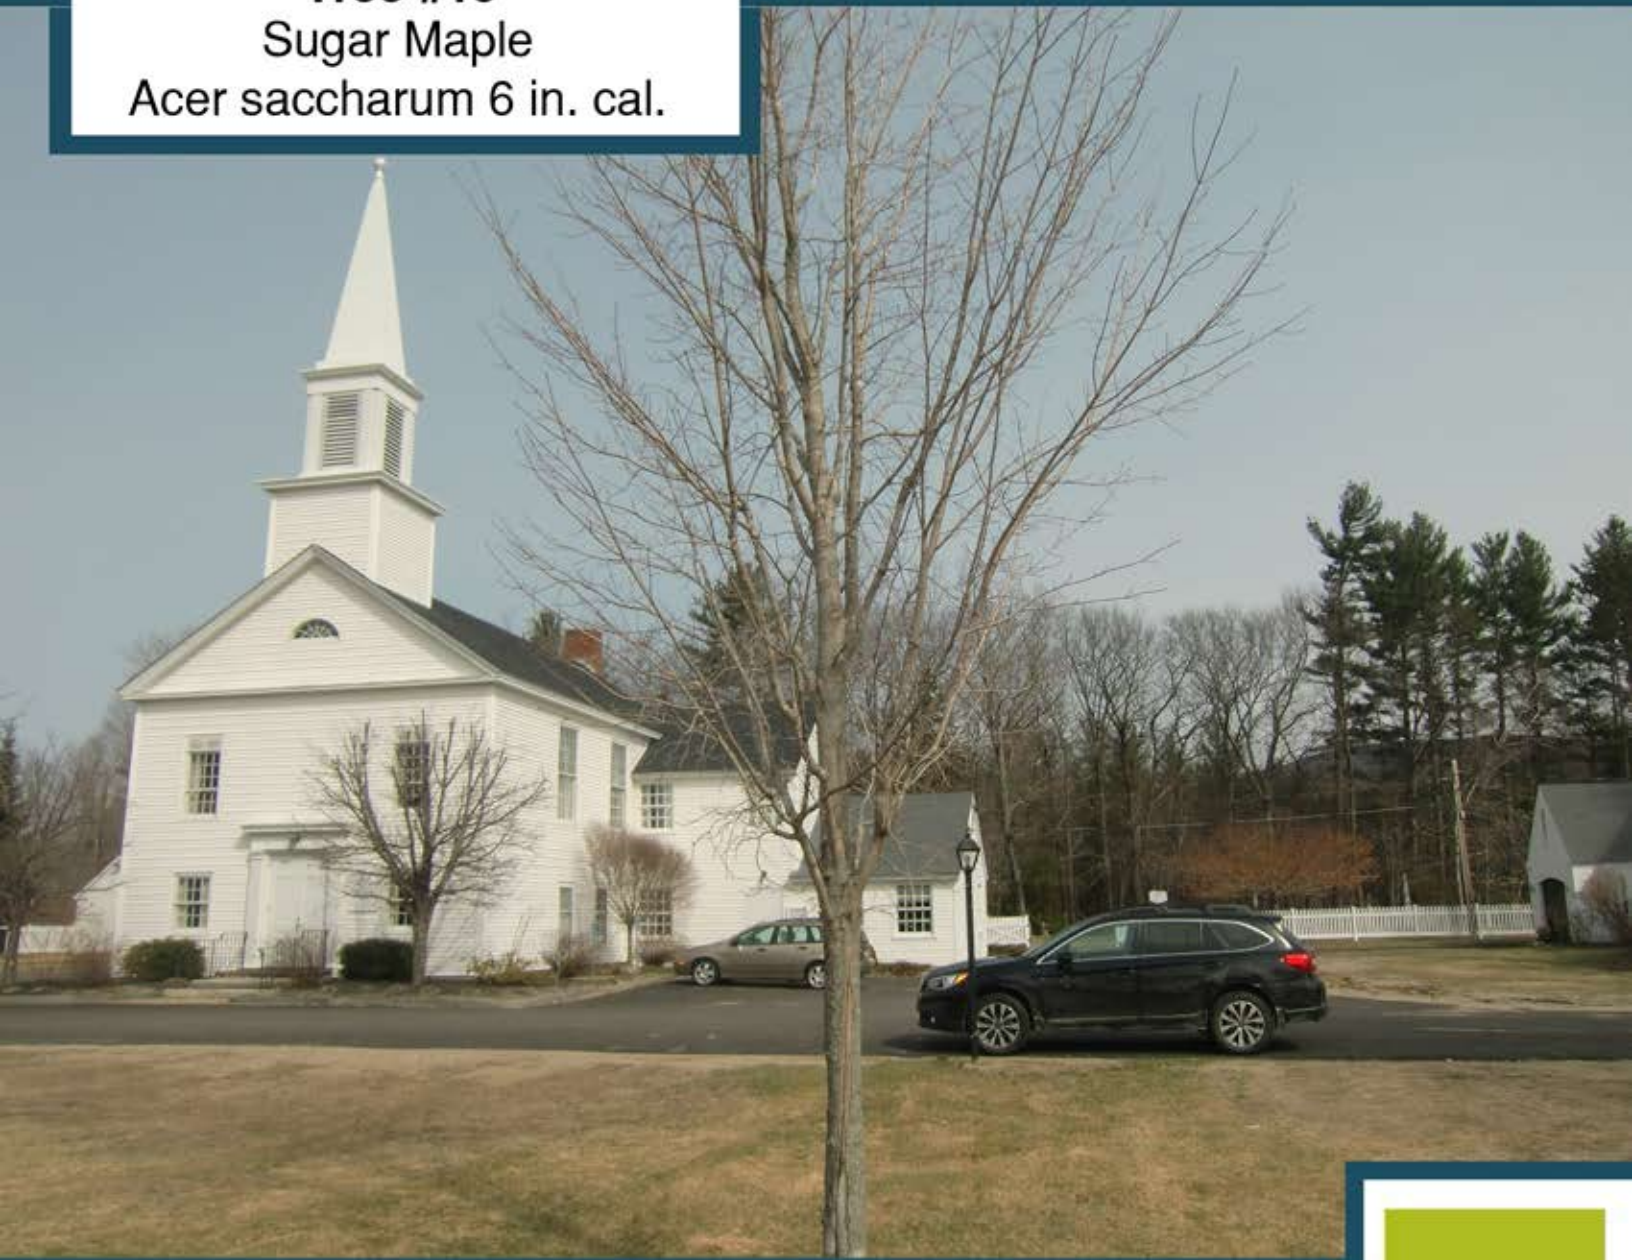
Tree #19
Sugar Maple
Acer saccharum 6 in. cal.

1. **Condition** - Good there is some lower trunk damage

2. **Save or Remove** - Save

- a. Clean out interior branches and potential crossing branches.
Root fertilize the tree and remove the plastic edging from the root area of the tree.

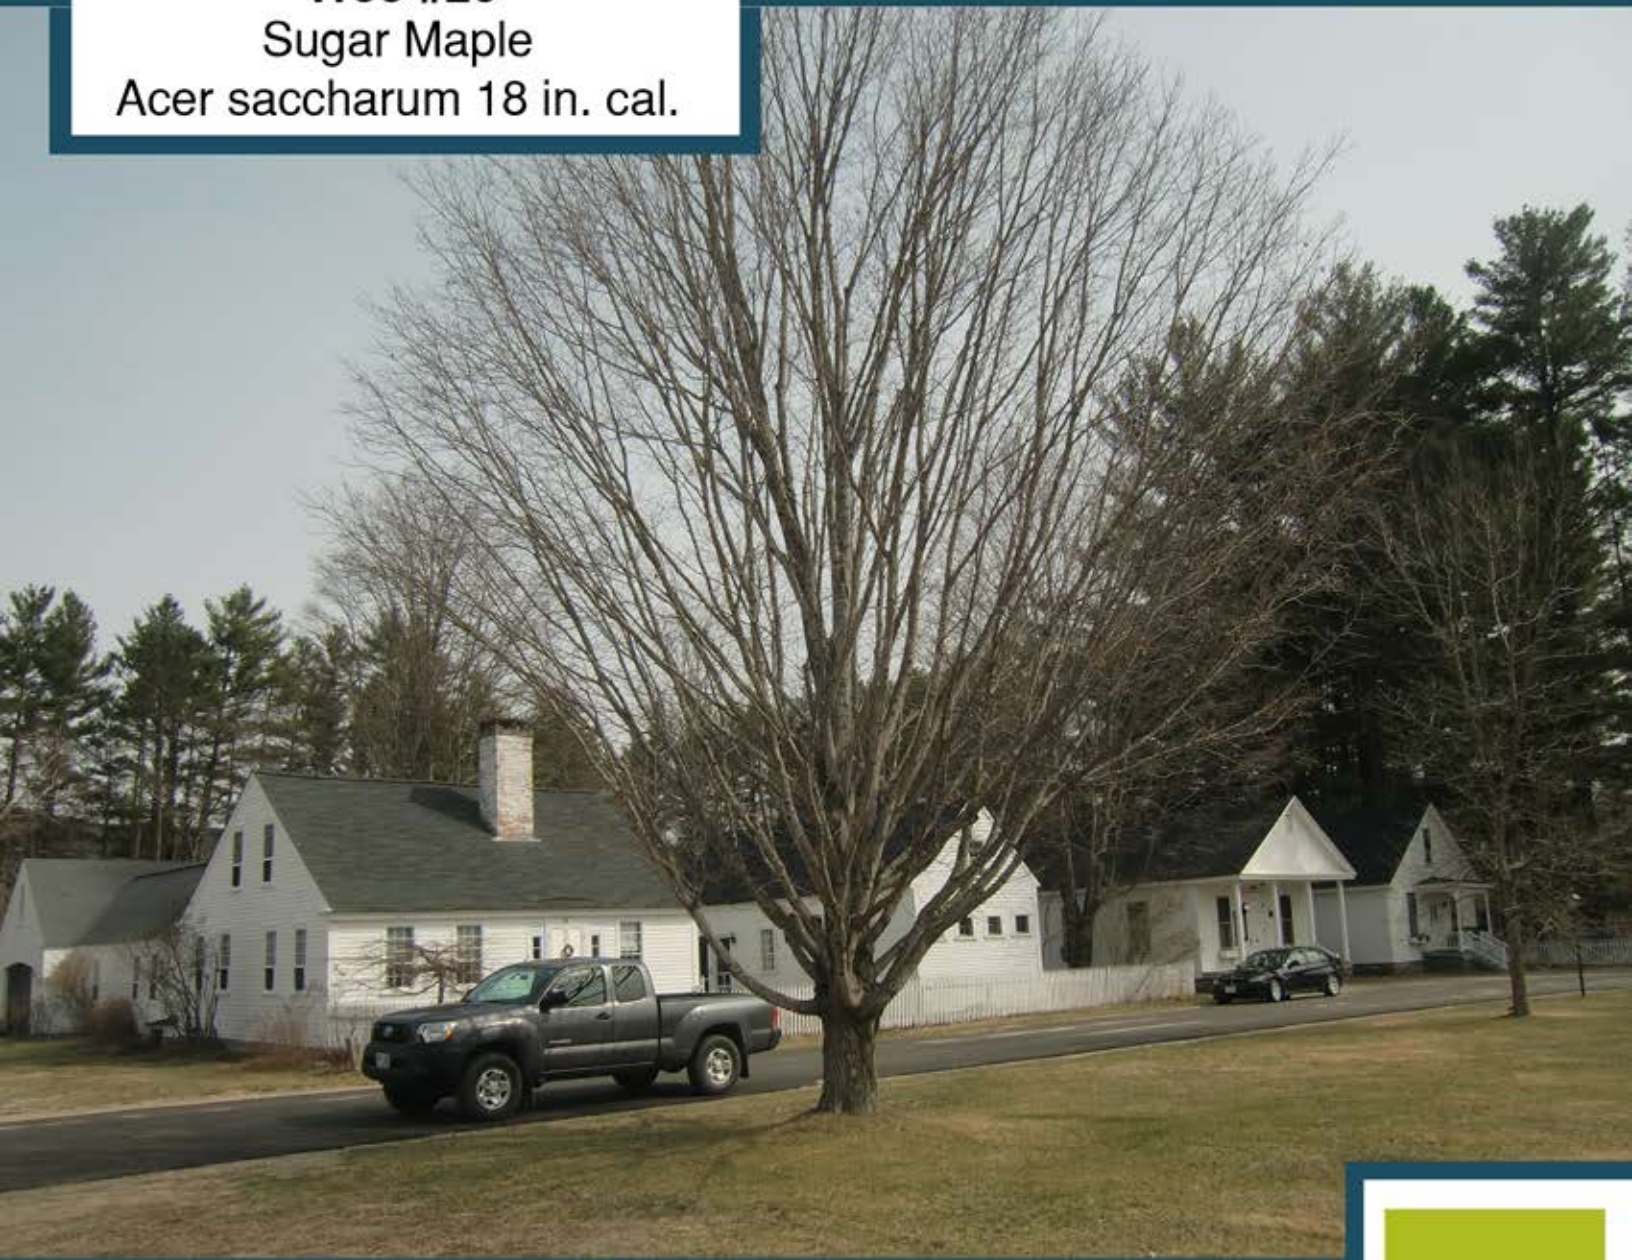
Tree #20
Sugar Maple
Acer saccharum 18 in. cal.

1. **Condition** - Good there is some lower trunk damage

2. **Save or Remove** - Save

a. Thin the crown of the tree by a professional arborist, remove crossing branches and root fertilize the tree.
