Hebron, NH

Tree Inventory

Hebron Town Common

June 6, 2016

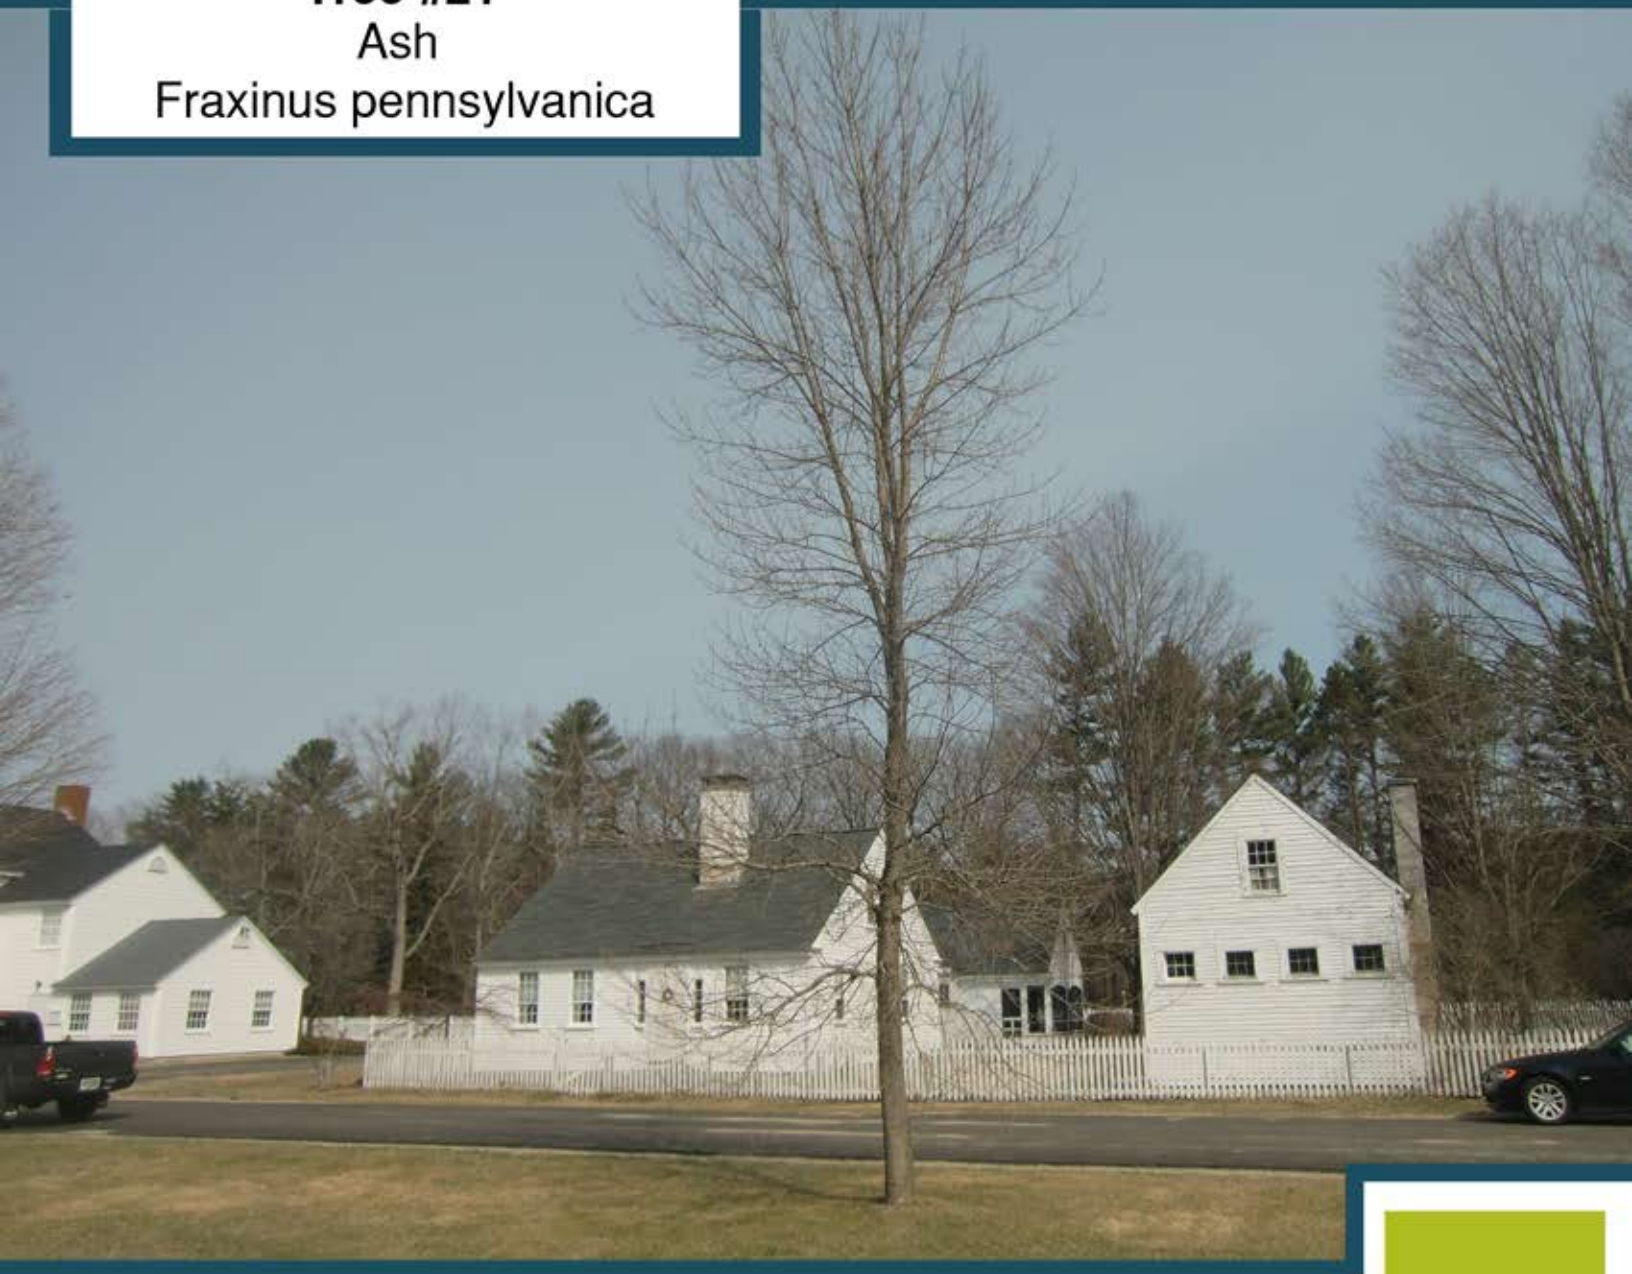
Tree #21
Ash
Fraxinus pennsylvanica

1. Condition - Good there is some lower trunk damage

2. Save or Remove - Save

- a. Watch out for the Emerald Ash Borer. Remove branches that are lower than six (6) feet above the ground. Remove interior branches on the interior stem. Root fertilize and aerate the soil in the root zone.

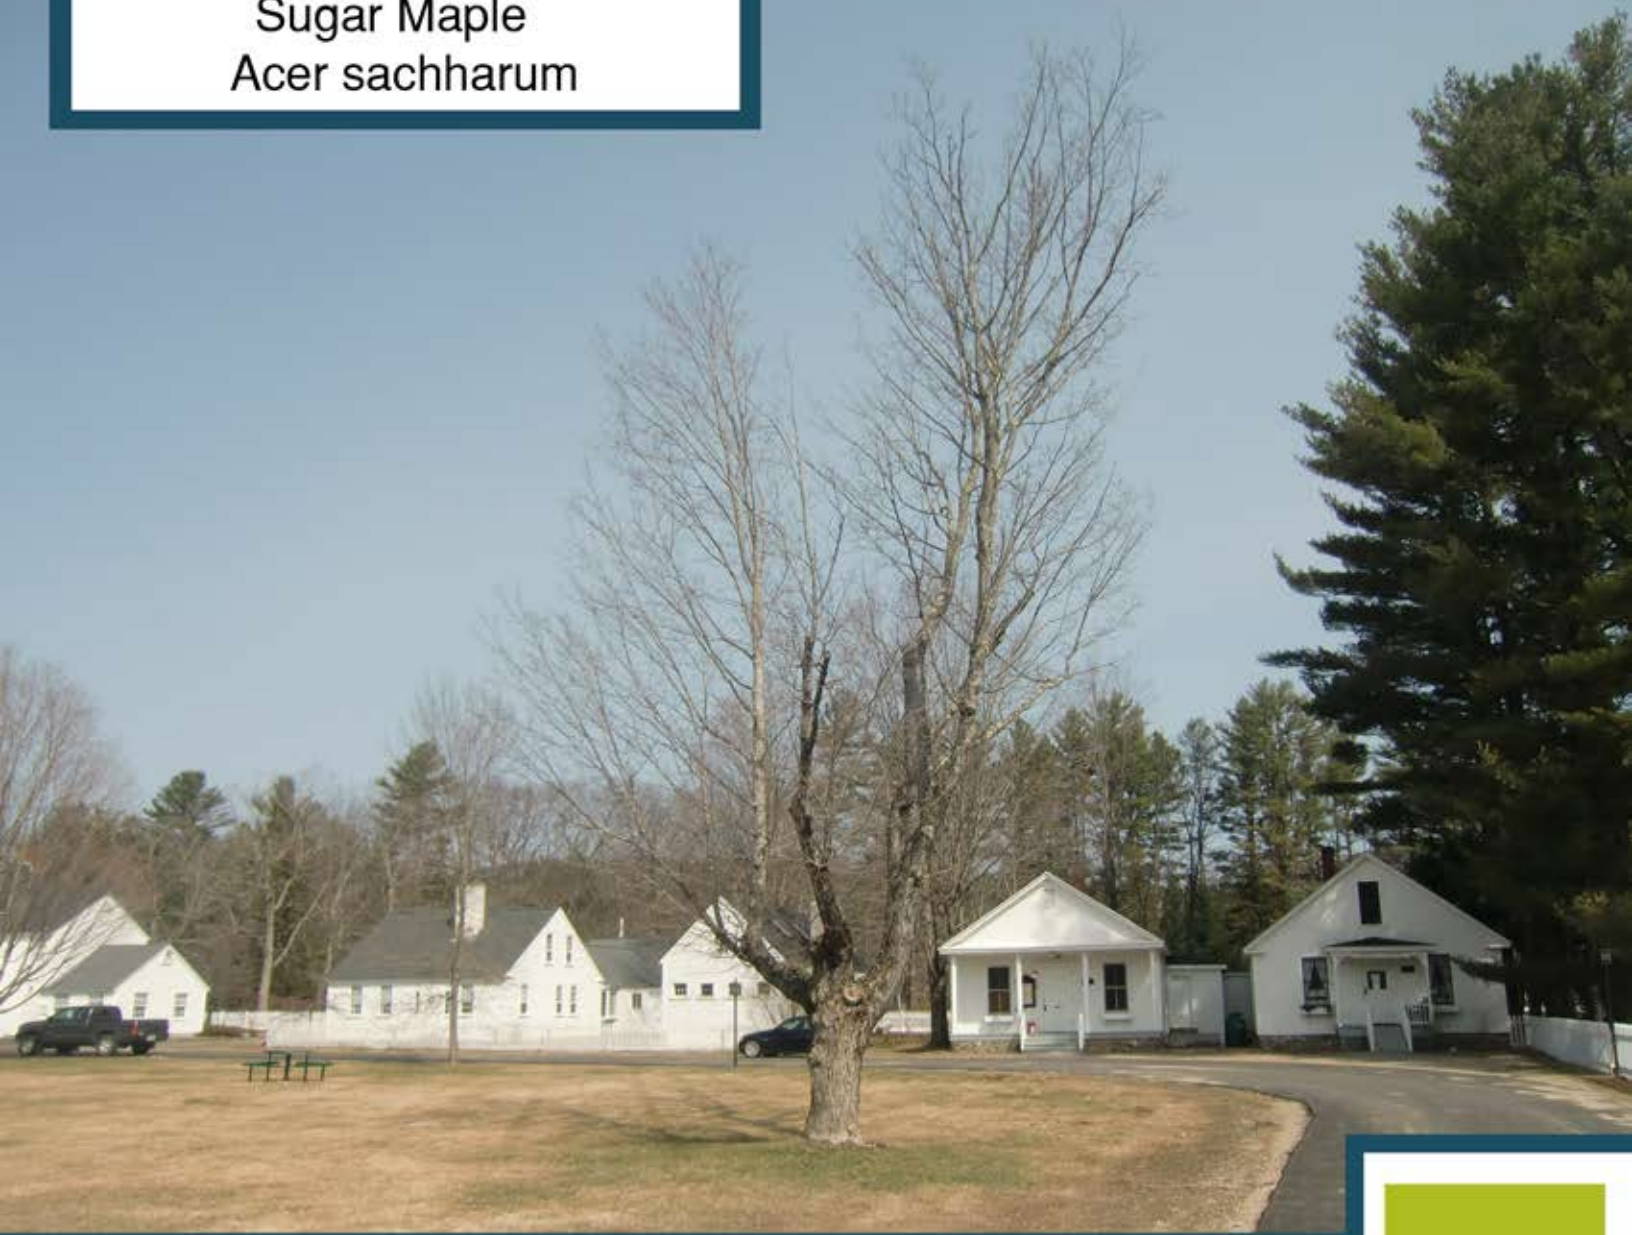
Tree #23
Sugar Maple
Acer sachharum

1. Conditon - Fair

2. Save or Remove - Remove

- a. There is substantial dead wood and interior decay in this tree. It is in failure condition and is too expensive to make temporary repairs to salvage it. Replace this tree in the same or near the same location with Sugar Maple 'Legacy' *Acer Saccharum* 'Legacy'

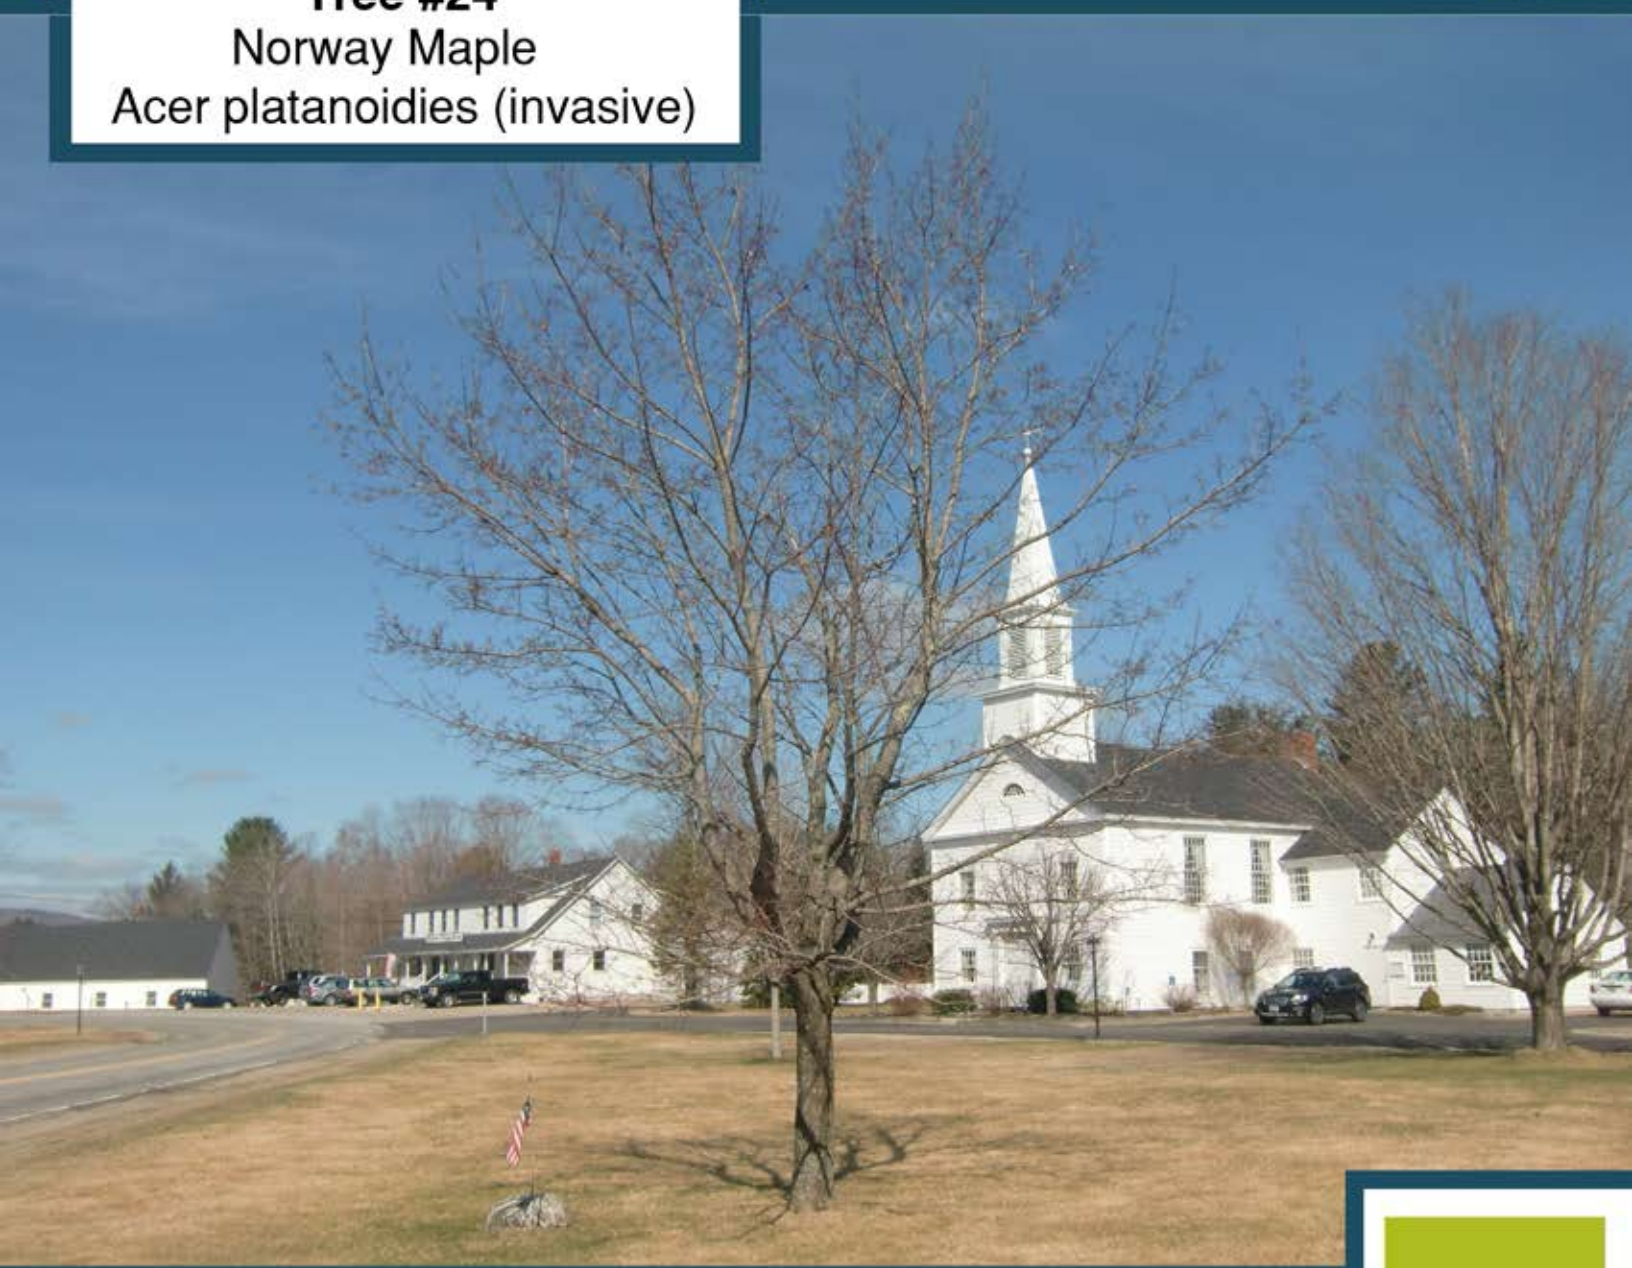
Tree #24
Norway Maple
Acer platanoides (invasive)

1. Condition - Fair

2. Save or Remove - Remove

- a. This tree has decay in its main stem. Temporary root fertilizing will extend its life. But should be replaced because it is invasive. Replace with a Red Maple 'October Glory' *Acer rubrum* 'October Glory'

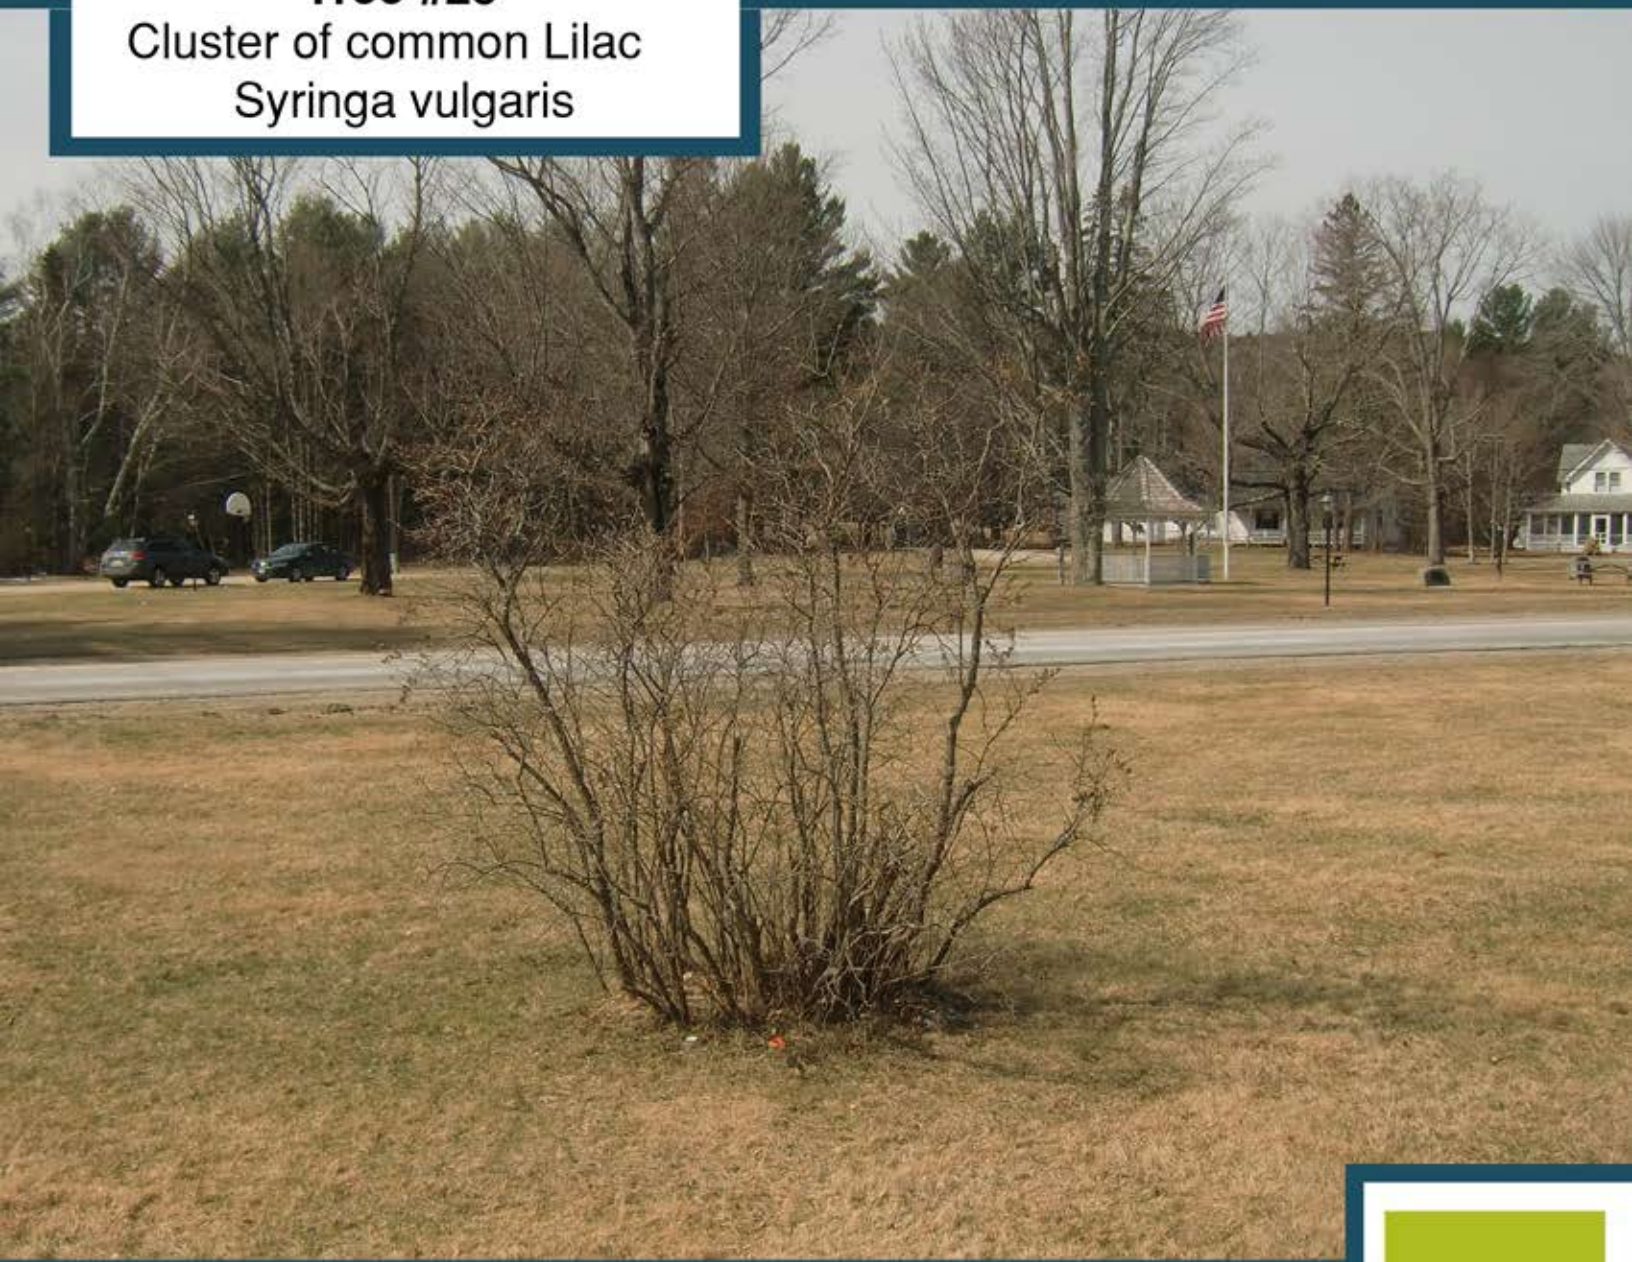
Tree #25
Cluster of common Lilac
Syringa vulgaris

1. Condition - Good

2. Save or Remove - Save

- a. This cluster of lilac seem a little out of place they would be better situated around the "town Clerk" sign as part of a unified planting bed rather than just placed in a random spot on the common. Transplant them as part of a planting bed.

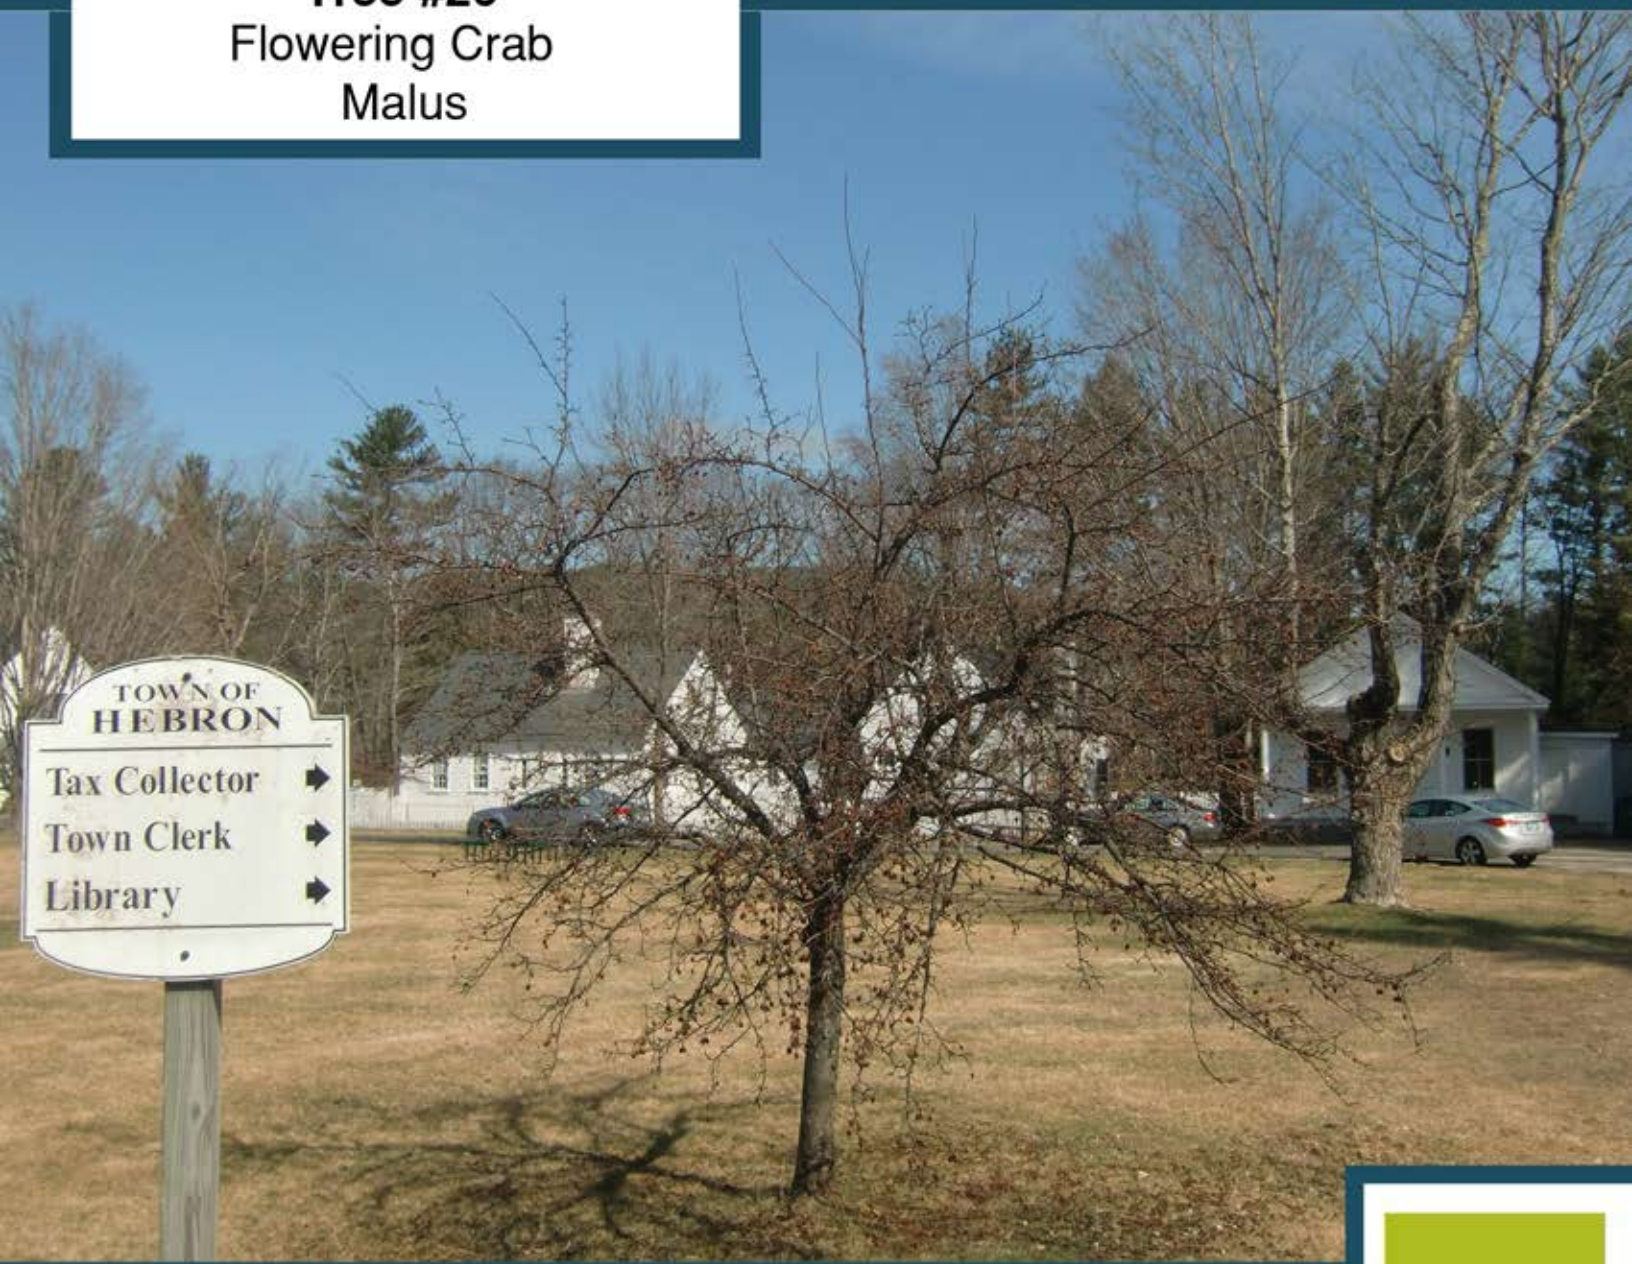
Tree #26
Flowering Crab
Malus

1. Condition - Good

2. Save or Remove - Save

- a.** This tree needs substantial pruning. Prune any interior branches and crossing branches. It should be pruned like a standard apple tree would be pruned. Root fertilize and mulch the root zone.

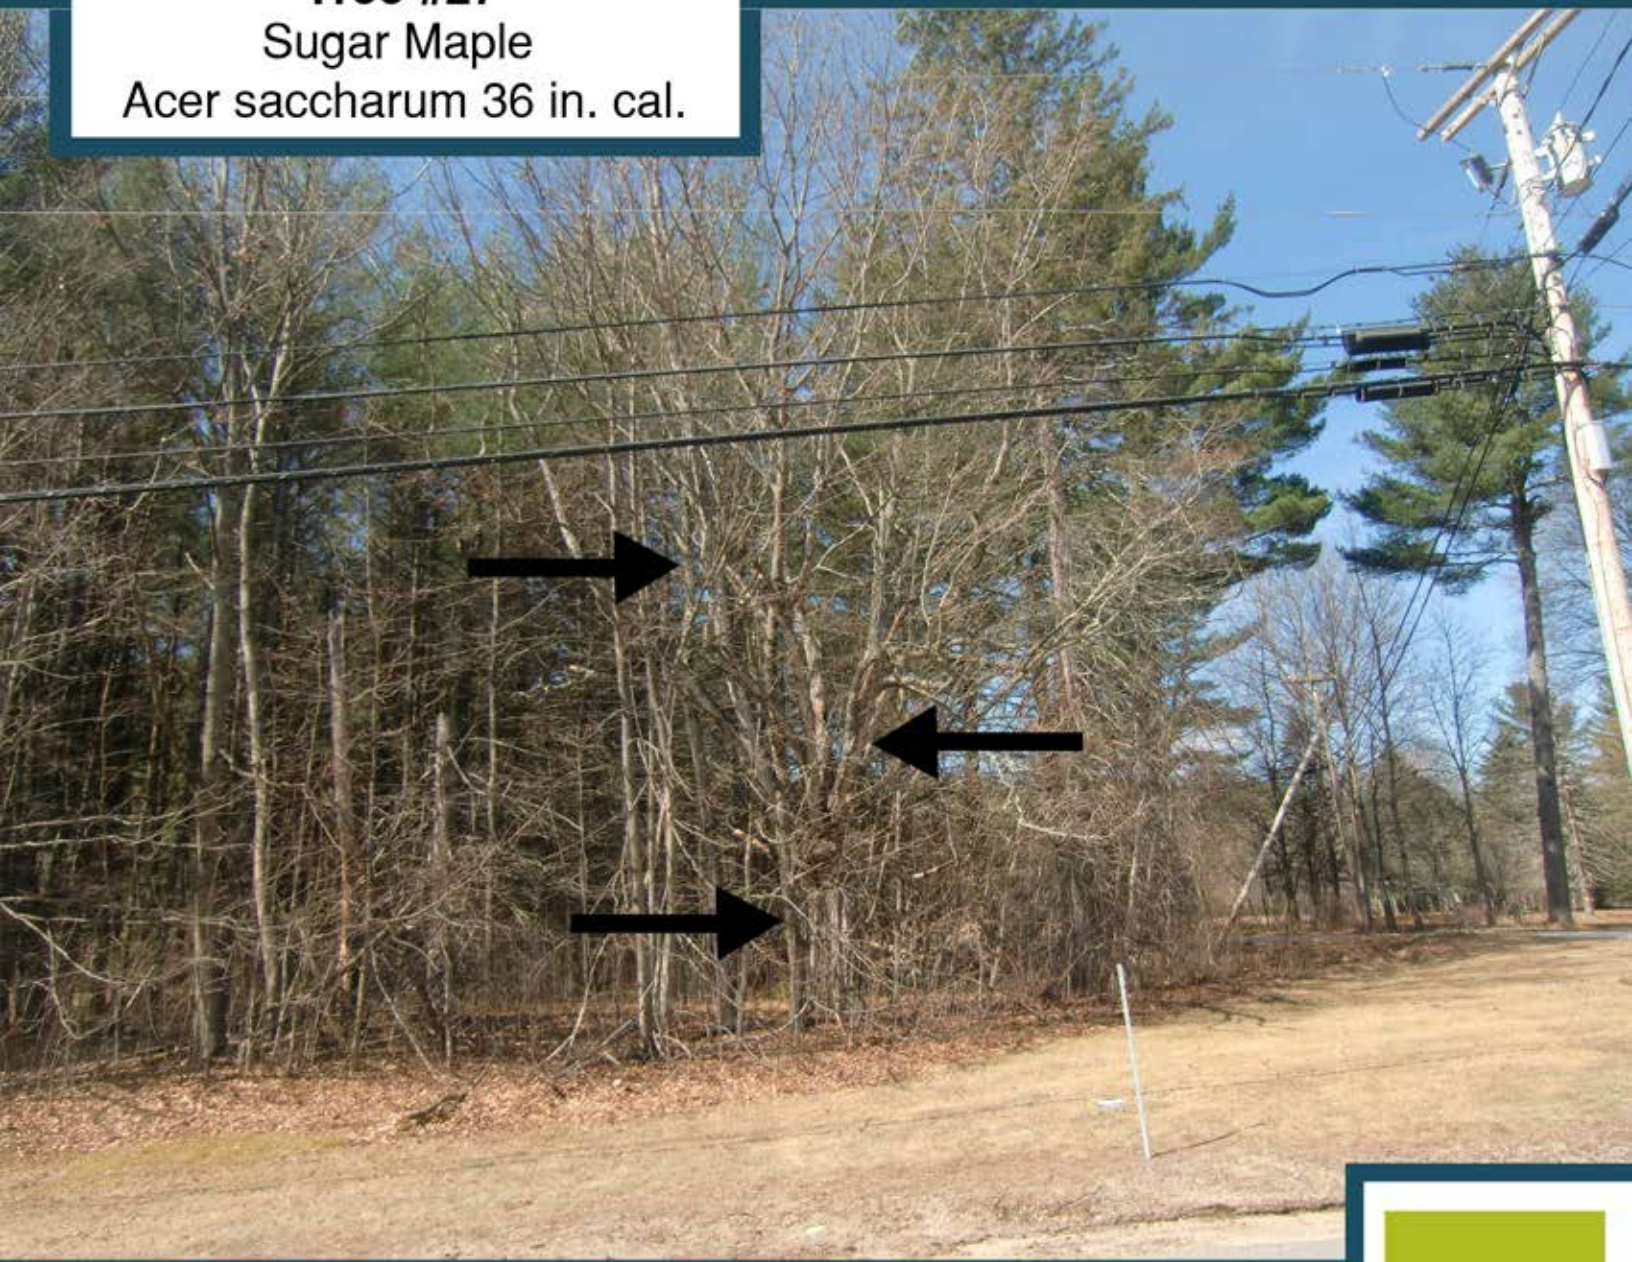
Tree #27
Sugar Maple
Acer saccharum 36 in. cal.

1. Condition - Good

2. Save or Remove - Save

- a.** This tree is located behind a lot of secondary growth. Clean out any secondary growth from around it so that it becomes the feature tree in this location. It probably has a fair amount of dead wood that should be cleared out. Just the removal of the competitive secondary growth will do a lot to sustain the life of this tree. It cannot be seen from West Shore Road.

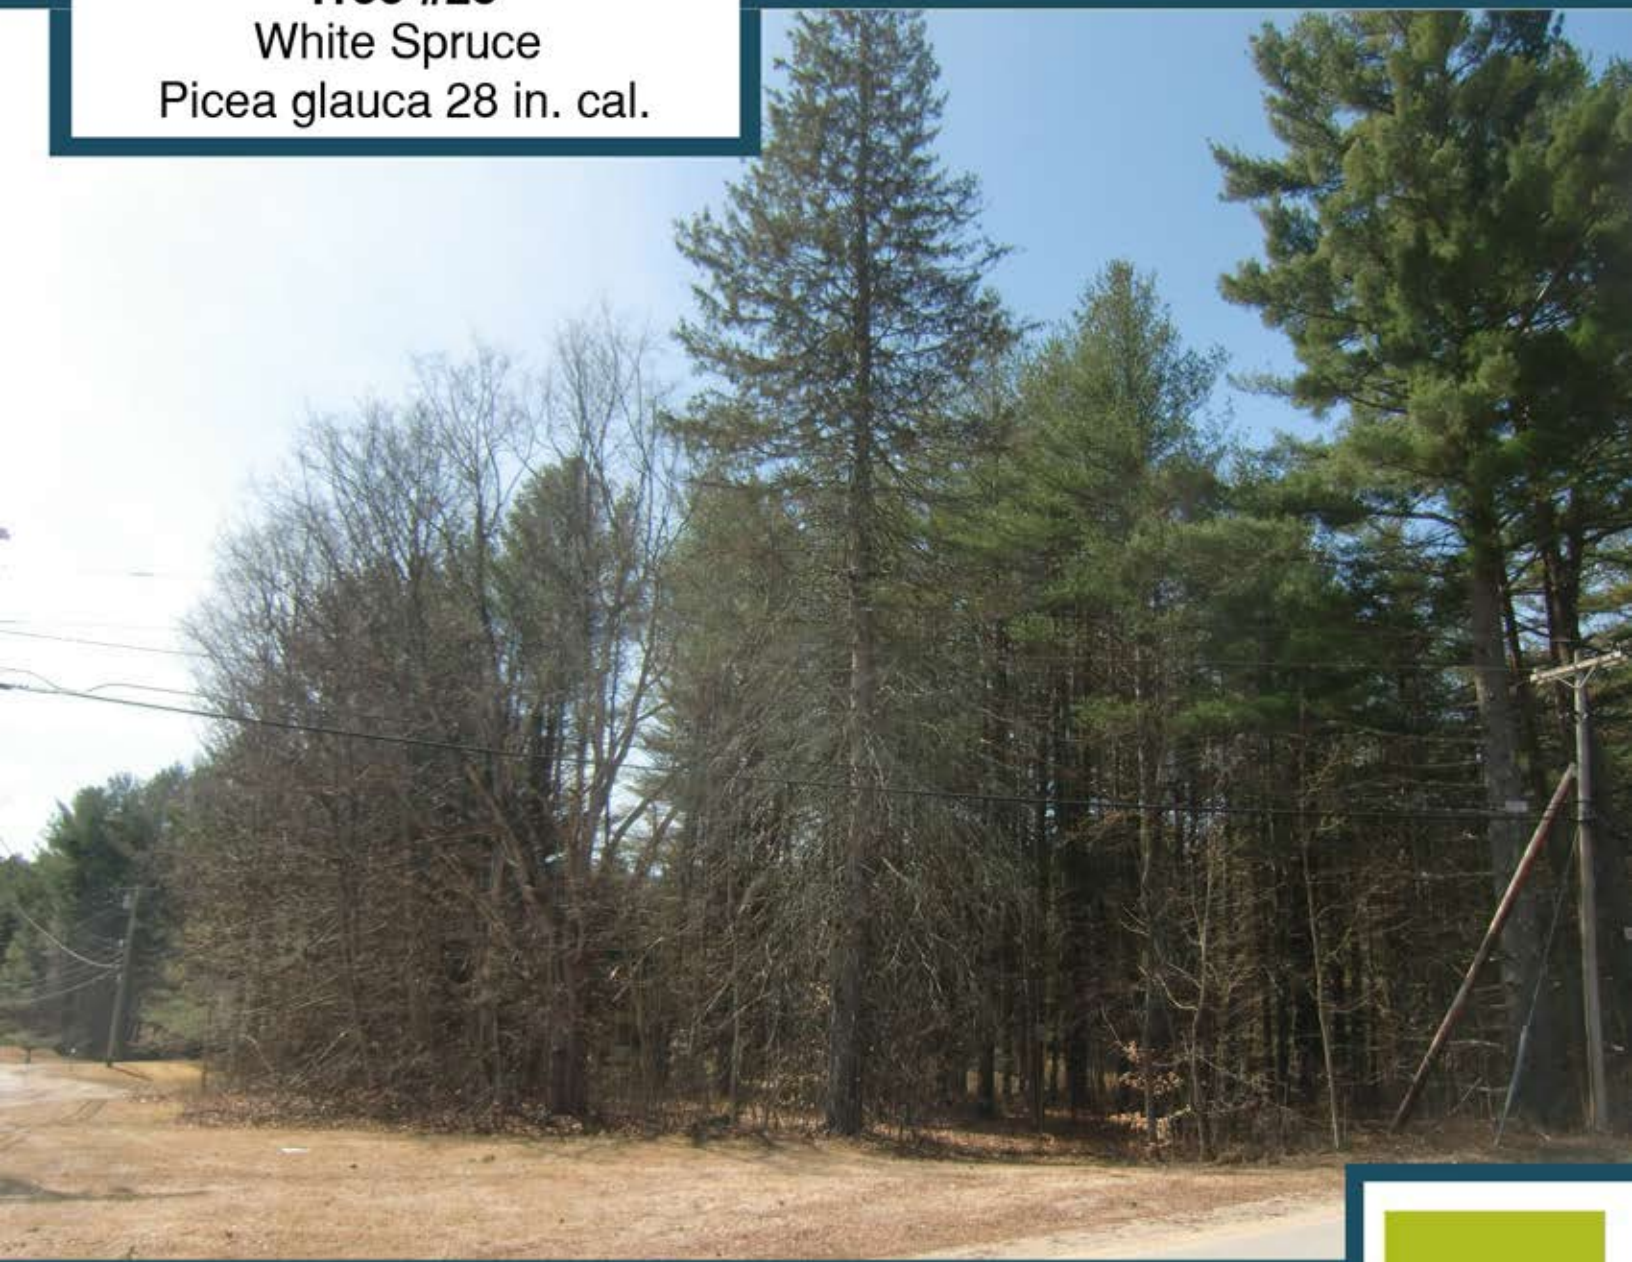
Tree #28
White Spruce
Picea glauca 28 in. cal.

1. Condition - Poor

2. Save or Remove - Remove

- a. Eventually this tree will fall down on its own under the existing conditions. When time and money allow, then remove the tree. It is behind a substantial amount of secondary growth and is not worth replacing. Unless there is some substantive reason to replace this tree it is recommended that the money saved on this tree be used on the primary portion of the common for larger caliper trees.

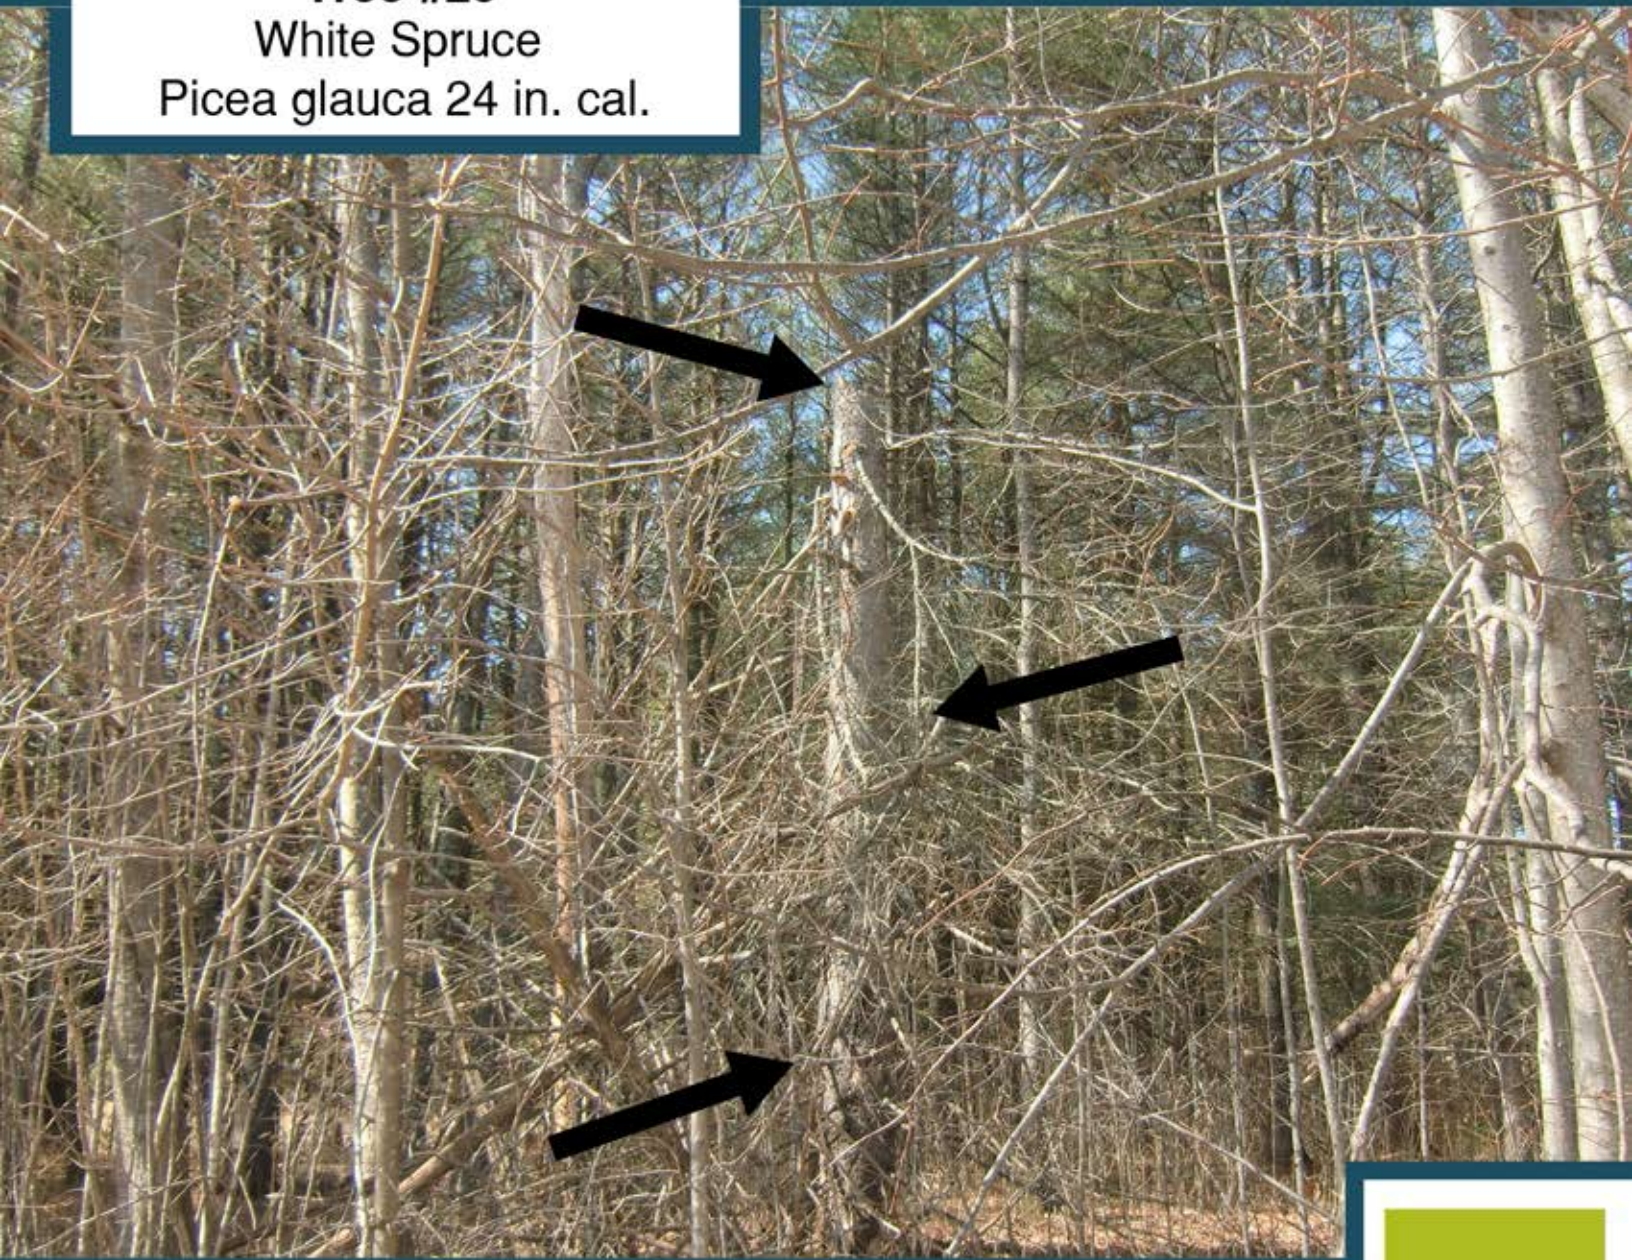
Tree #29
White Spruce
Picea glauca 24 in. cal.

1. Condition - Poor (Dead)

2. Save or Remove - Remove

- a. Remove what remains of the tall snag, it is not worth replacing it because it is behind a large amount of secondary growth and cannot be seen from West Shore Road. Unless there is a planned substantive use of this property on the west side of West Shore Road, put the money into planting larger tree on the primary part of the common.

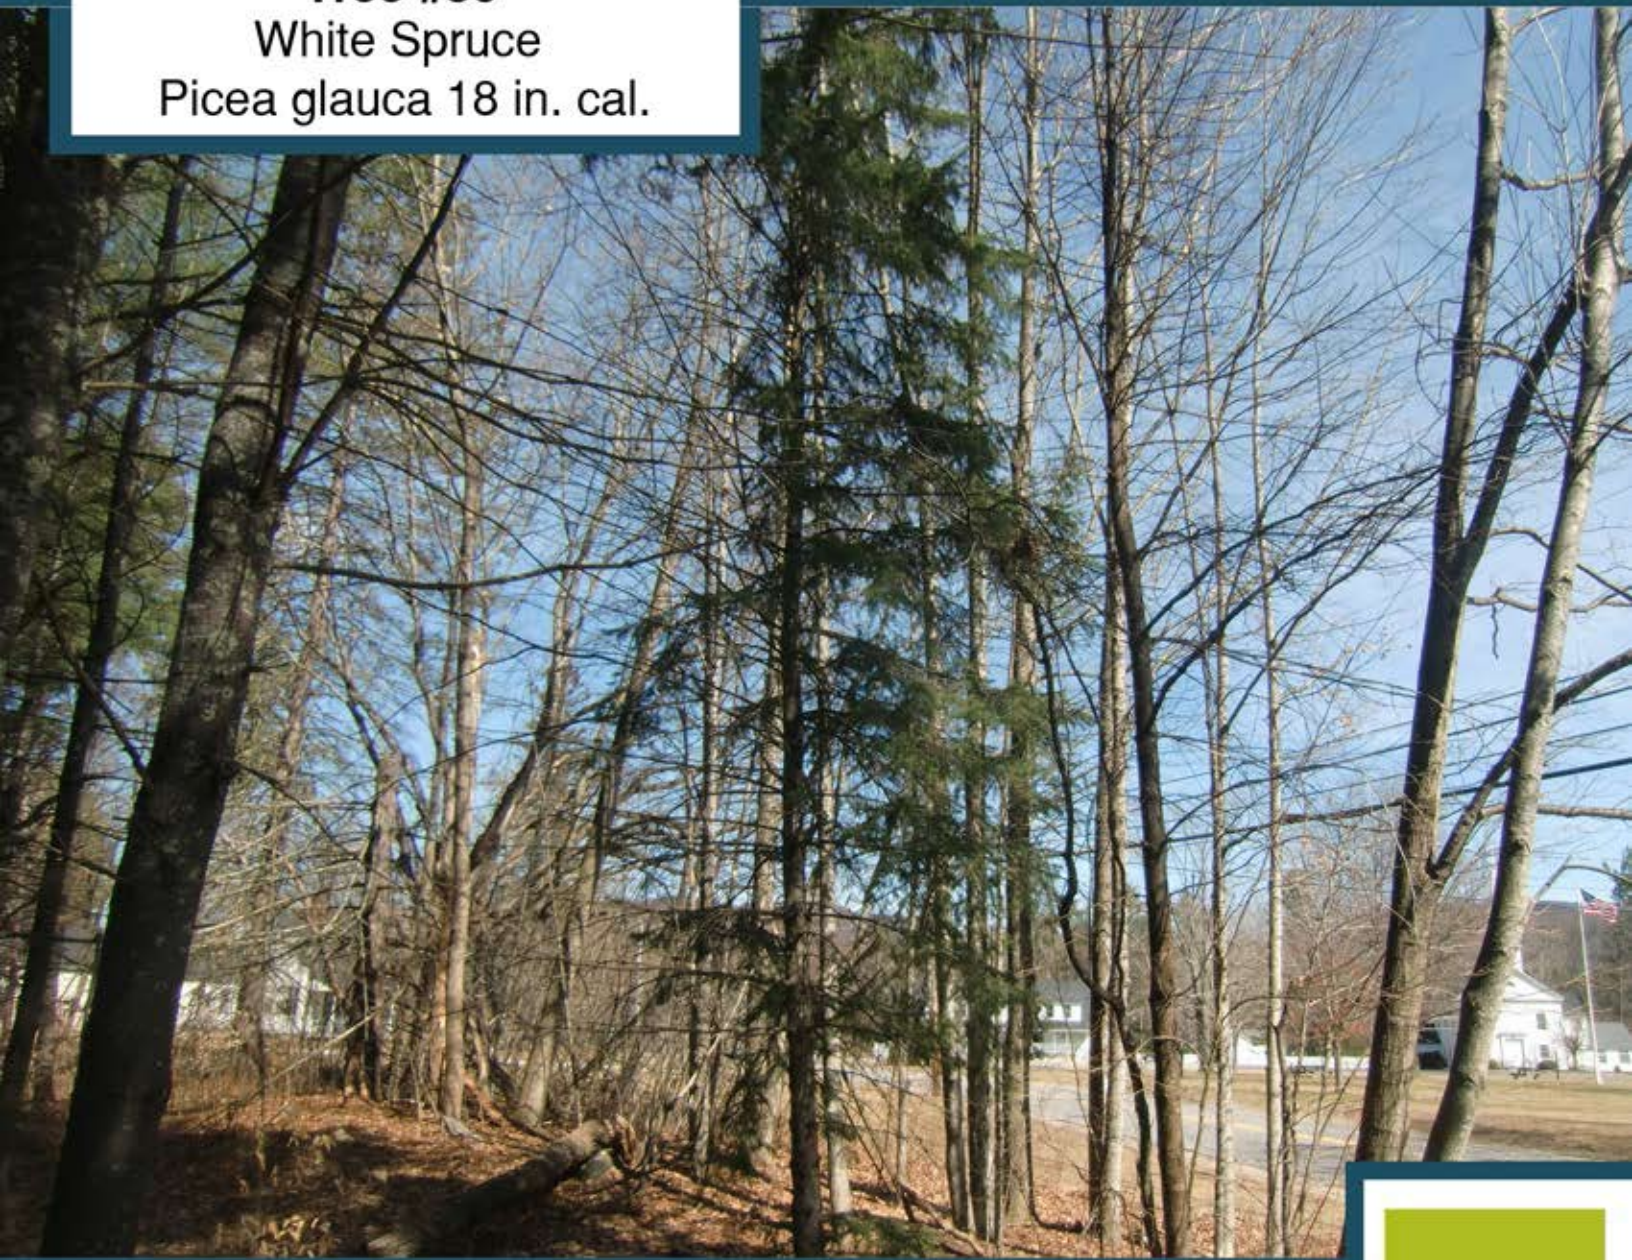
Tree #30
White Spruce
Picea glauca 18 in. cal.

1. Condition - Fair

2. Save or Remove - Leave alone

- a.** This tree has too much competition from other trees that it will eventually die. It is not worth spending time to remove or salvage. Let nature take its course. This tree is not worth putting money into either saving or removing the money could be better spent to plant larger trees on the primary area of the common. Because of the secondary growth this tree cannot be seen from West Shore Road.

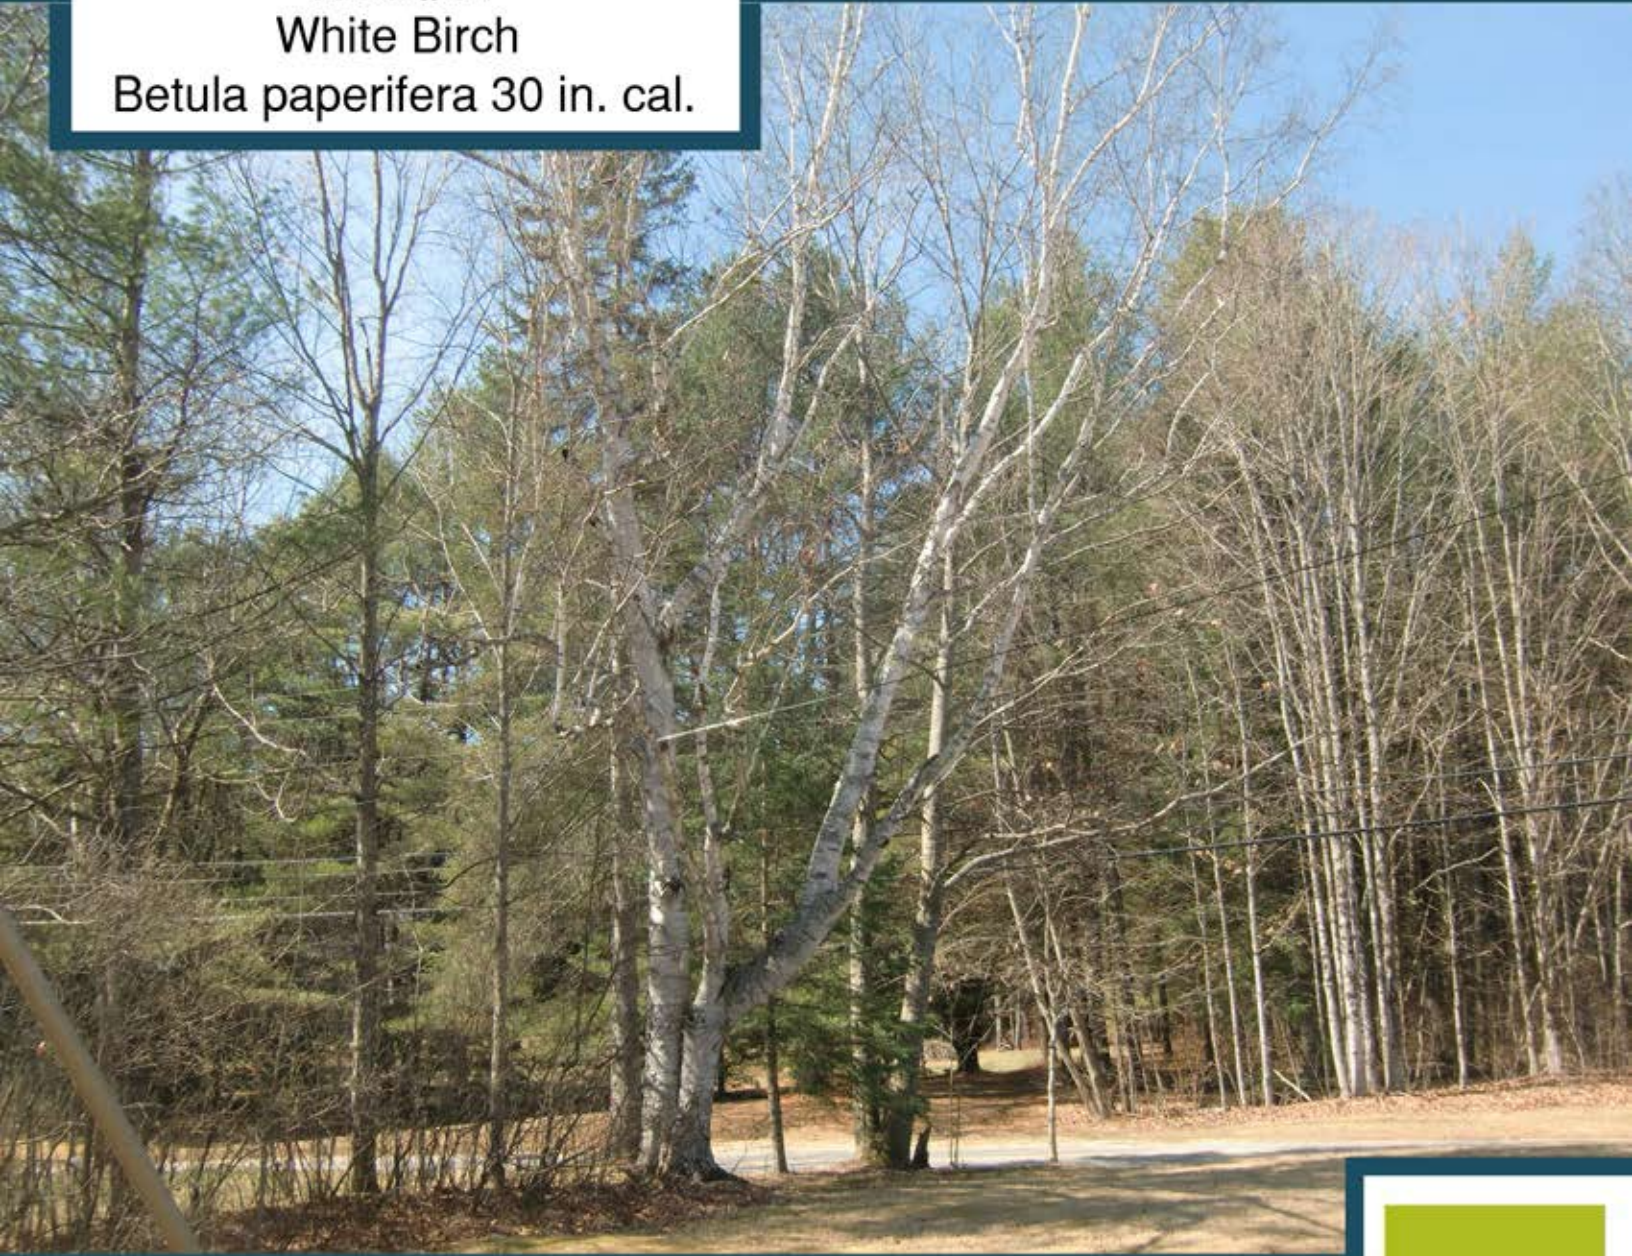
Tree #31
White Birch
Betula papyrifera 30 in. cal.

1. Condition - Good

2. Save or Remove - Save

- a. For the time being, this tree is worth saving. Birches are notoriously short lived trees in the world of trees. Eventually in time, it will go into decline and will have to be removed. At this time do some fall pruning to remove the dead wood. Root fertilization and aeration of the soil and some mulching of the root area. Cabling the two stems would be recommended also.
