Hebron, NH

Tree Inventory

Hebron Town Common

June 6, 2016

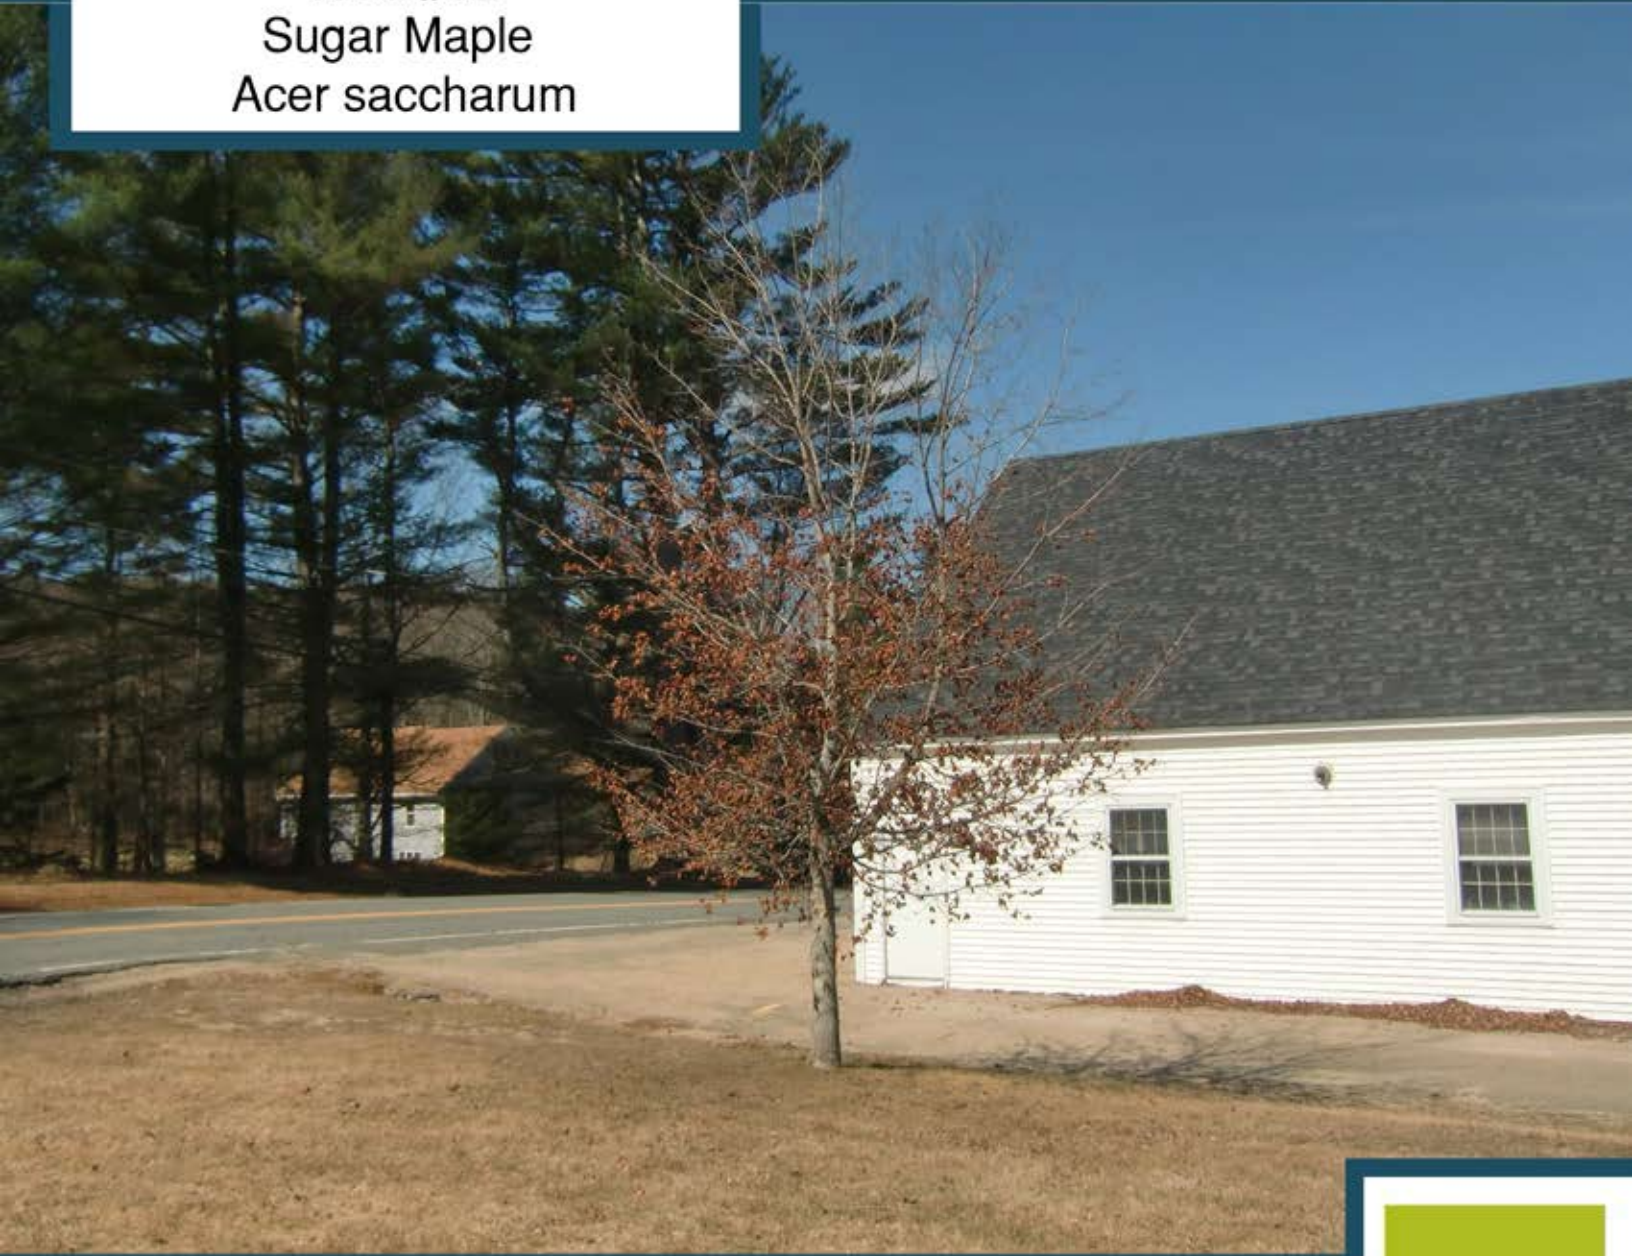
Tree #32
Sugar Maple
Acer saccharum

1. Condition - Excellent

2. Save or Remove - Save

- a. One of the better trees in the common inventory. The crown should be thinned by a professional arborist. The tree should be root fertilized and the root area aerated and mulched. The ground appears to be very compact in this area.
